**Reg. No: SKA2010027**

**FINAL REPORT**

on investigation of an air accident  
of powered hang glider **ANTEA XL / WJ-F200**  
Registration No. **OM-P757 / P-757**

Date: 24.10.2010

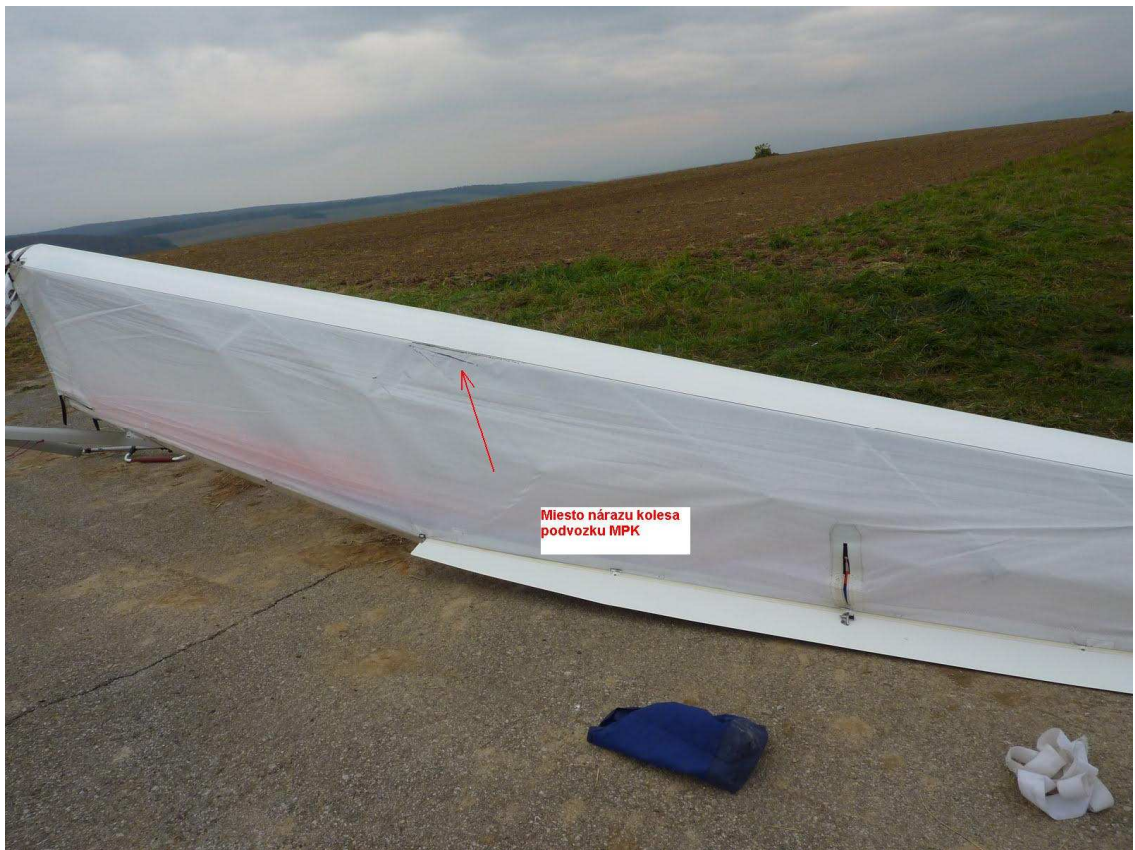
Fig. 1: Wing of Phantom PHG and point of impact of the landing gear wheel

The place of accident is situated in the north aircraft turning area of farmland Čečejevce – Seleška. Due to the impact the wing of PHG parked on the ground turned by 30° against the initial parking position. The wheel of PPG hit the right half of the wing (its nose section, approximately in the middle of the length of the nose D–box).

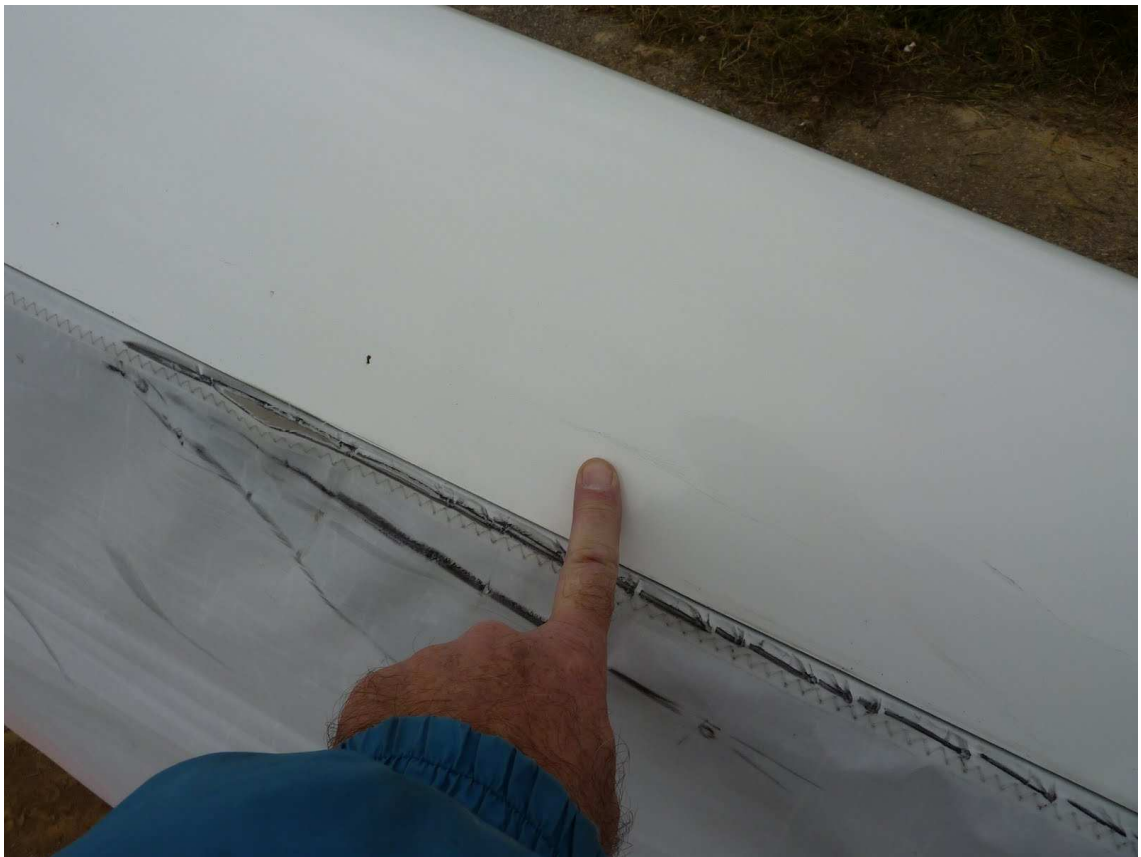
The nose D-box of wing and the wing covering of PHG parked on the ground were damaged. The attachment of the PHG wing rib was damaged. PPG was not damaged.

Fig.. 2: Damaged D-box and wing covering of Phantom PHG

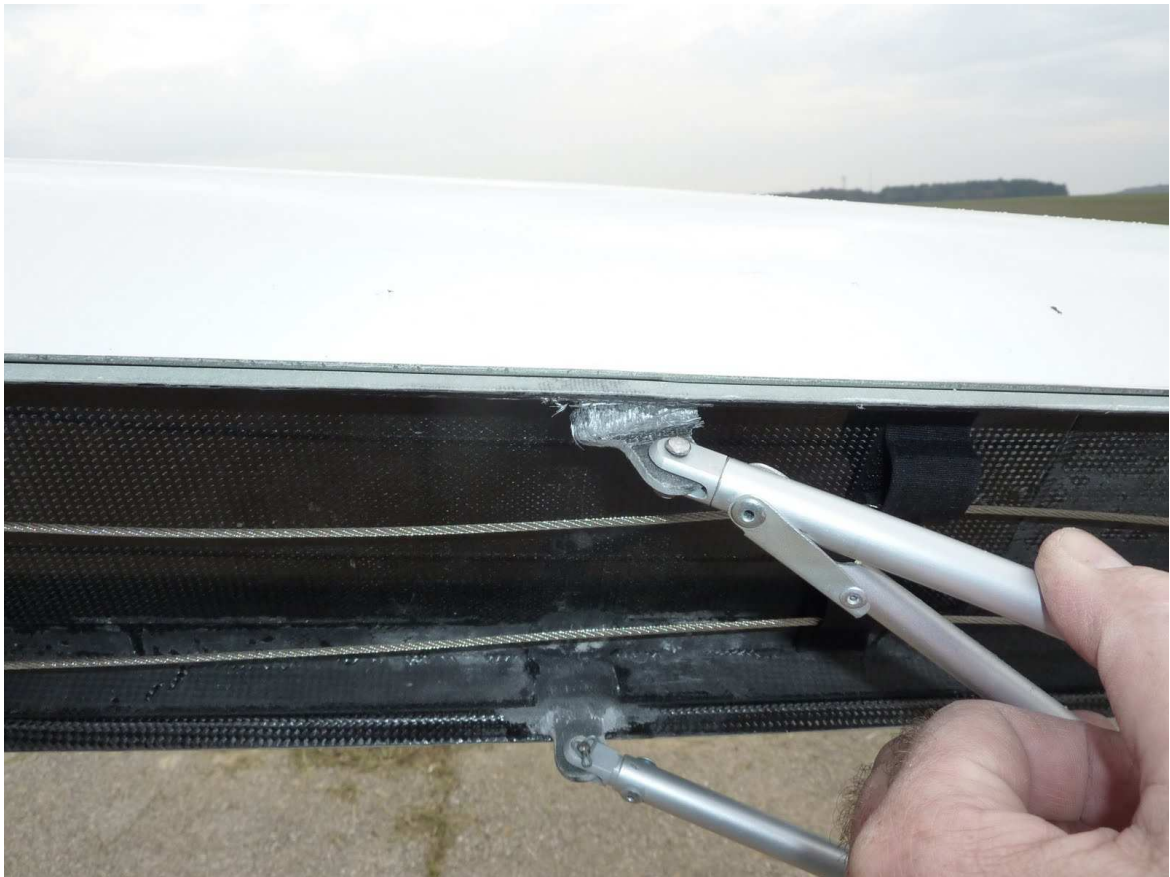
Fig. 3: Damaged upper attachment of Phantom PHG wing rib
