AVIATION AND MARITIME INVESTIGATION AUTHORITY
Námestie slobody 6, P.O.BOX 100
810 05 Bratislava 15

FINAL REPORT

on Safety Investigation
of a flying sports device
Axis Paraglider VEGA 4 L
registration mark **OM-P801**

Reg. No.: **SKA2019001**

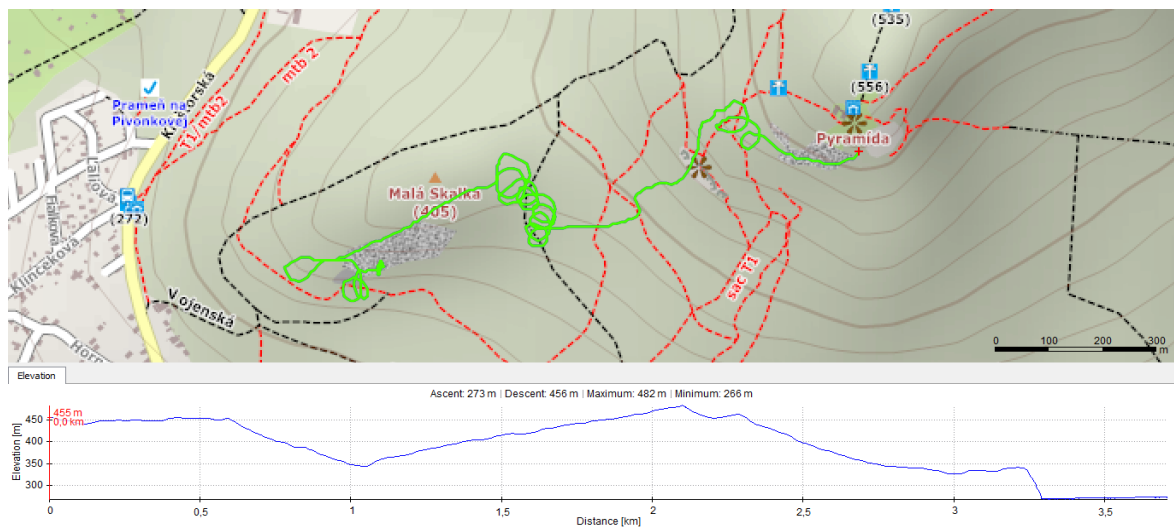
Fig. No. 1 Flight Trajectory

After 20 minutes of flight, he reached the area of “Kameňolom,” about 50 meters above the ground. This place is generally known as thermal, where FSD pilots can climb. The pilot began to climb 360 degrees at the first thermal vertical gust in turns. After three turns he reached a height of about 80 m above the terrain, when the second and then the third much stronger thermal vertical gust arose, which caused the collapse of the PG canopy. Despite the effort, the pilot failed to regenerate the PG canopy to a normal flight position and a fall followed subsequently. The pilot did not manage to use the reserve parachute.

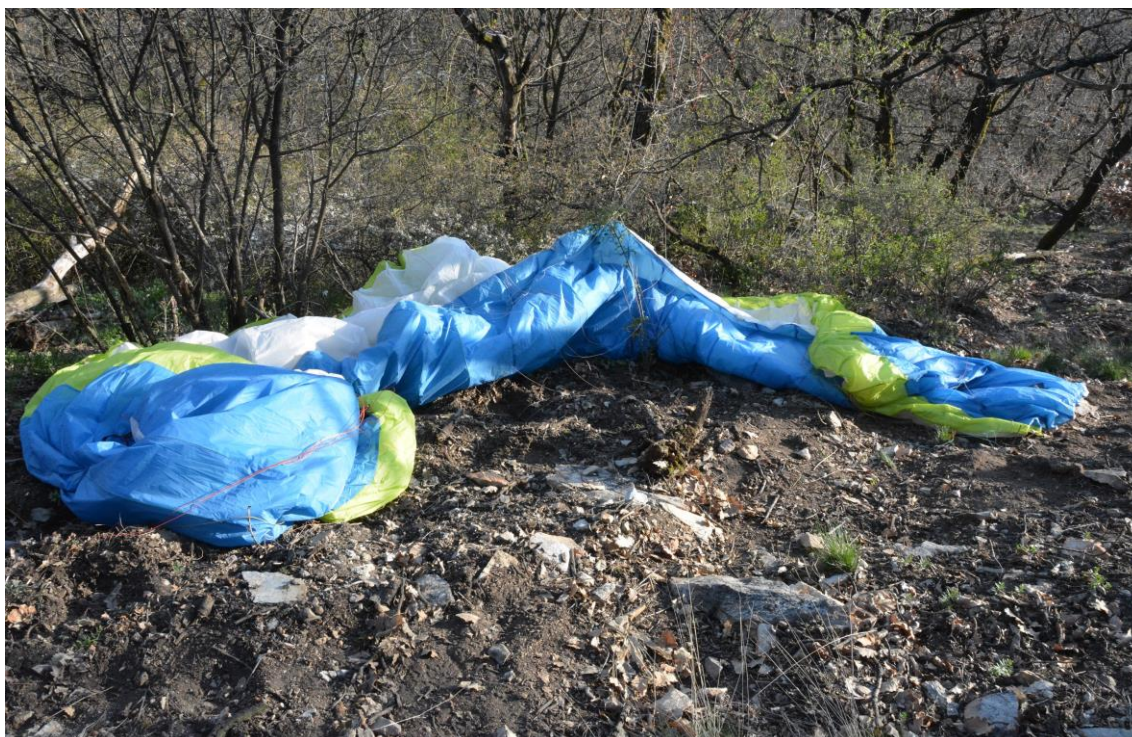
The pilot hit the rocky surface and the PG canopy caught on the surrounding trees.

Fig. No. 2 PG canopy at the air accident site

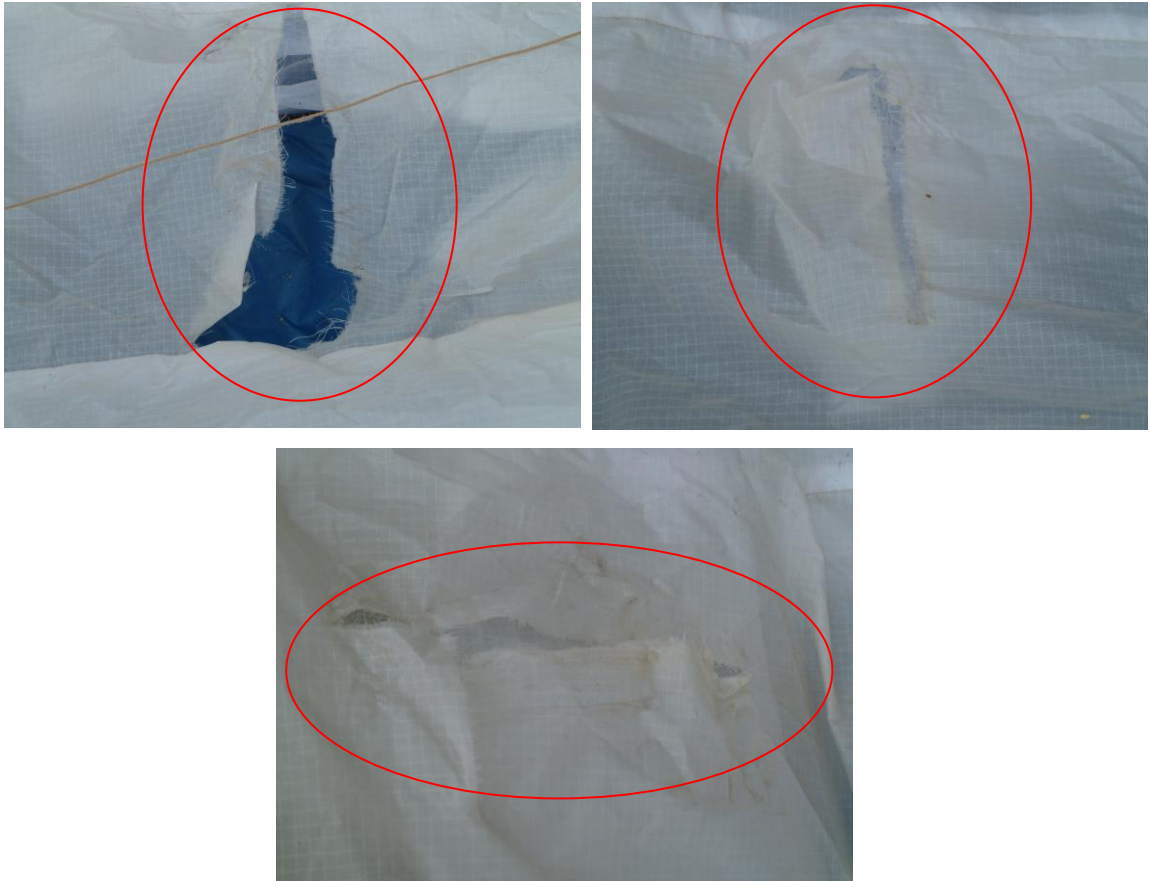
The PG was damaged to a large extent in the air accident. Damage was caused by the trapping in obstacles (trees) for three chambers on the right side of the PG.

Fig. No. 3 Damage to the chamber of the PG canopy after the impact on obstacles

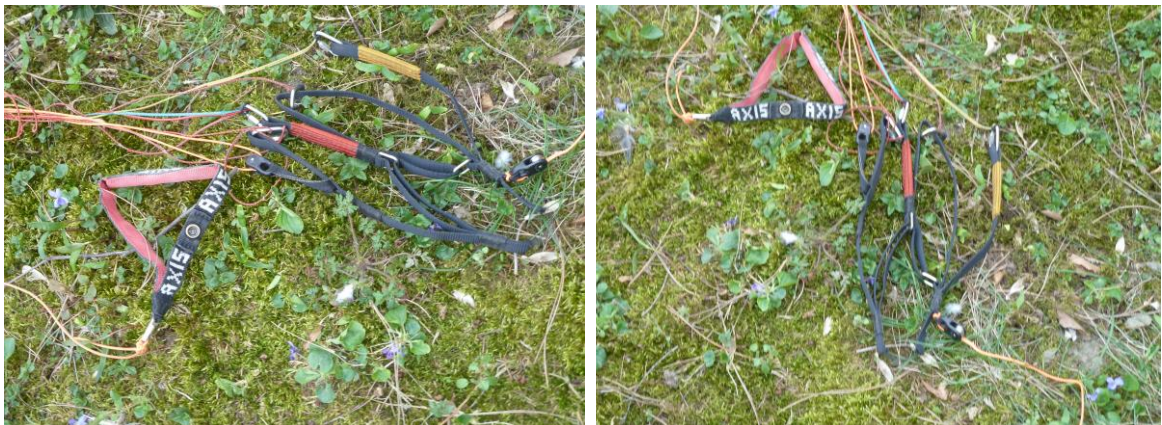
The free ends of the PG were cut to provide assistance to the pilot.

Fig. No. 4 Cutting free ends of PG
