# FINAL REPORT

on safety investigation of an aviation accident

of aircraft type **Z-226 MS**

registration mark **OM-MFN**

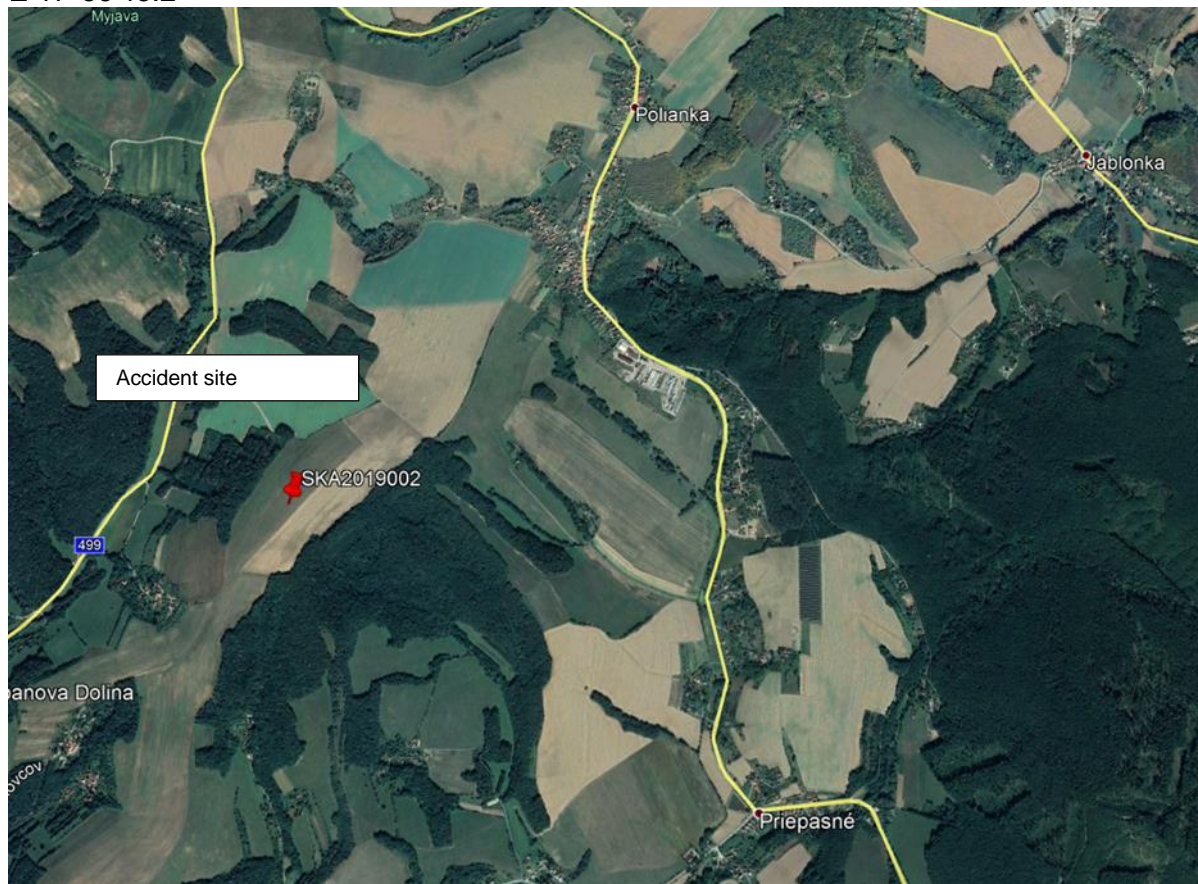
The accident site is located in the cadastral territory of Prieprasné and it may be delimited with coordinates as follows:

N 48°42'41.3"

E 17°33'45.2"

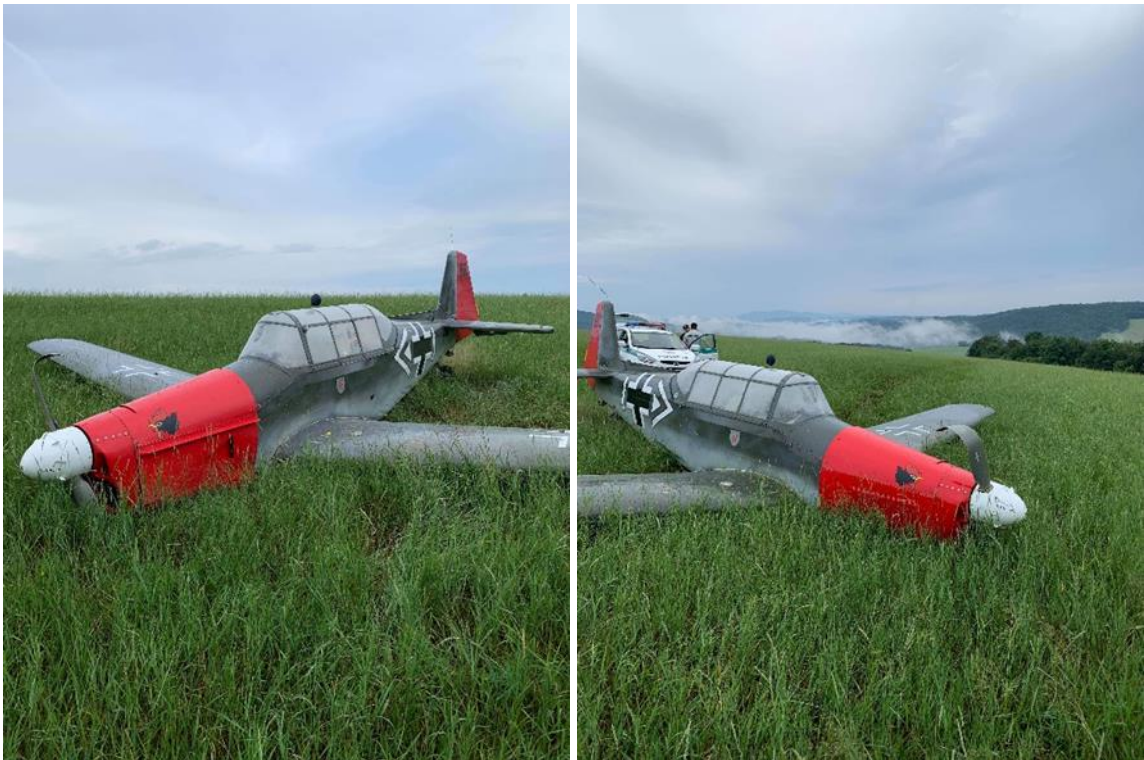
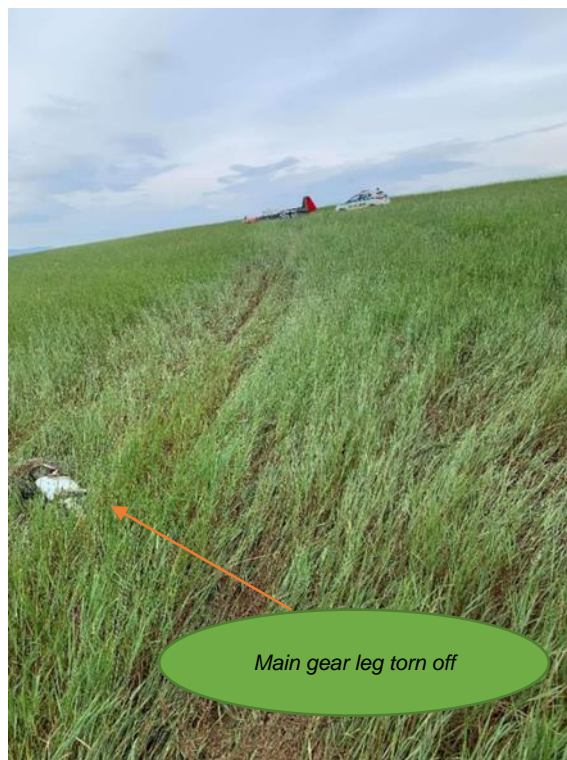
After the aircraft landed on a wet uneven terrain, the main landing gear legs tore off, the engine stopped working, the propeller, the bottom part of the fuselage and both wing parts were damaged.

The OM-MFN aircraft sustained major damage during the accident.

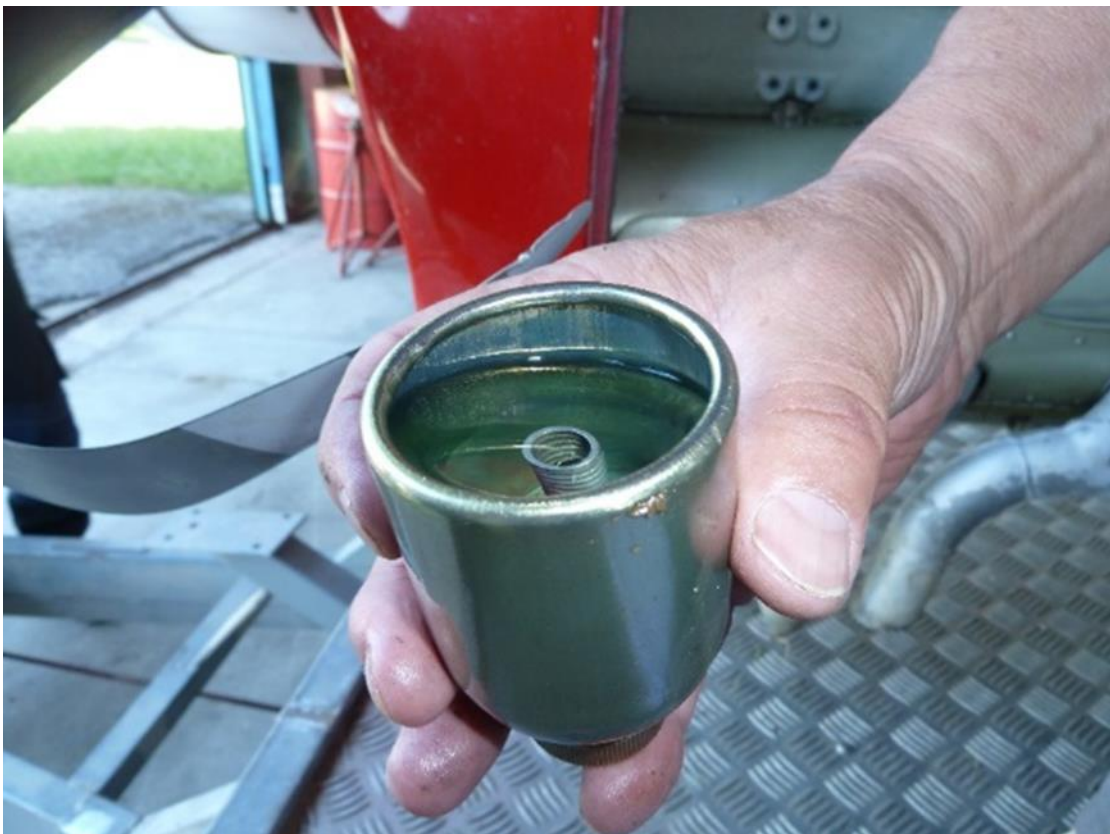
- fuel presence in fuel filter cups and fuel nozzles of the engine;

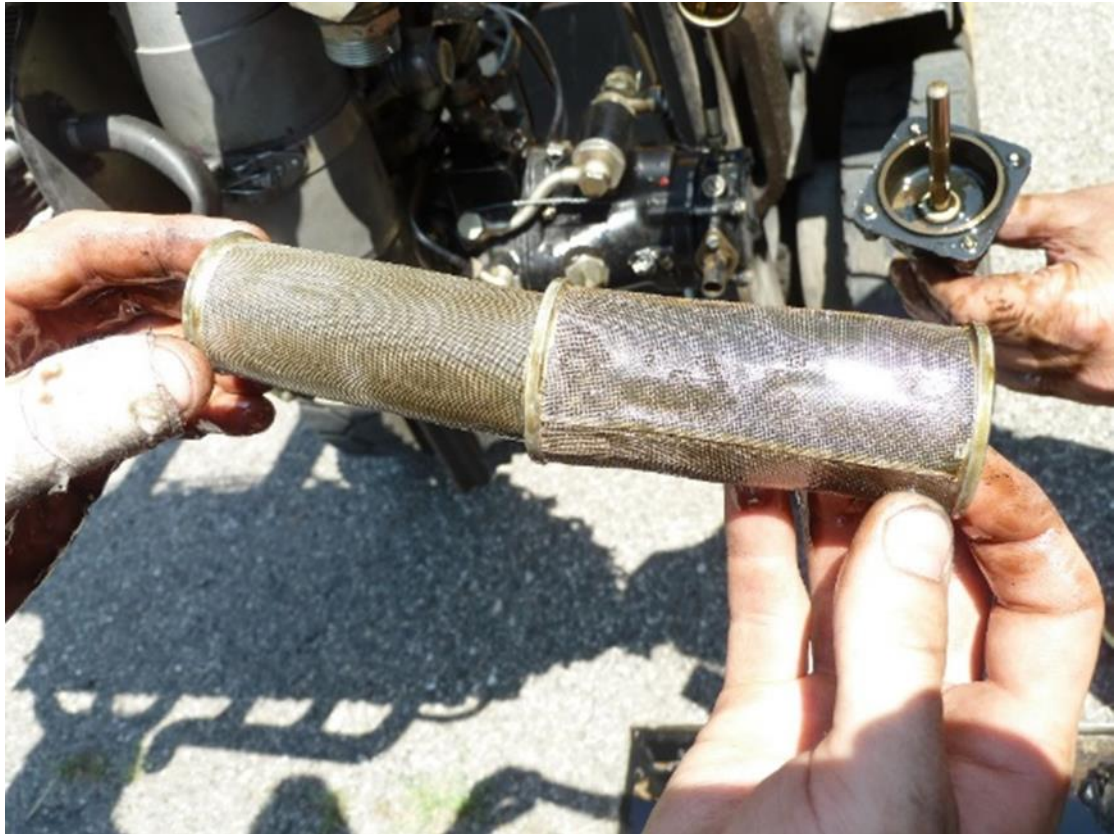
- no impurities which may have affected the engine function were detected during the oil filter visual inspection;

- **presence of water (drops) in exhaust apertures of the first three cylinder heads;**
- remains of grass in the engine intake manifold.
