AVIATION AND MARITIME INVESTIGATION AUTHORITY
Námestie slobody 6, P.O.BOX 100
810 05 Bratislava

FINAL REPORT

on the safety investigation of an air accident
of a glider type **ASTIR CS 77**
registration mark **OM - 7686**

Reg. No: **SKA2019003**

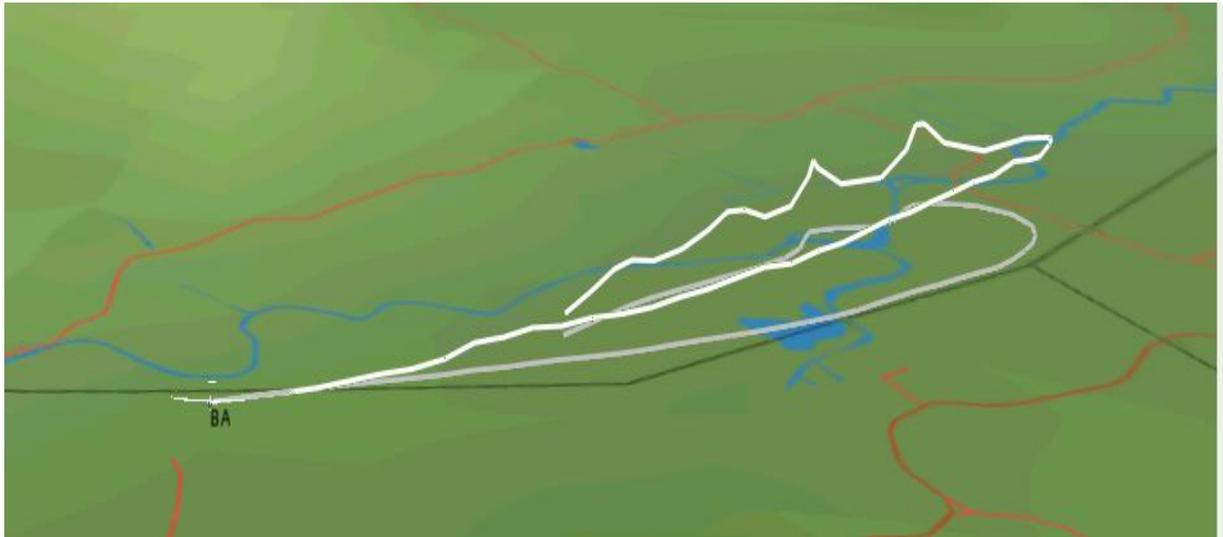
Picture 1 Glider flight trajectory

When adjusting the flight altitude during the next course of the flight she discovered that the glider was not responding to movements of the control stick and she realized that it was not a piloting mistake but that her elevator was not working. She tried to adjust the flight altitude with pitch trim control but she did not realize that such glider type did not have "aerodynamic" trim tab. Flight altitude could not be changed by moving the pitch trim control. She reported the situation to the pilot of the tow plane and she released off the aerotow. She was controlling the glider only with a rudder, ailerons and flaps.

After making a 180° turn she performed an emergency landing on RWY25 at LZPT. The approach for landing was unstable with a higher rate of descent (up to 10 m.s⁻¹).

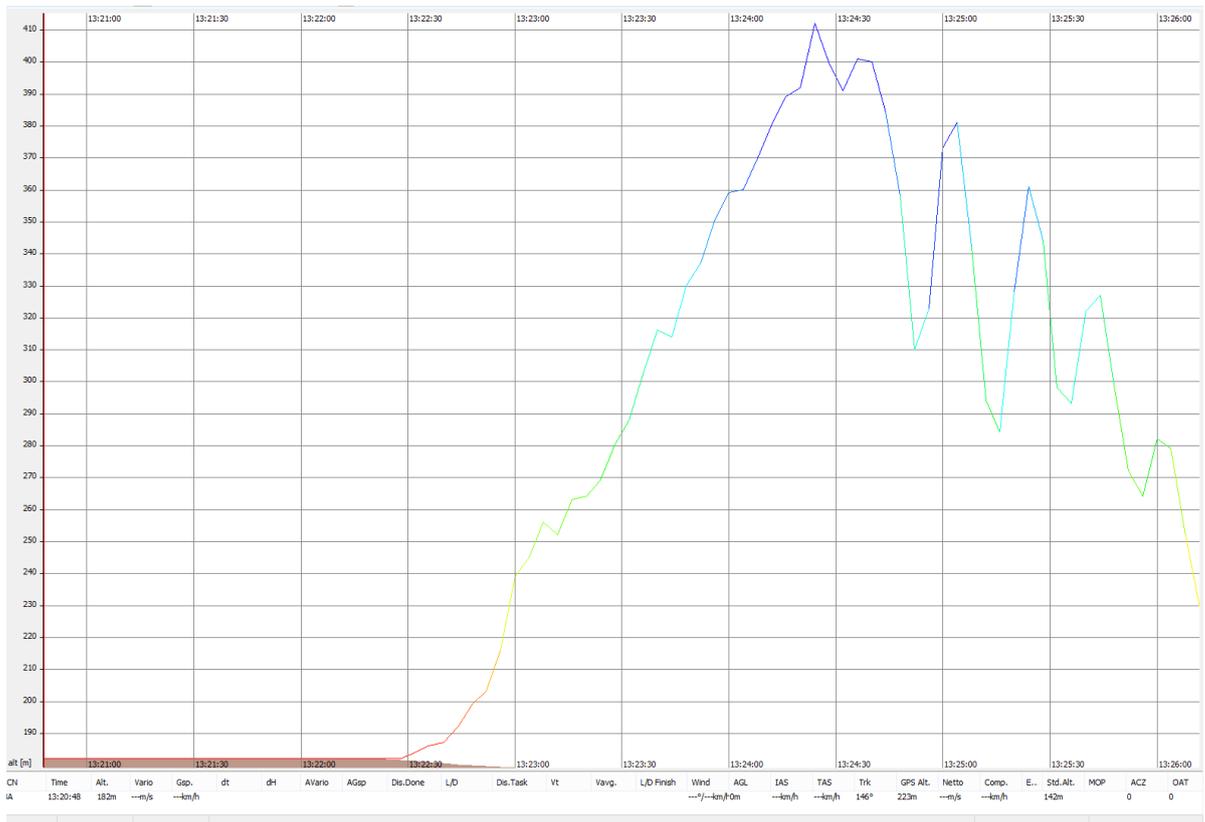
Picture 3 Flight altitude

The record was evaluated using the "SeeYou" programme. The record evaluation confirmed an unstable flight of the glider with frequent changes of altitude and vertical speed.

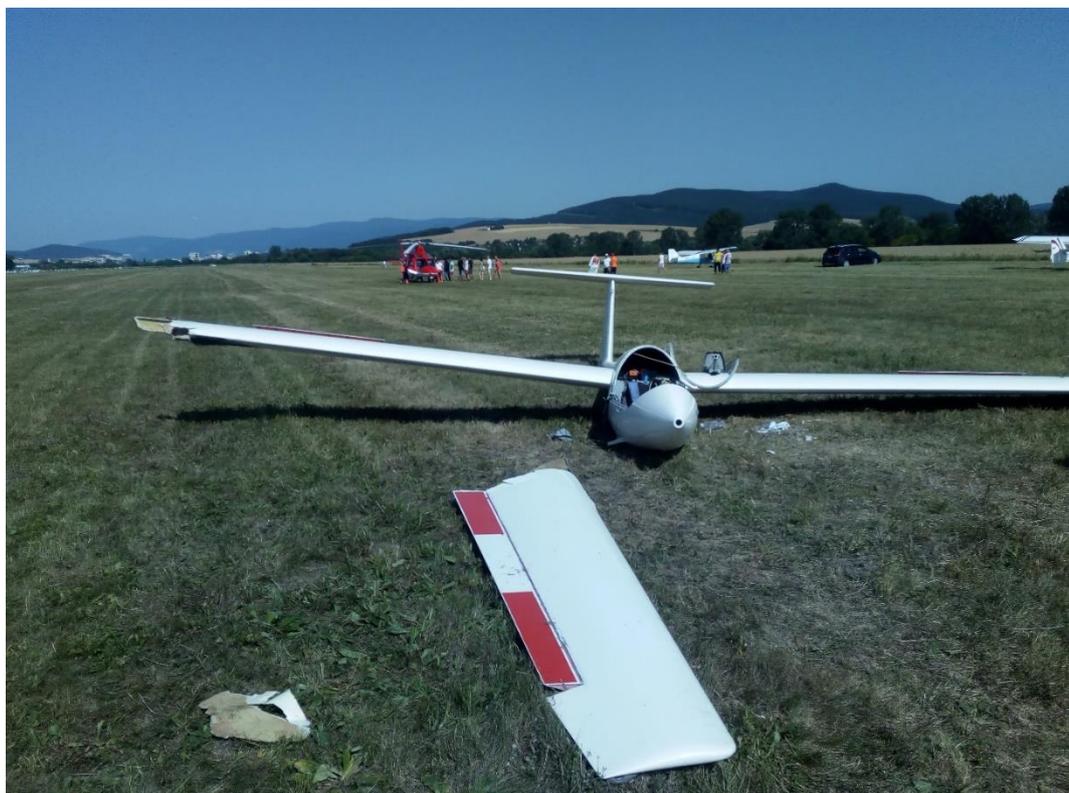
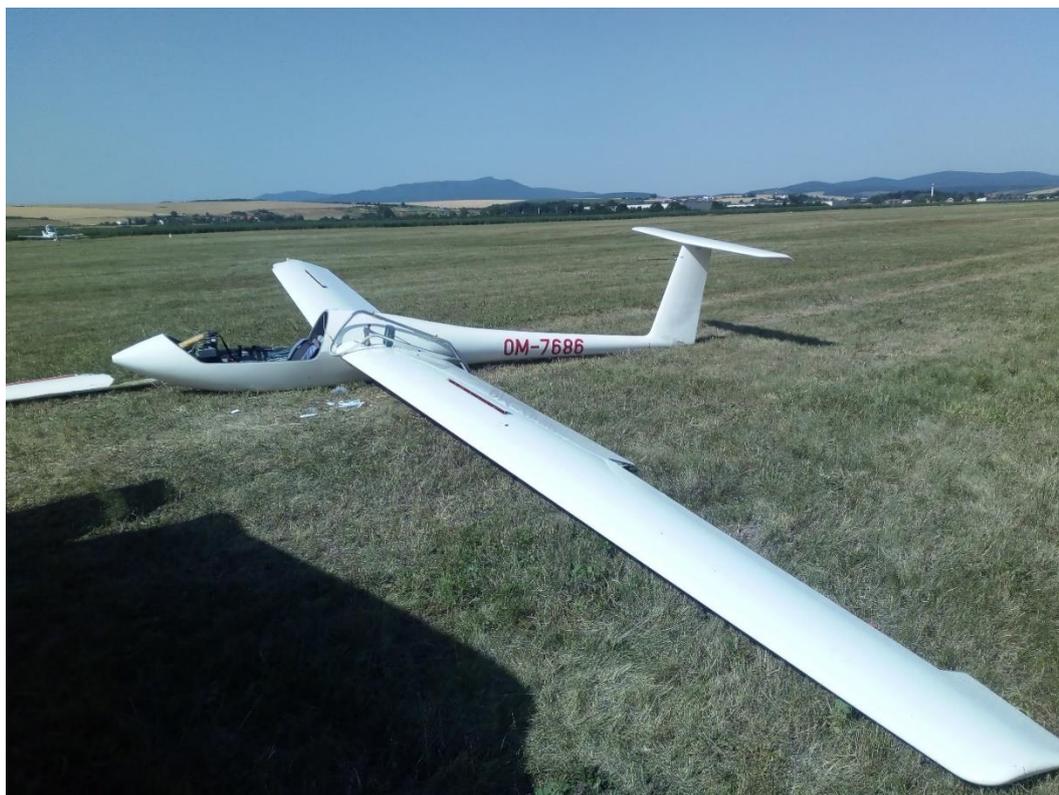
Picture 4 Glider after landing

Landing was performed without levelling out and with a large angle of descent, as a result of what the front part of the fuselage and the tip of the left wing touched the ground first. This caused a sharp rotation to the left during which the right wing broke off and the aileron and the rudder ripped off. After stopping the glider remained turned by 180° in the landing direction on RWY25.

The glider was destroyed in the accident. The inspection showed extensive damage to the right wing and the rudder, extensive delamination of the bottom part of the fuselage in the area of the cabin and the keel, broken undercarriage and broken cabin cover.

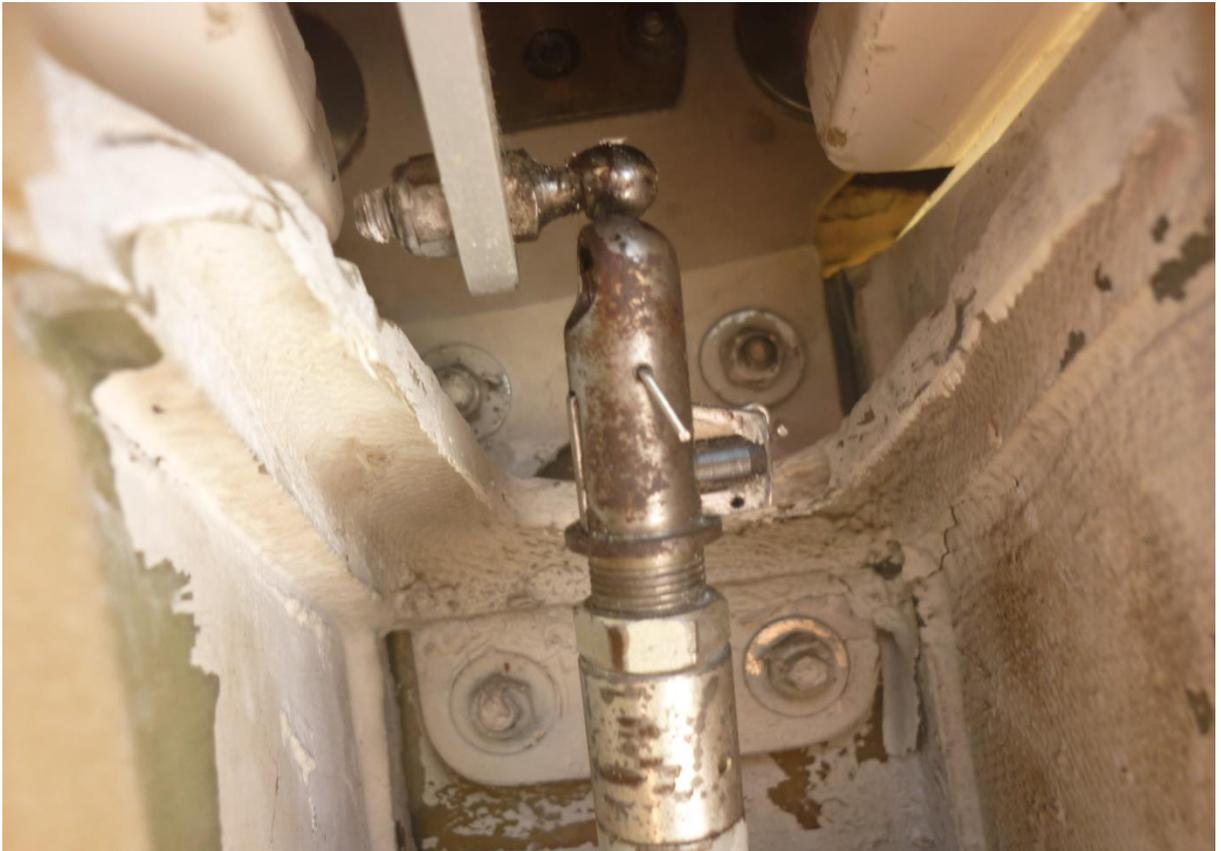
Picture 7 Unconnected elevator rod

The member of the investigation committee inspected control elements of the glider immediately at the accident site at LZPT where he discovered that the elevator rod was not connected.

When further examining the accident, the investigation committee checked the process of assembling and disassembling the stabilizer with elevator on a glider of the same type at Boleráz/LZTR airport. It was discovered during such check that when the elevator rod was not connected, the elevator remained in the position for descending flight. When the elevator rod was connected, the elevator remained in a horizontal position.

Inconsistent glider assembly (failure to connect the elevator rod) and pre-flight preparation.
