# FINAL REPORT

on the safety investigation of an air accident  
of aircraft type **Pilatus PC-6/B2-H4**  
registration mark **OM-FAA**

Reg. No: **SKA2019004**

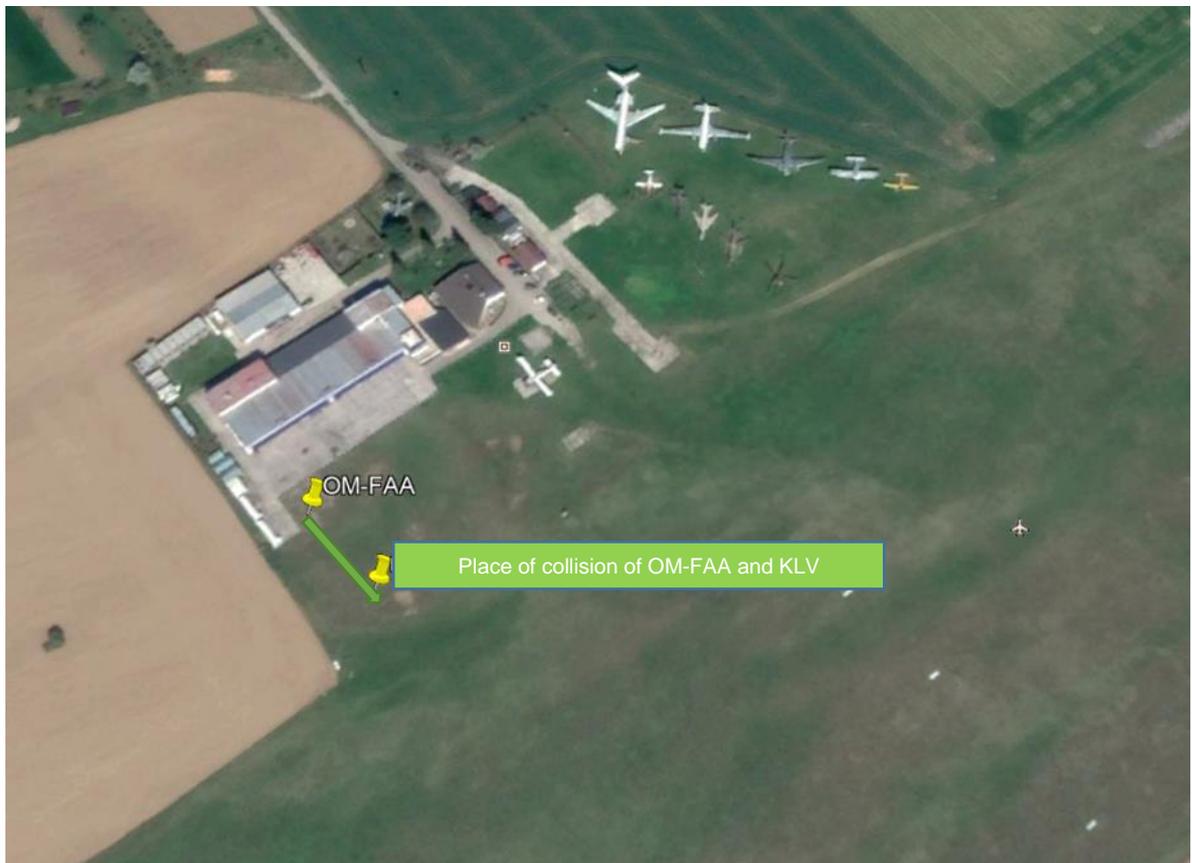
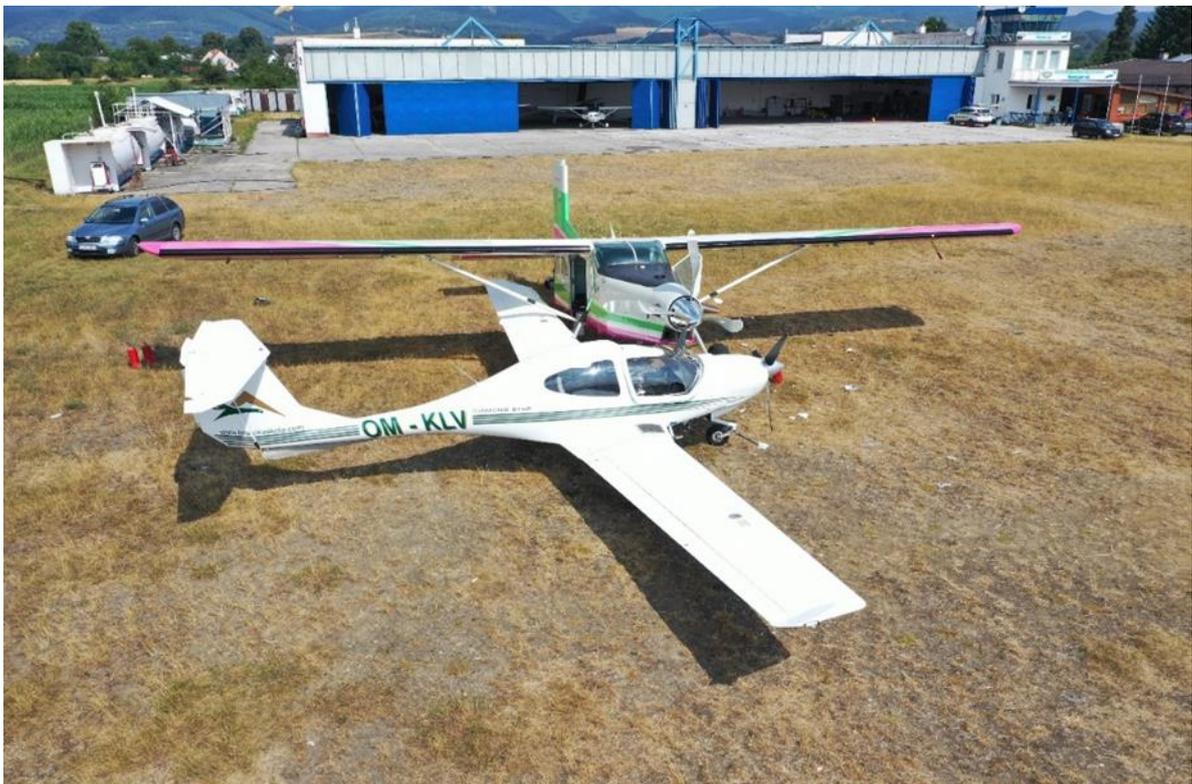
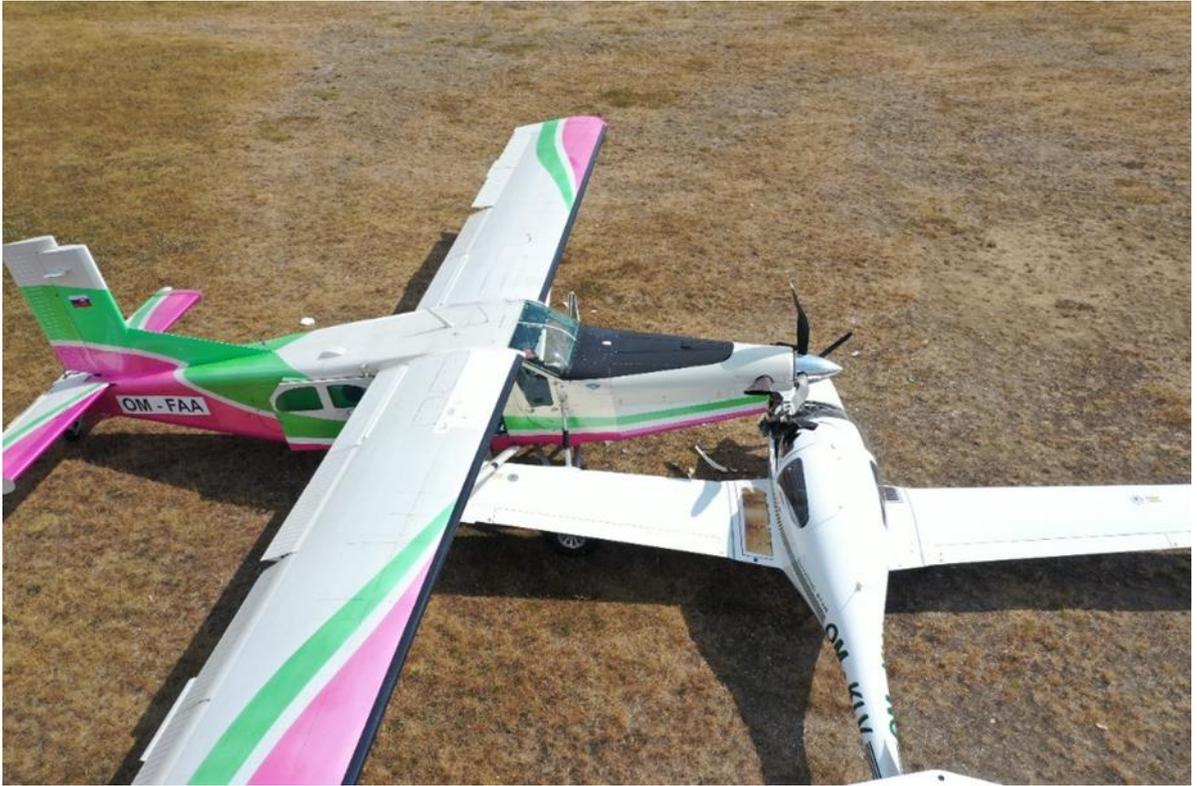
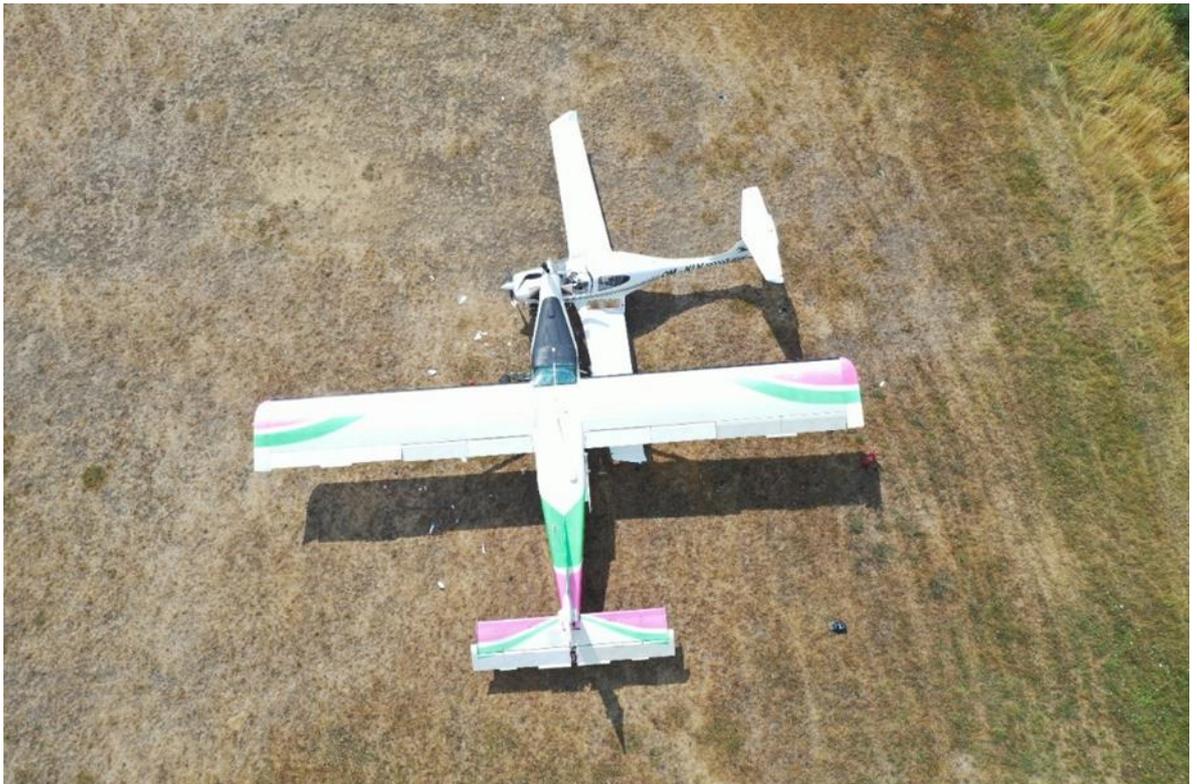
During the occurrence the aircraft sustained major damage (the engine was stopped forcefully and the propeller was destroyed).

OM-KLV was destroyed during the occurrence (the left half of the wing was damaged, the left part of the fuselage was destroyed at the firewall place and the aircraft cabin was destroyed).

After the impact OM-FAA remained standing in front of the hangar, stuck in the wreckage of OM-KLV.

When taxiing, the pilot did not pay sufficient attention to obstacles in the taxiing direction and OM-FAA collided with OM-KLV which was parking there.

The main cause of the aviation accident was a failure of the pilot to look out for obstacles when taxiing across an aircraft parking area - outside the manoeuvring areas specified in the Dubnica Airport Operations Manual, what led to a collision with OM-KLV which was parking there.
