AVIATION AND MARITIME INVESTIGATION AUTHORITY
Námestie slobody 6, P.O.BOX 100
810 05 Bratislava

FINAL REPORT

on safety investigation of an aviation accident
of an aircraft type **PIPISTREL VIRUS SW 121**
with registration mark **OM-PFC**

Reg. No: **SKA2019005**

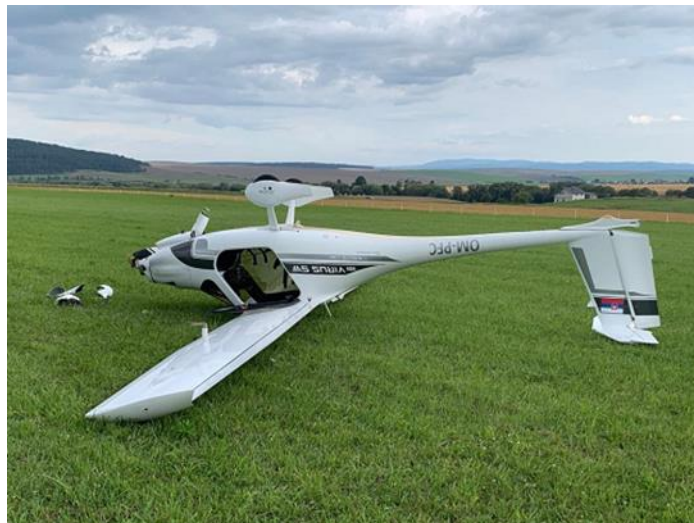
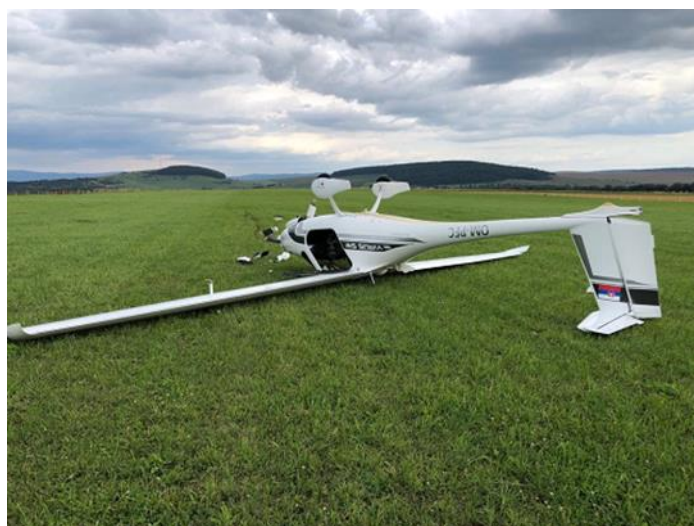
1.12 Wreckage and impact information

The aircraft sustained major damage during the accident.

When the aircraft bounced the pilot did not correct the mistake appropriately; as a result, the front landing gear of the aircraft hit VPP MC and broke, and the aircraft turned over.

The cause of the aviation accident was an inappropriate response of the pilot to the aircraft bounce (wrong correction of the mistake when the aircraft bounced), resulting in a hard hit of the front landing gear with VPP MC.
