FINAL REPORT

on the safety investigation
of flying sports device
type **Axis Paraglider Swing Mirage RS 9,5**
without registration number

Ref. No.: **SKP2019001**

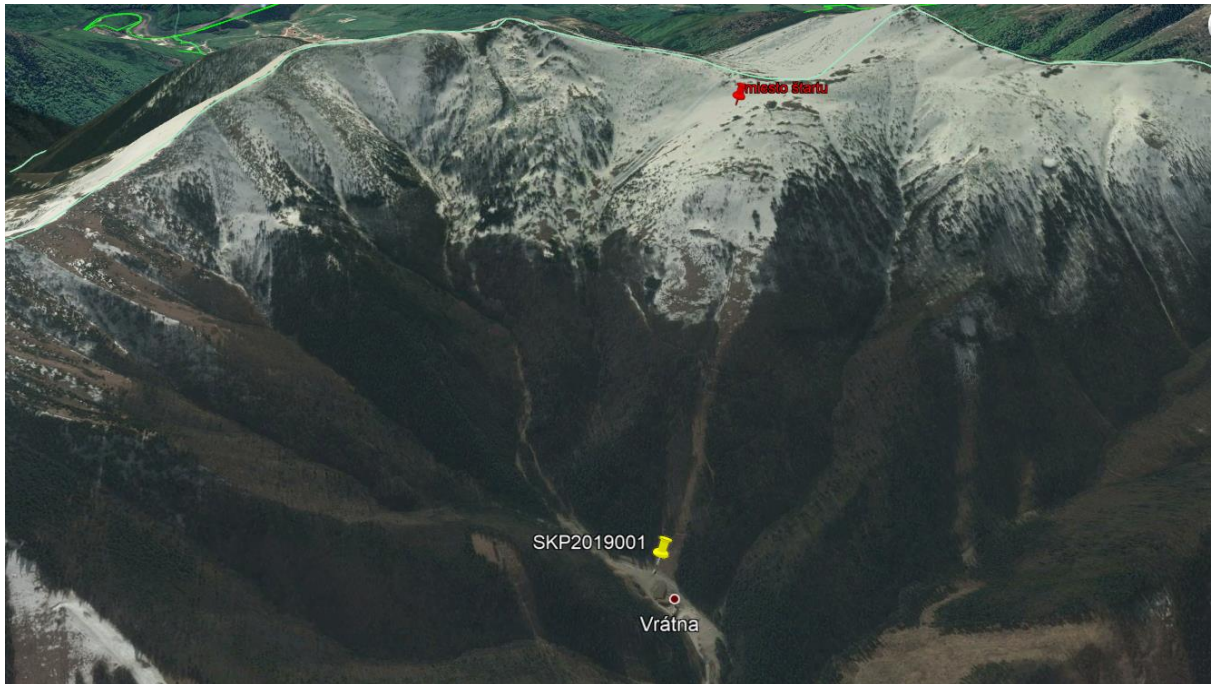
The hard-landing occurred near the cable car Vrátna-Chleb valley station. The place of the air accident is determined with the following geographical coordinates:

N 49°12'27,45''
E 019°02'35,51''
