FINAL REPORT

on investigation of the serious incident
of helicopter type **Eurocopter AS-355N**
reg. No. **OM-IKM**

Date: 23.09.2010

Place: Ružín dam

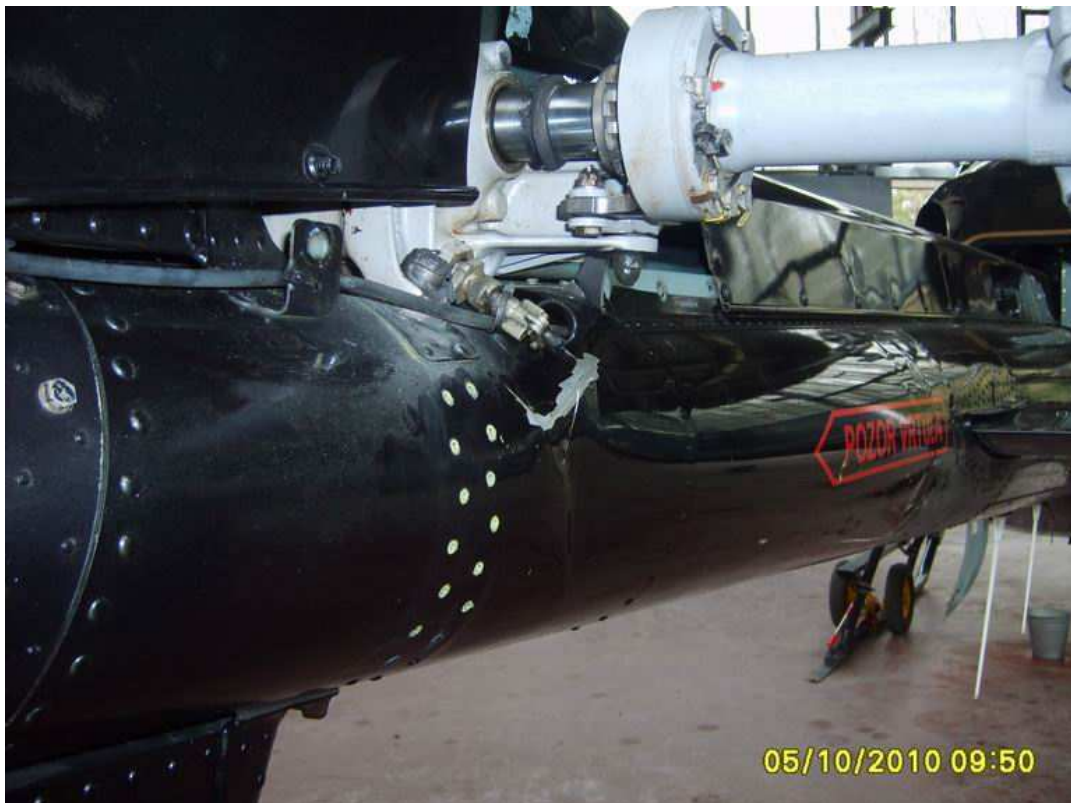
The tail-rotor boom was slightly damaged by vibrations from the anti-torque rotor.

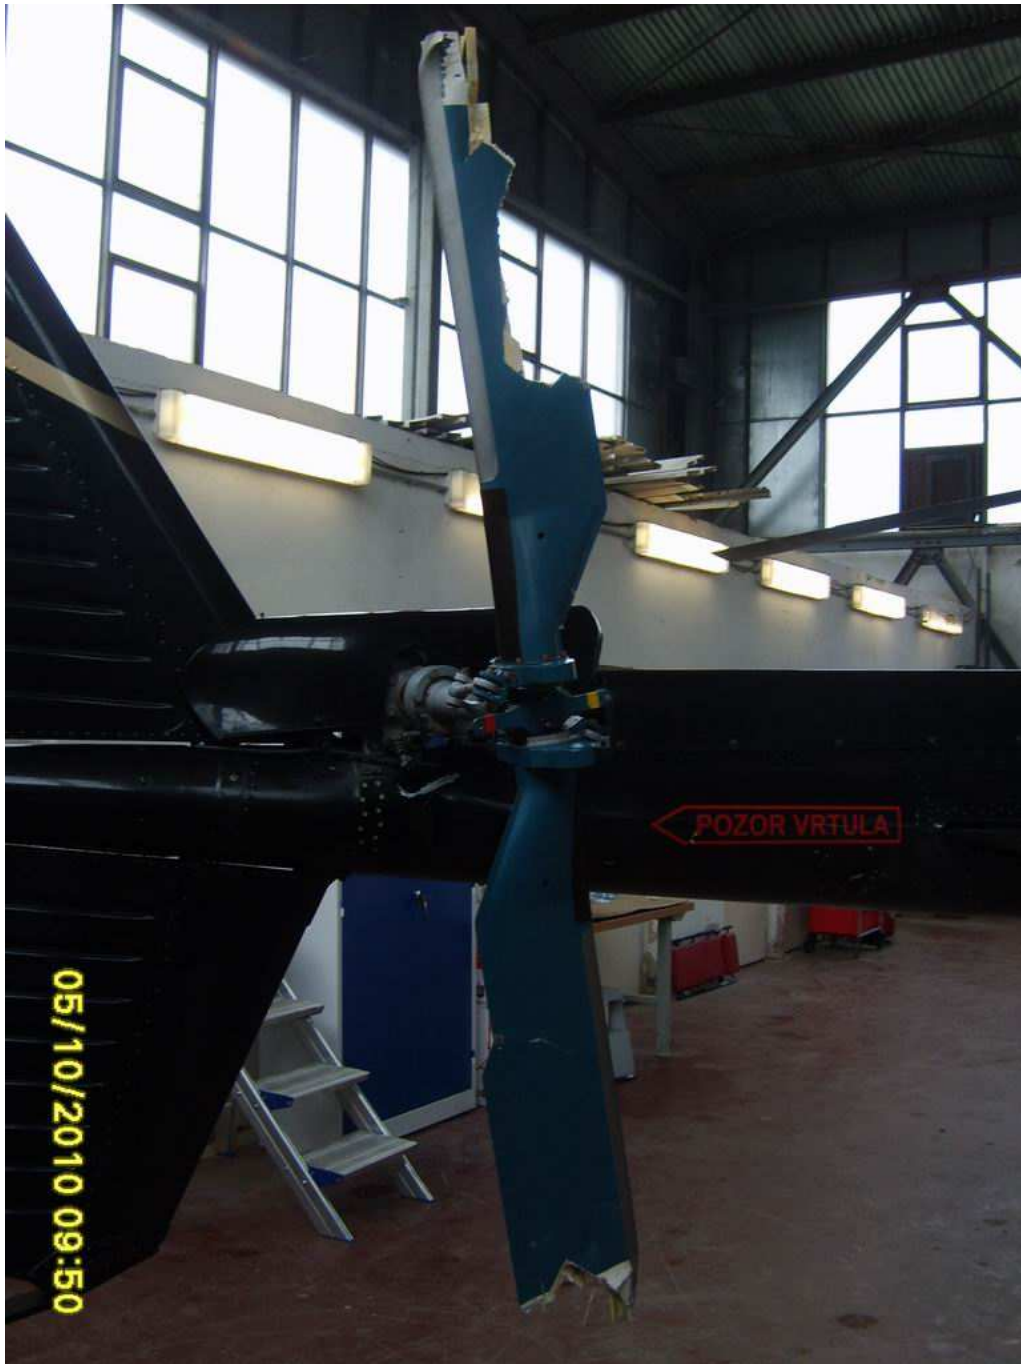
The anti-torque rotor of the helicopter was damaged and will have to be replaced.

The cause of the serious incident was the anti-torque rotor getting caught on a stone, which was not registered by the helicopter crew during ground landing training.

The helicopter skid at the critical moment sank under the level of hidden stone on the ground and did not prevent the anti-torque rotor from getting caught on the stone.

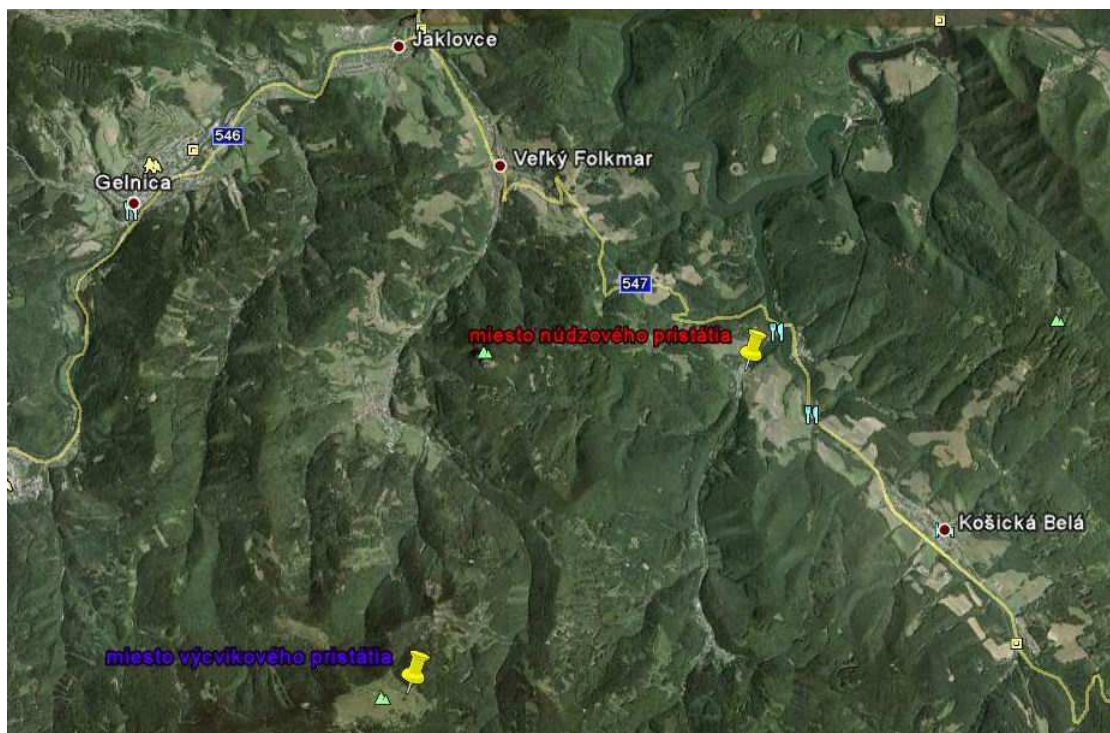
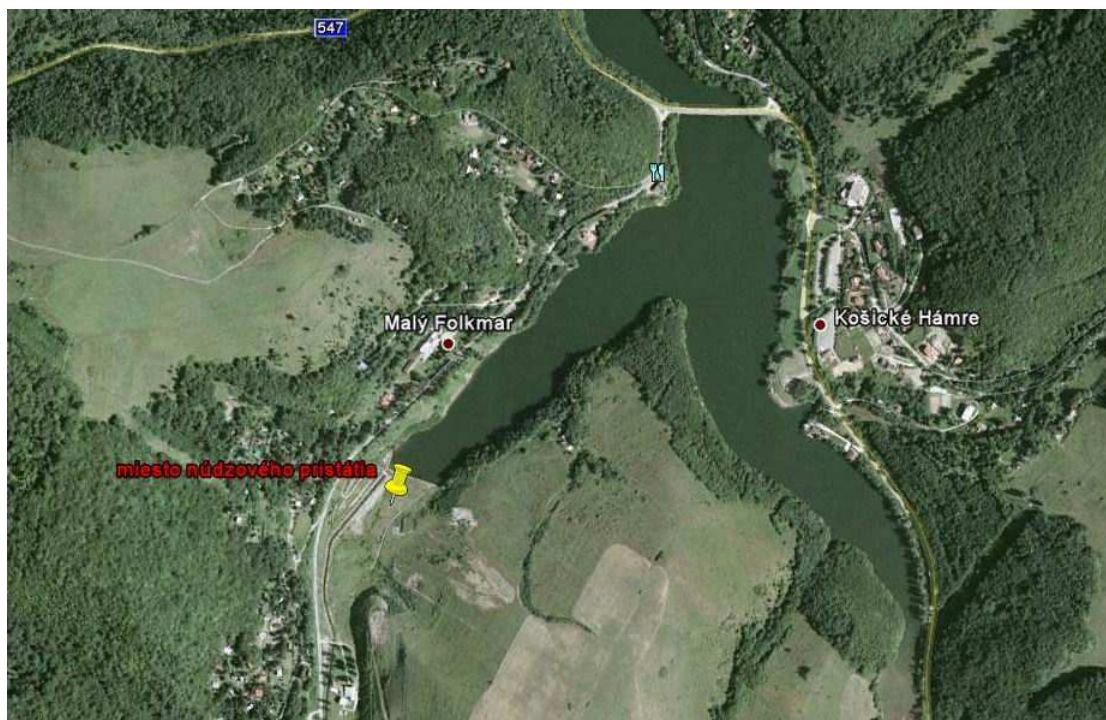
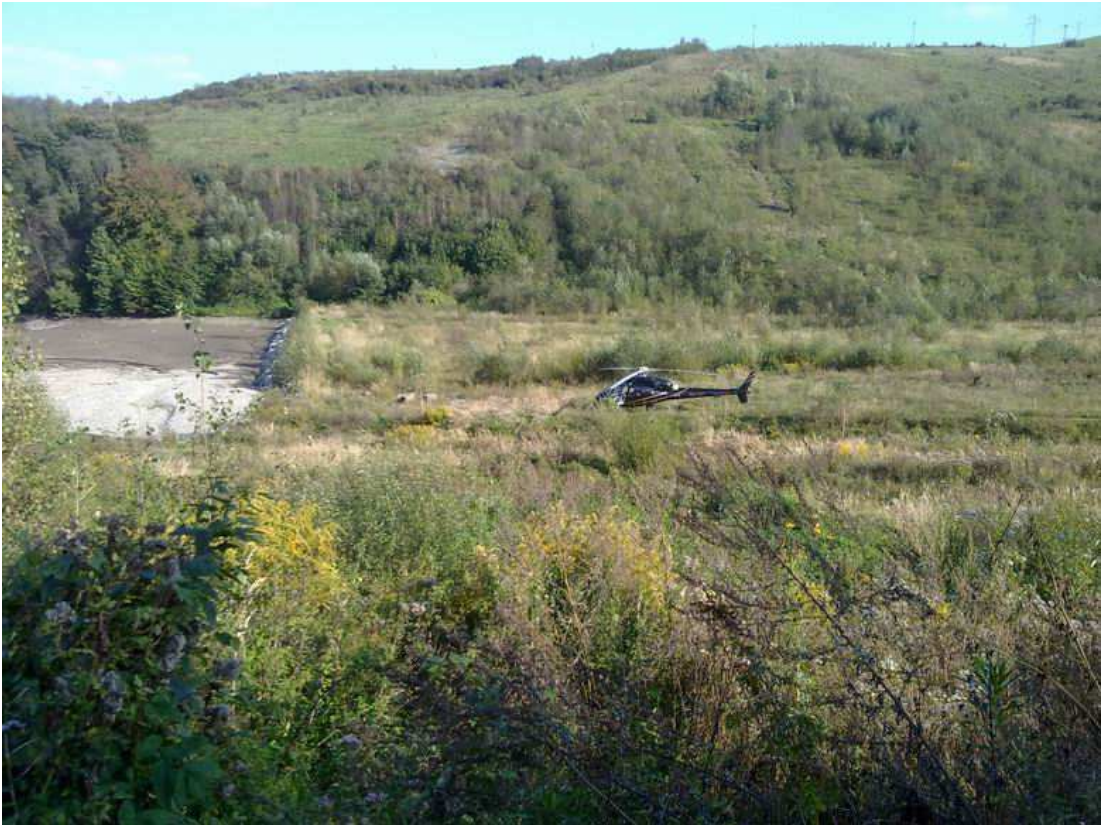
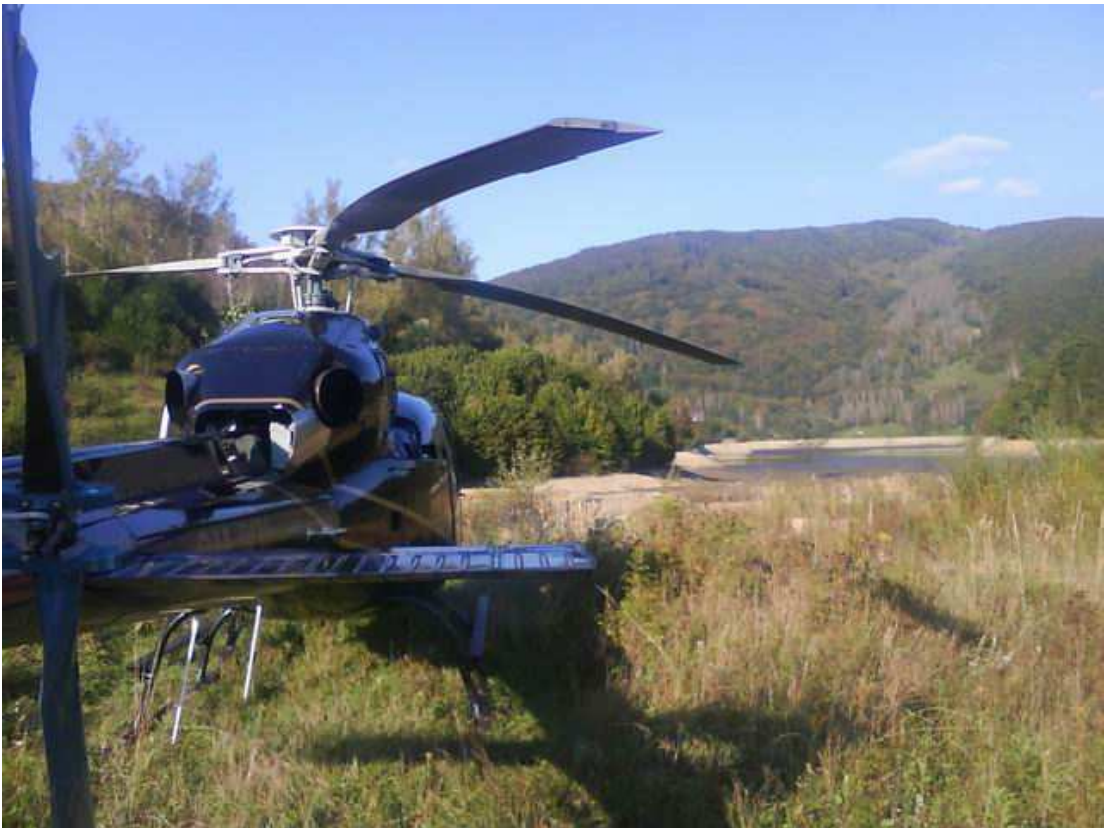
Geographic co-ordinates of the ground of emergency landing of the helicopter near the Ružín dam:

N: 48°49' 33,65'' E: 021°04' 02,61''
