FINAL REPORT

on safety investigation of a serious incident

incorrect action of the ATS Authority, reduction of separation minimum

Reg. No: SKS2019001

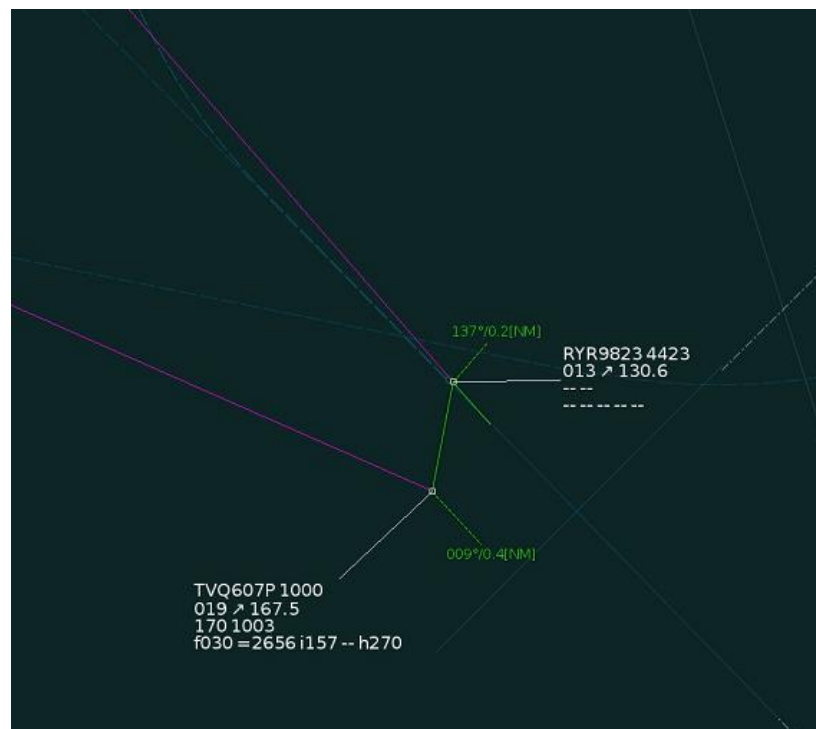
EI-FOO took off according to plan. The first radar record of the flight in E2000 was displayed at 07:24:10 as a non-correlated target after take-off.

At 07:24:13, the EI-FOO flight was displayed in E2000 as a correlated target with A013.
