# **FINAL REPORT**

on the safety investigation of an air accident  
of flying sports equipment, type **paraglider NOVA MENTOR4 XS**  
OM L 043

**Reg. No.: SKA2020001**

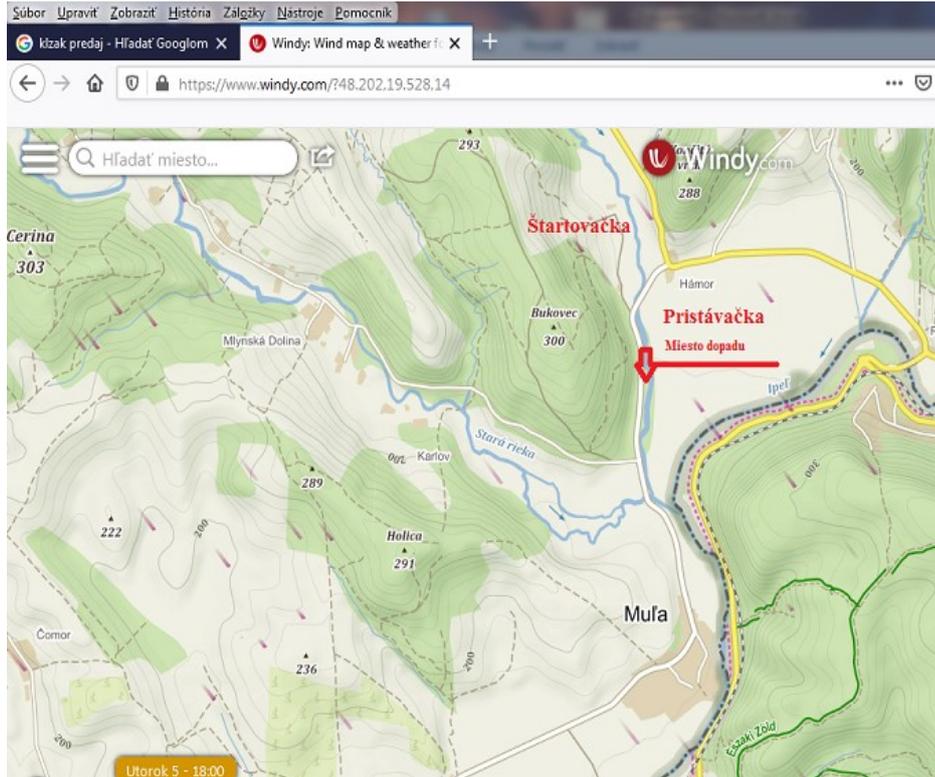
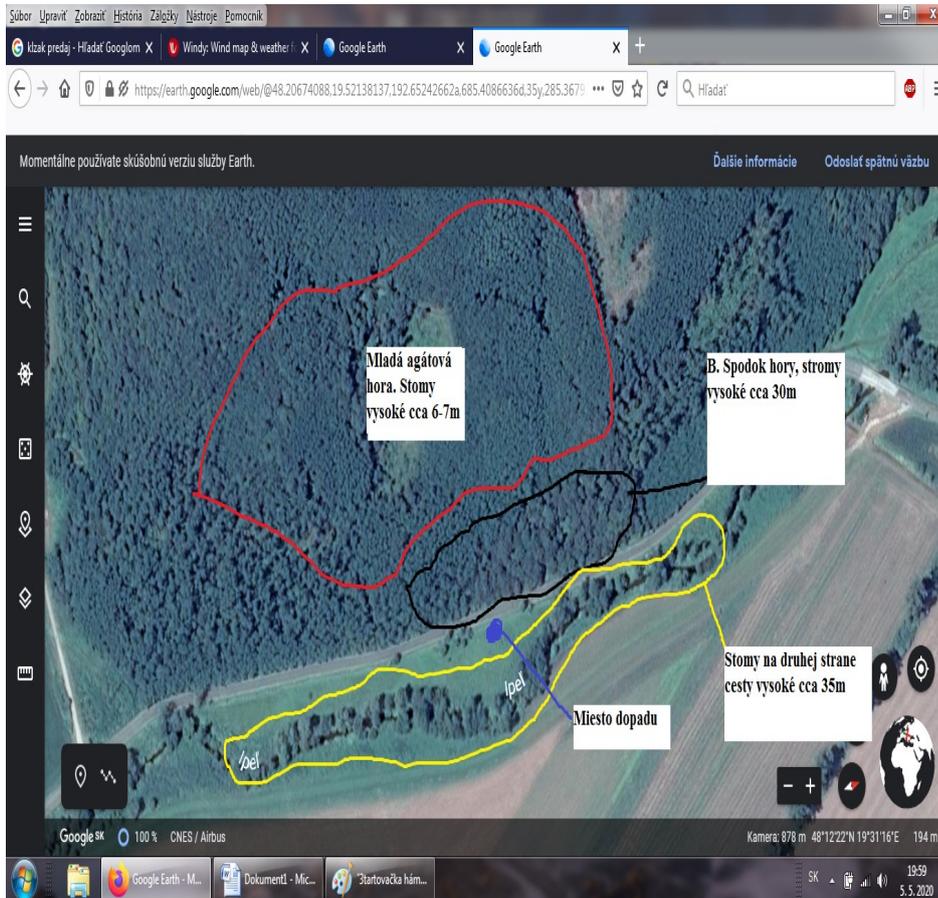
### Take-off and landing site

The pilot landed hard among the trees at the road between the village Muľa and the settlement Hámor.
