FINAL REPORT

on the safety investigation of an air accident

of the aircraft type **Viper SD4 RTC**
registration mark **OM-VIP**

Reg. No.: **SKA2020002**

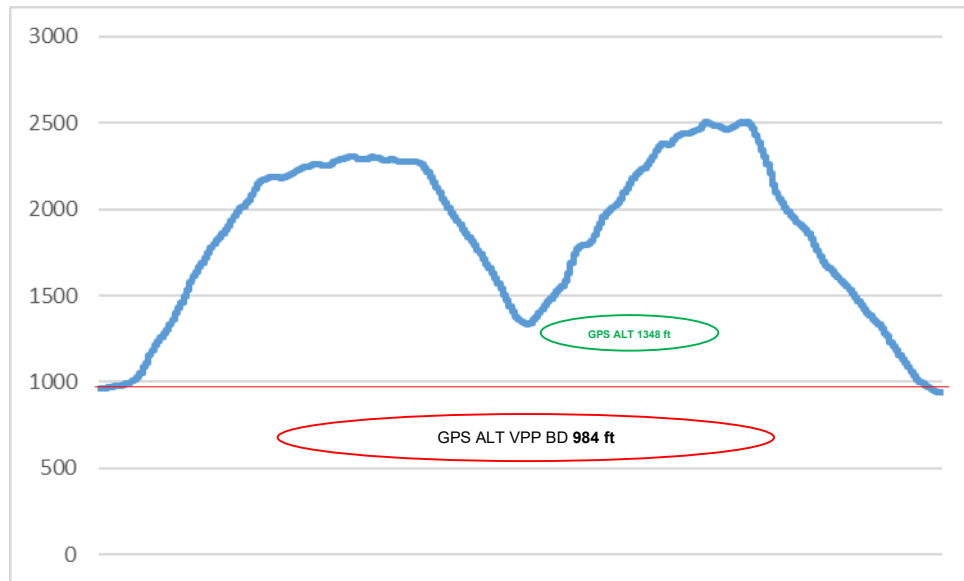
Height course - 07:07:18– 07:16:46

At 07:12:00 the crew interrupted the approach to the landing VPP BD17 by right turn at a distance of 1,270 m from the threshold VPP BD17, GPS ALT 1348 ft, IAS 71.5 kt, wind 7 kt and continued for about 1 min. at 050°. At 7:13:02 it started to make 360° turns at the height of GPS ALT 2010-2500 ft above the village Nižná Kamenica.

At 7:14:10 it began to perform at a height of GPS ALT 2223 ft a turn to the left to approach landing above the village Čakanovce.

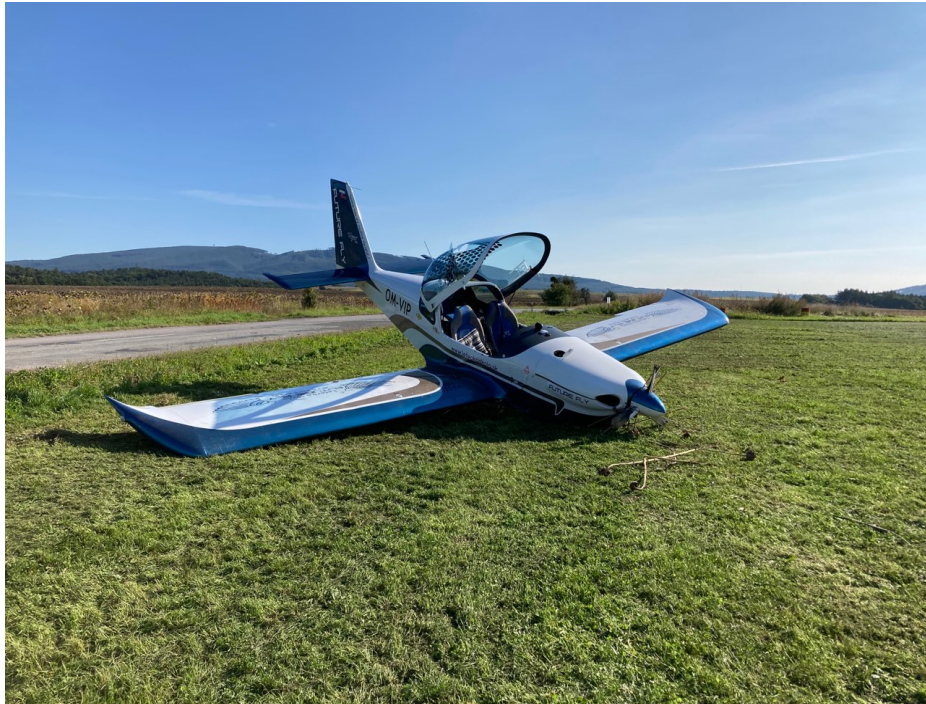
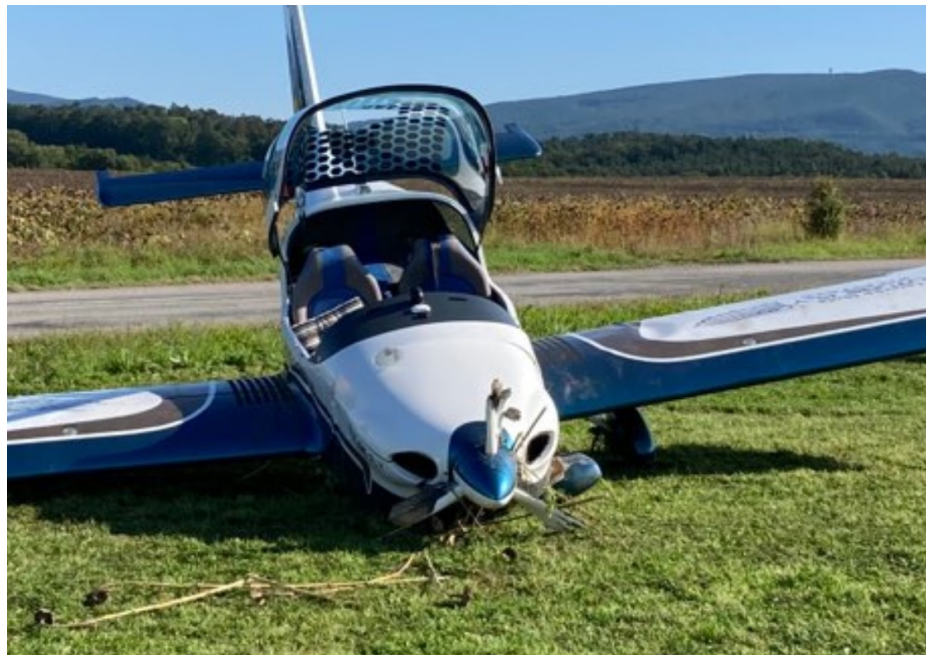
Final stop position of the aircraft 48°44'47.26"N, 21°26'49.42"E.

- significant deformation of the fuselage and central wing cover,
- destruction of the undercarriage shaft,
- damage to the auxiliary hinges fuselage - wing,
- dragon levelling out of tolerance.

- damage to torsion boxes and hinges of wings, beams, covers, flaps and winglets,
- wings levelling out of tolerance.

- destroyed welded part and steering of the front landing gear leg,
- destroyed front wheel aerodynamic cover,
- destroyed front undercarriage fork with a wheel,
- destroyed both legs of the main undercarriage with wheels, brake system and aerodynamic wheel covers.

The aircraft remained behind the road no. 576 in the modified grassy foreland of the asphalt VPP BD17. The aircraft was damaged to a large extent in the plane crash.

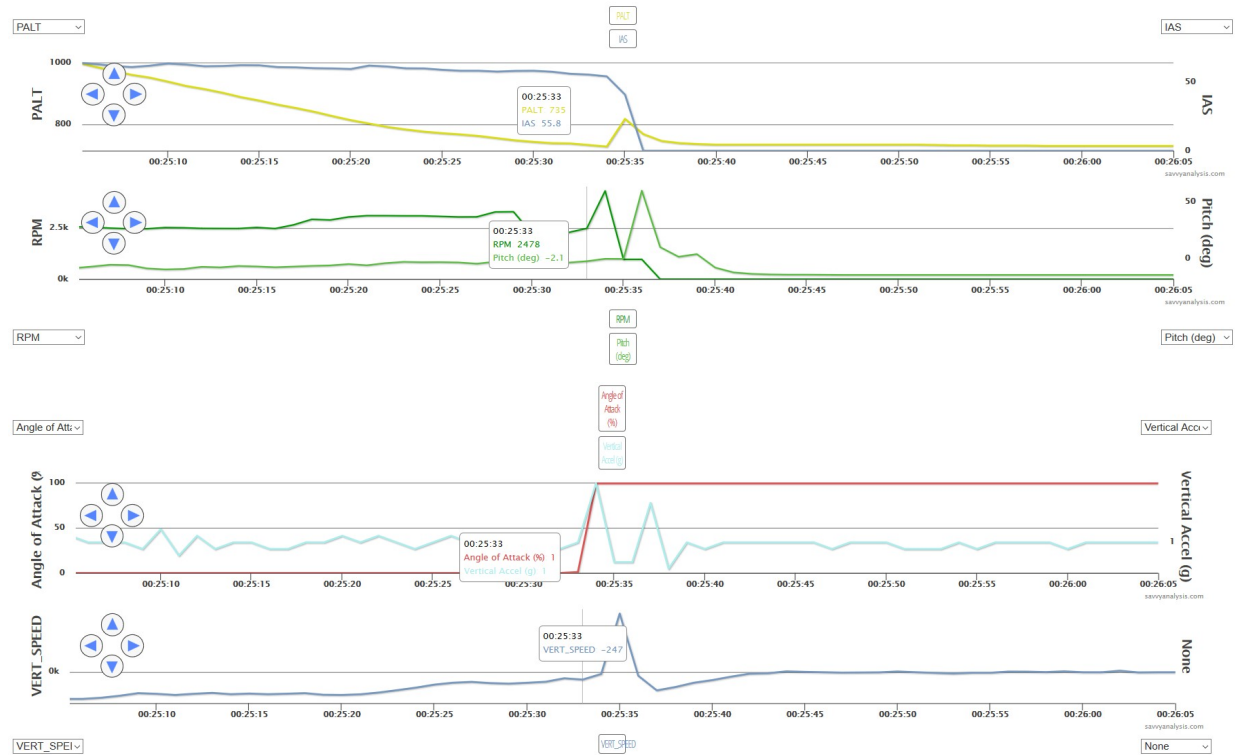
Graph of the course of flight before entering the rate of fall

The plane after 25 min. and 33 s from the take-off for the second flight was located at an altitude of 735 ft PALT at a flight speed of 55.8 kt IAS, engine speed 2,478 RPM, angle of inclination -2.1° at a vertical speed of -247 ft/min. The rate of fall for the Viper SD4 RTC aircraft in the landing configuration (flaps in position II) is 43 kt IAS. At this time, the flight speed was sufficient to make safe landing.

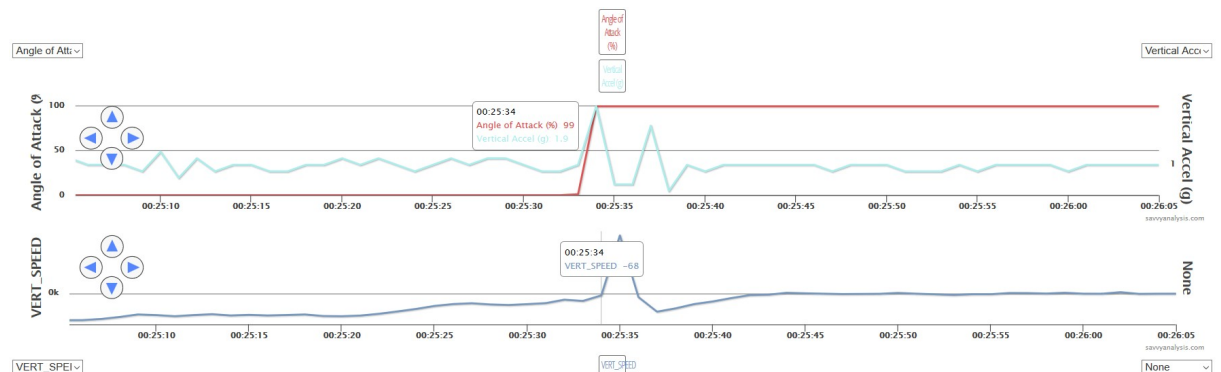
Graph of the course of flight at the time of the rate of fall

At 25 min. 34 s from the take-off, the aircraft was at an altitude of 730 ft PALT at a flight speed of 54.5 kt IAS. At this point, an attempt was made to climb by increasing the engine speed to 4,308 RPM at an aircraft pitch angle of 0° and a vertical speed of -68 ft/min.

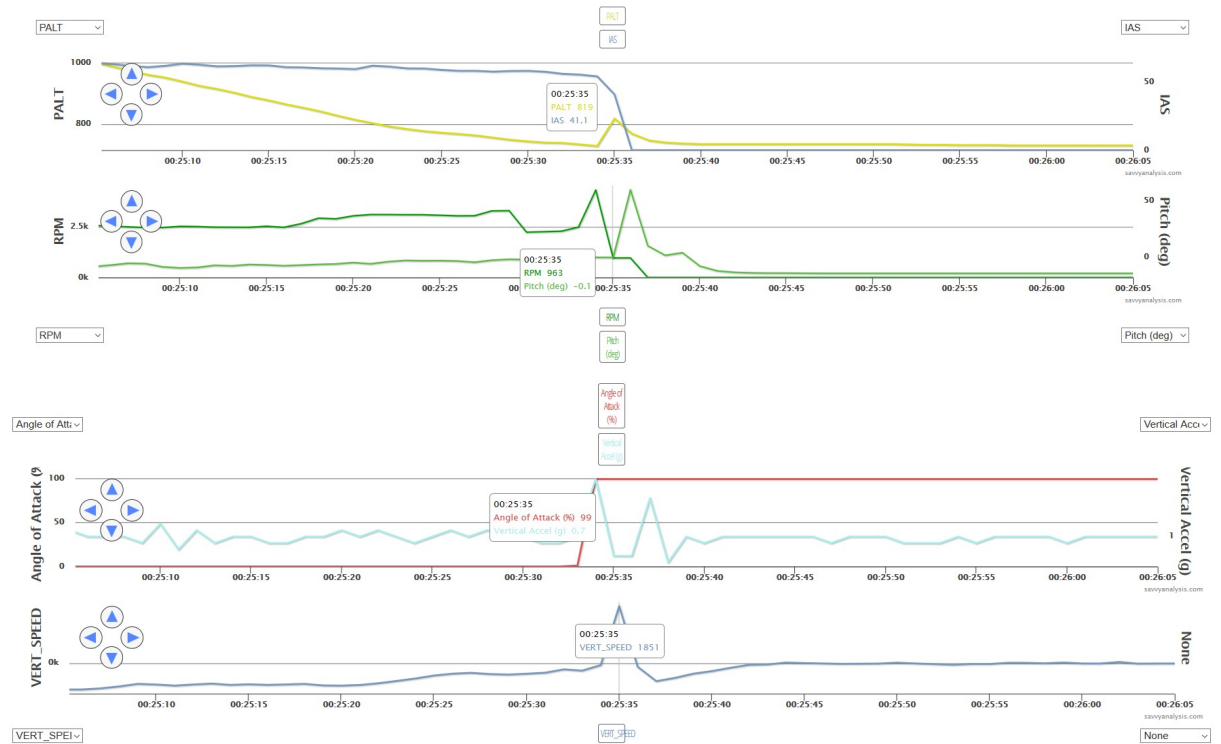
Graph of the course of flight at the time of the rate of fall and impact on the terrain

At 25 min. and 35 s from the take-off, the aircraft was at an altitude of 819 ft PALT at a flight speed of 41.1 kt IAS, angle of inclination -0.1° . The vertical speed increased to 1,851 ft/min. and the engine speed dropped to 963 RPM.

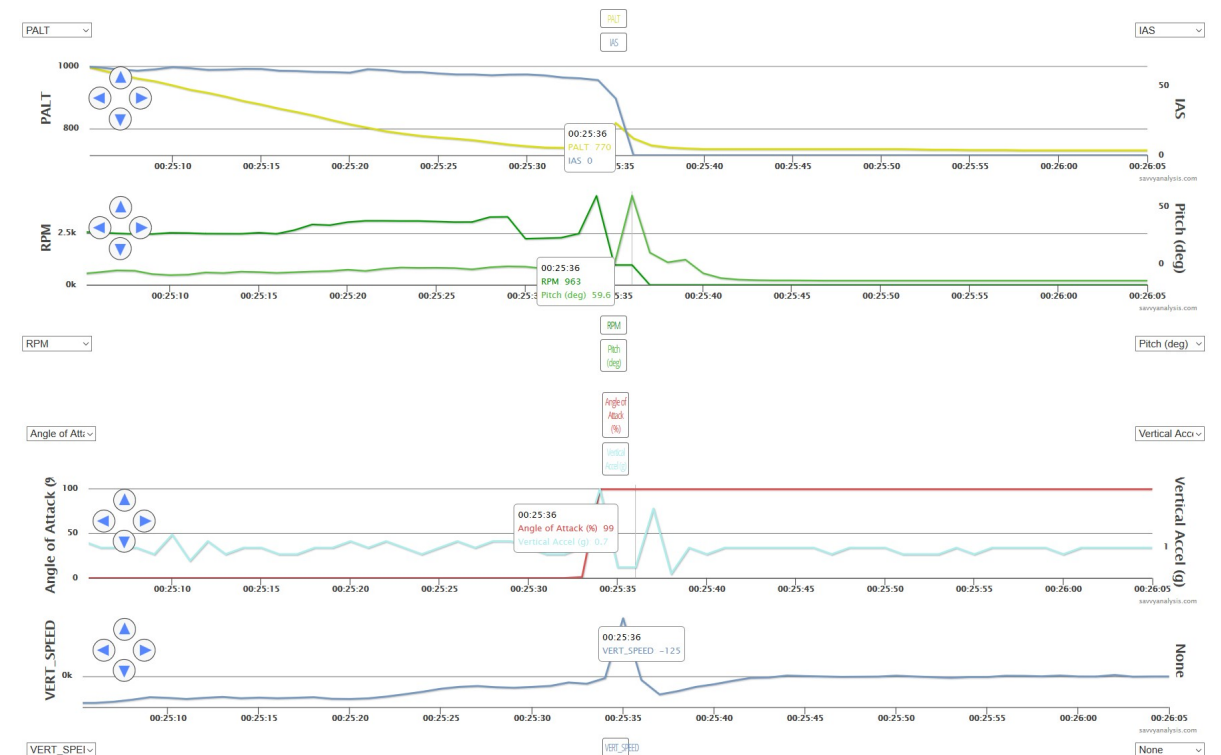
Graph of the course of flight at the time of the rate of fall and impact on the terrain

At 25 min. and 36 s, the aircraft was at an altitude of 770 ft PALT with zero IAS speed, engine speed was recorded at 963 RPM, angle of inclination -59.6° and vertical speed -125 ft/min.

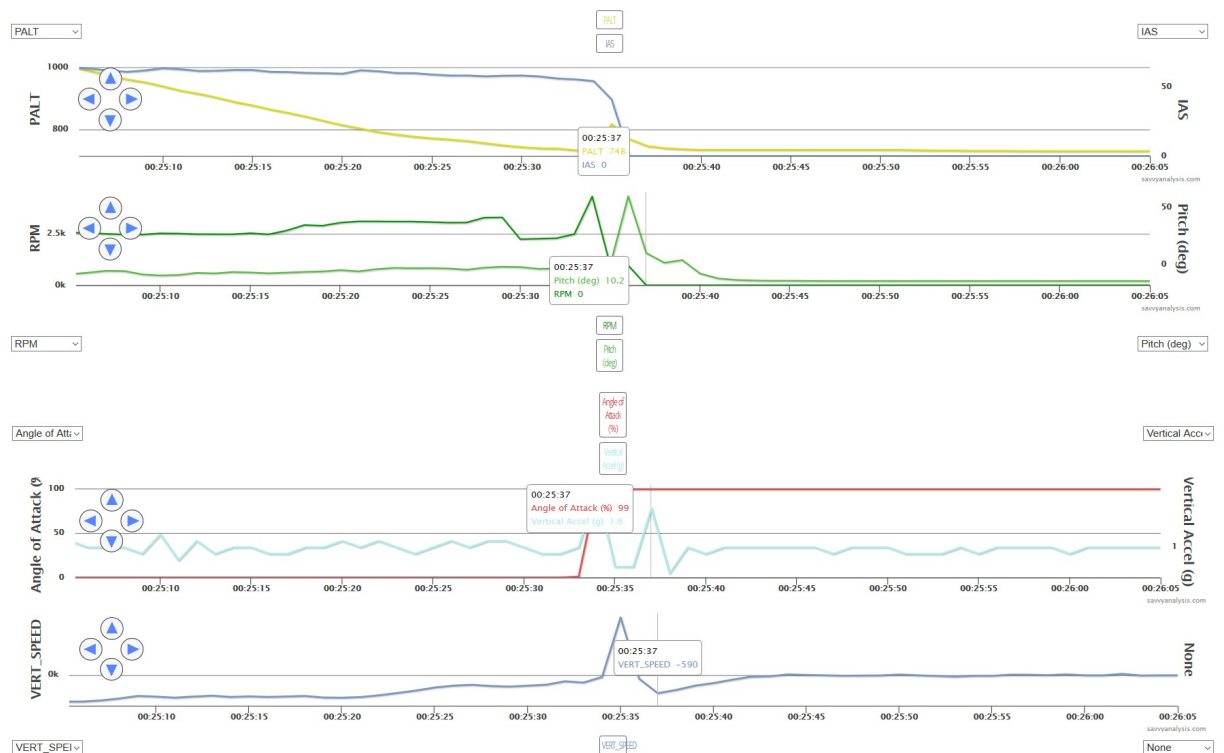
At 25 min. and 37 s, the aircraft was located at an altitude of 748 ft PALT with zero flight speed. The engine stopped.
