# FINAL REPORT

on investigation of serious incident

Flying sport vehicle type **GIN / BOLERO 5S**

Identification number **OM – P565**

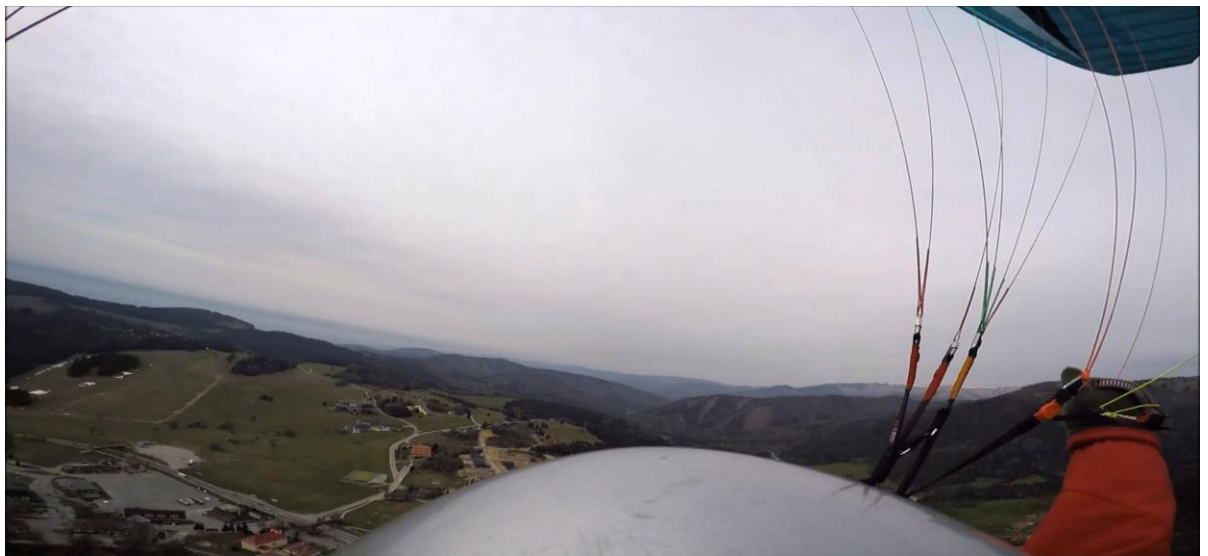
Pilot with FSV started the training flight at 07:45. The flight occurred normally and during this flight the pilot fulfilled instructions given to him by the instructor via a radio station. After 5 minutes of flight the instructor instructed the pilot to perform a task – closing of external parts of the parachute canopy, when the pilot pulled wrong ropes.

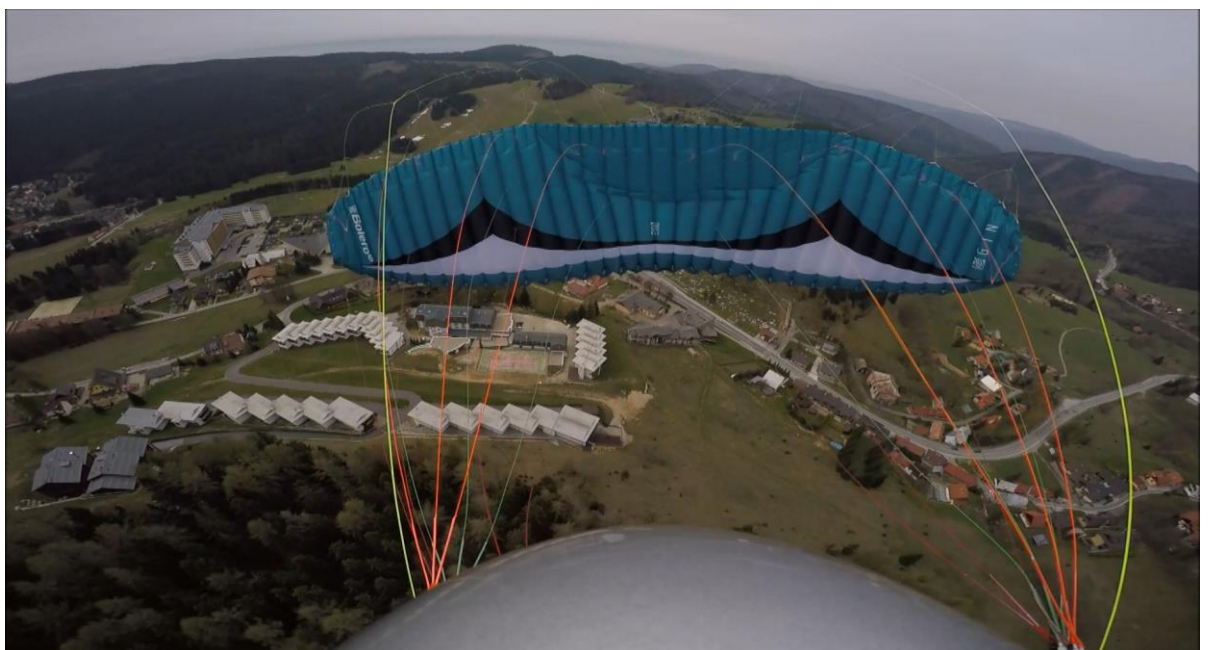
This caused deformation of the parachute wing (fullstal), followed by its shooting under the pilot

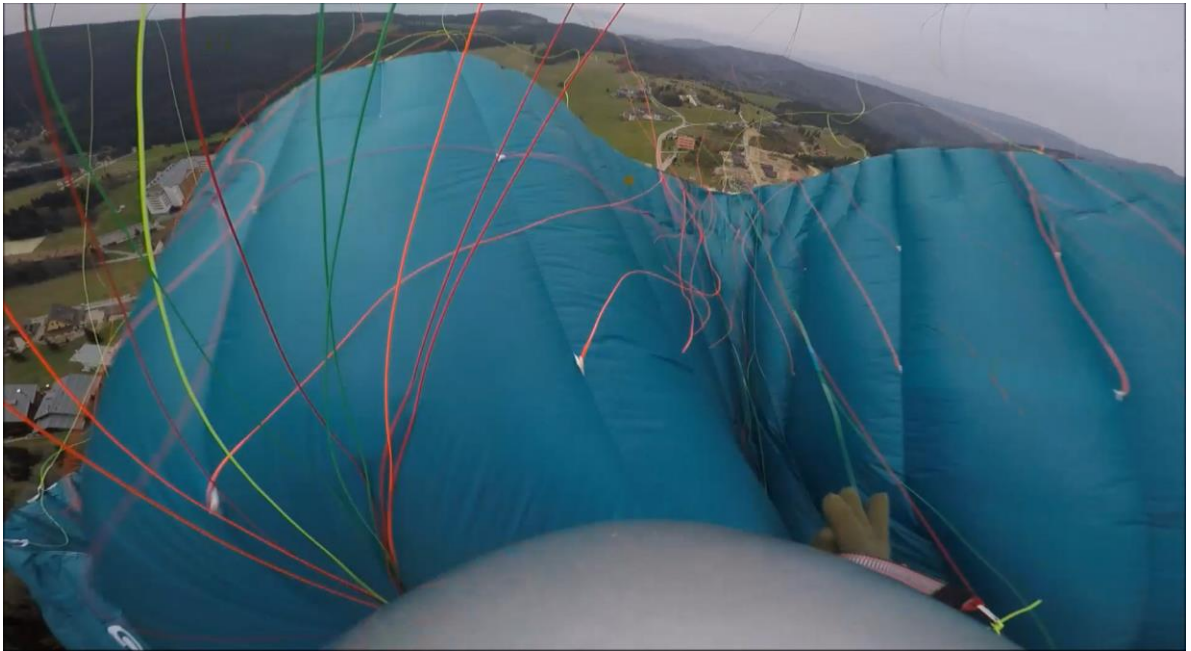
and his fall into the canopy and then to the ground.

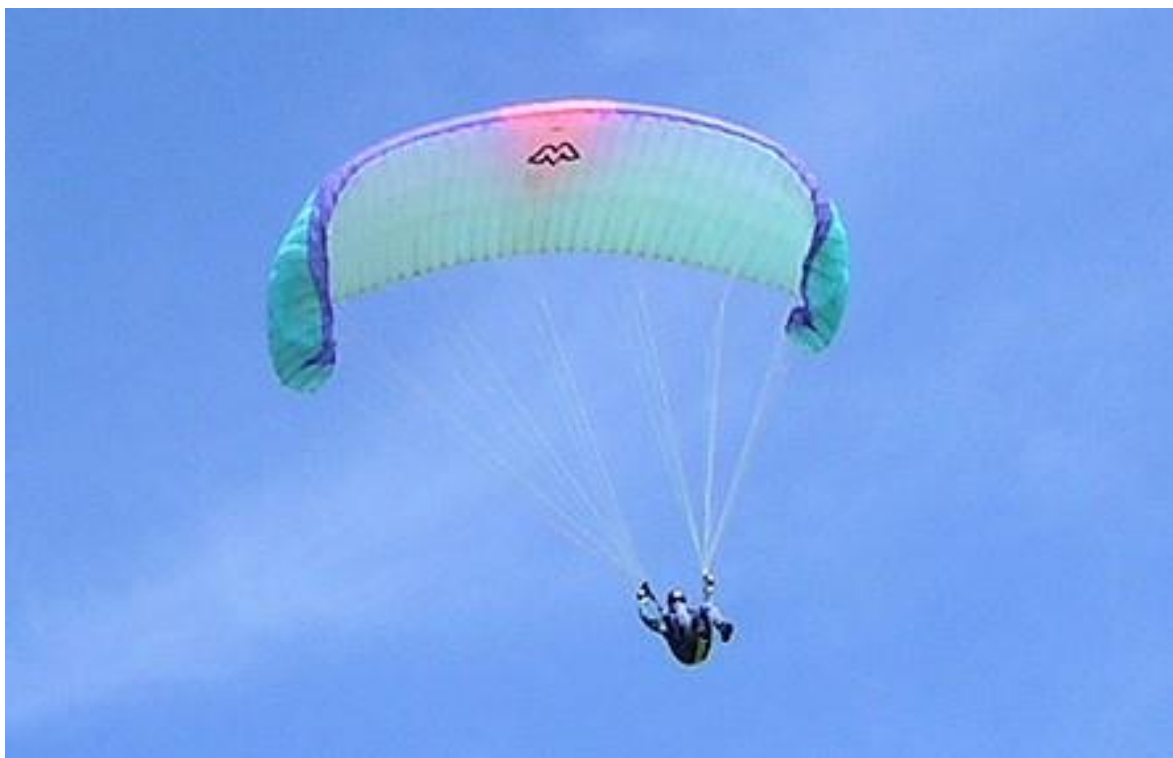
The pilot under training with minimum flying experience practiced the closing of external parts of the canopy during the first flight from the hill Nová Hoľa in Donovaly.

By ignorance he pulled the whole set of C-cords (trailing edge) ended in the leading edge of parachute wing, instead of the outer A-cords. It caused separation of flow lines and drop of deformed parachute wing behind the pilot. When the pilot realized his mistake he suddenly let loose this set of cords, which caused inflation of the wing, followed by its shooting under the pilot and his fall into the canopy.

Insufficient flying experience and poor mastering of the flying technique in performance of the respective task.

- To analyze the accident with training centre managers of LAA SR;
- To publish the final report on the website of LAA SR;
- Training centre managers of LAA SR – to put emphasis on keeping of training records.
