PILOTNÝ PROJEKT - UL. ROSNÁ Č. 3, KOŠICE

V rámci vedeckotechnického projektu VTP 6 - 400 "Obnova budov pozemných stavieb s dôrazom na bytový fond" sa riešil **pilotný projekt** Košice, Rosná ul. č. 3 zameraný na odstránenie systémovej poruchy (neskoršie zavedenej ako systémová porucha) a zníženie spotreby tepla pri prevádzke budovy.

In frame of the Research and Technology Project 6 - 400 "Rehabilitation of Ground Surface Buildings with Emphasis Put on the Housing Stock" we have developed the solution of the **Pilote Project** Košice, Rosná Str. No.3, aimed at removal of failures in the building systematic defects and on reduction of heat consumption by using of buildings.

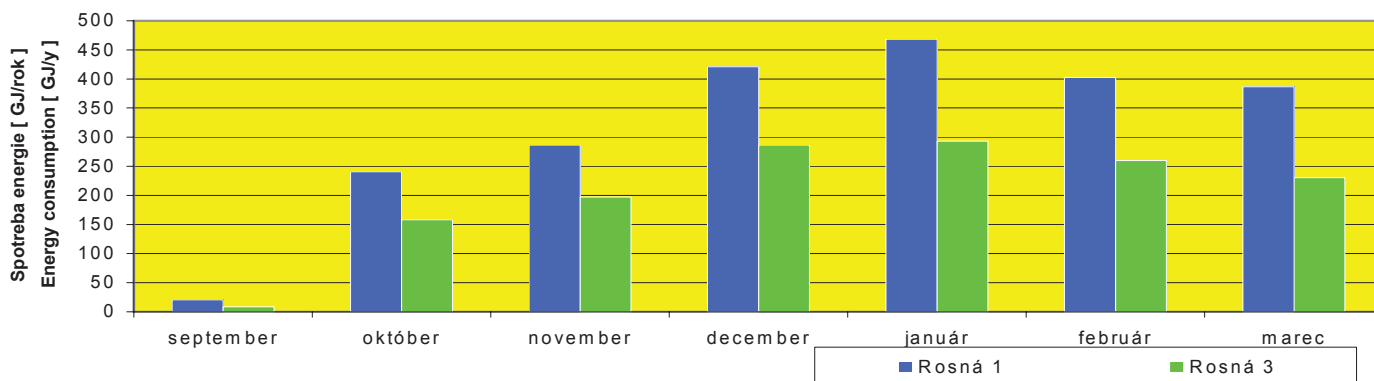
Energetická spotreba za rok 1997/98

Energy consumption in year 1997/98

**Conclusion** – through above mentioned adaptations we have achieved safe operation of apartment house through removal of building statics failure and through the improvement of building-physical parameters of the building jacket of the apartment house, and from November 1996 until March 1997, the heat savings of 20%, 40% saving has been proved for the heating period September 1997 until March/1998 after completion of the refurbishment works on the building. The heat use has been reduced to  $E = 128 \text{ kWh}/(\text{m}^2 \cdot \text{year})$ , per 1 unit flat.
