FINAL REPORT

on investigation of air accident
of aircraft type **MPX – 741 - Zenair**
registration **OM-AXM**

Date: 22. 05. 2011

Place: Bidovce

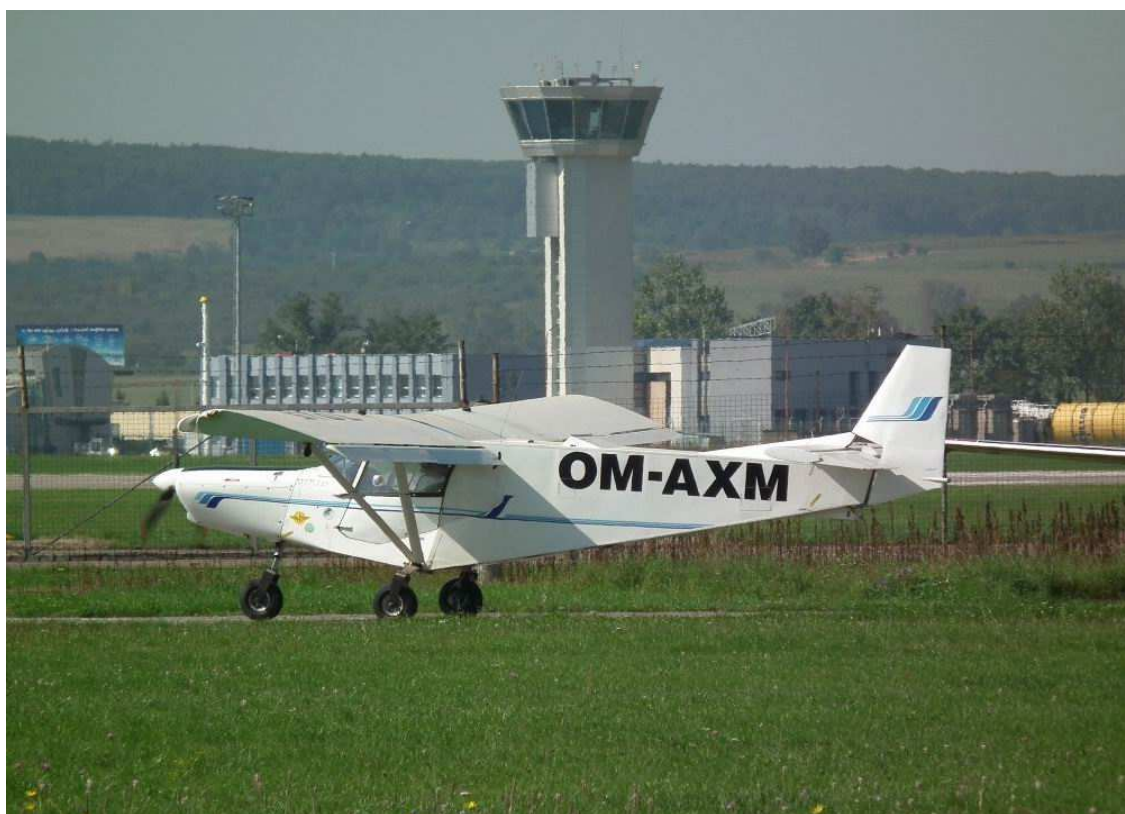
On 22 May 2011, the crew with aircraft with registration. OM-AXM was making training flights on the circuit with landing on runway 17. During the fifth flight the aircraft landed hard on the grass surface of the runway (RWY).

The aircraft was substantial damaged.

The aircraft was substantially damaged in the air accident.
