FINAL REPORT

on investigation of air accident
of helicopter type **Robinson R44 II**
registration **OM - JOJ**

Date: 18.06.2011

Place: Airport Boleráz / LZTR

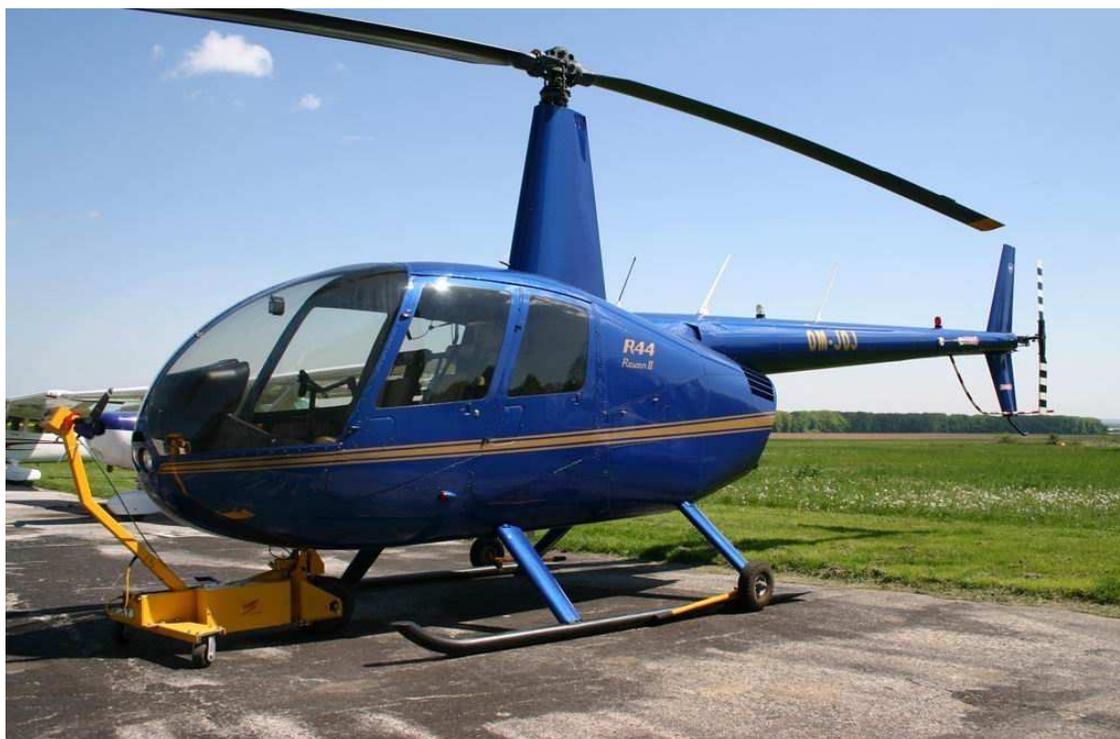
The pilot started the take-off and boosted the engine. When the skids lost contact with the ground and the helicopter turned 90° to the left side, it started swinging in the longitudinal direction after reaching the height of 0.5 to 1 m above the ground. The helicopter touched the ground with the tail propeller which caused the breaking-off of tail reducer with propeller, tail beam and main rotor blades and the fall of the helicopter on its right side.

The pilot did not react to these instructions. The skids repeatedly came into contact with the ground and the helicopter turned around its vertical axis. The tail propeller blade touched the ground, the tail reductor with propeller came loose, the tail beam got broken and the main rotor blades come into contact with the ground and got broken. Finally the helicopter fell to the right side and the engine stopped.
