FINAL REPORT

on investigation of air accident
of glider type **L-13 SE VIVAT**
registration No. **OM – 9109**

Date: 10.07.2011

Place: Airport Prešov / LZPW

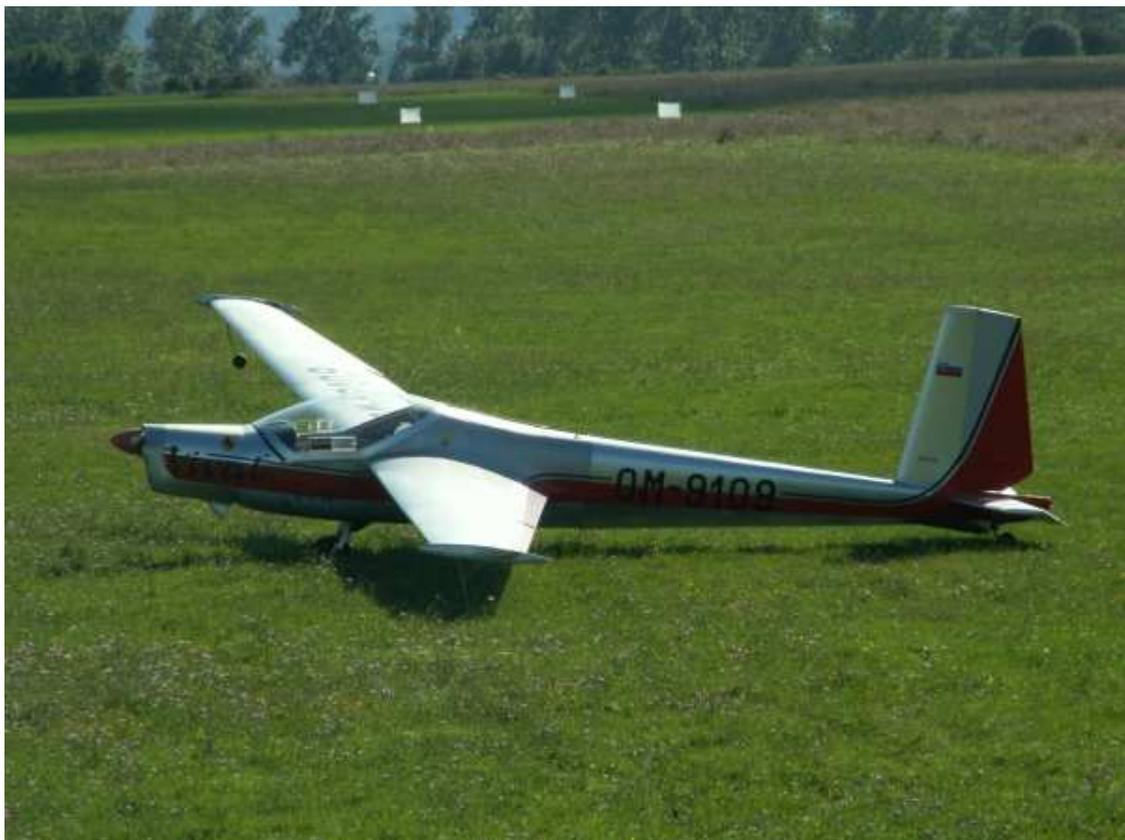
The lower engine hood was damaged and became deformed and the propeller was destroyed during landing.

Damages to the glider allow the repair to be done using standard procedures and by replacement of damaged parts.
