Reg. No.: SKA2011011

FINAL REPORT

on investigation of air accident
of aircraft type **CESSNA 150 L**
registration No. **SP-KDN**

Date: 20.08.2011

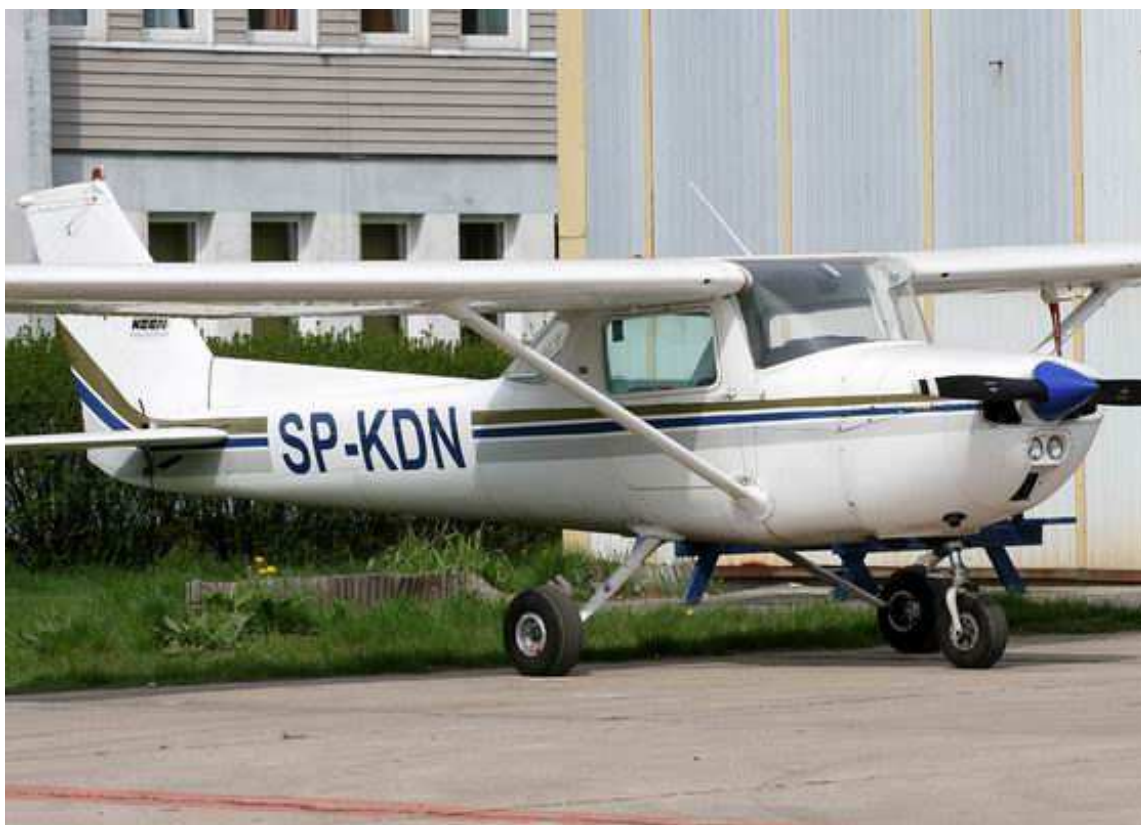
On 20 August 2011 at 11:00 hrs the pilot started with aircraft from the Airport EPNL in direction of the Airport LZKC. He had submitted the flight plan for the flight. When he landed at the Airport LZKC, the aircraft came into hard contact with the ground 30 m in front of the grass runway 070° („RWY“). Due to the hard landing and subsequent movement of the aircraft until the stop on RWY the aircraft was seriously damaged.

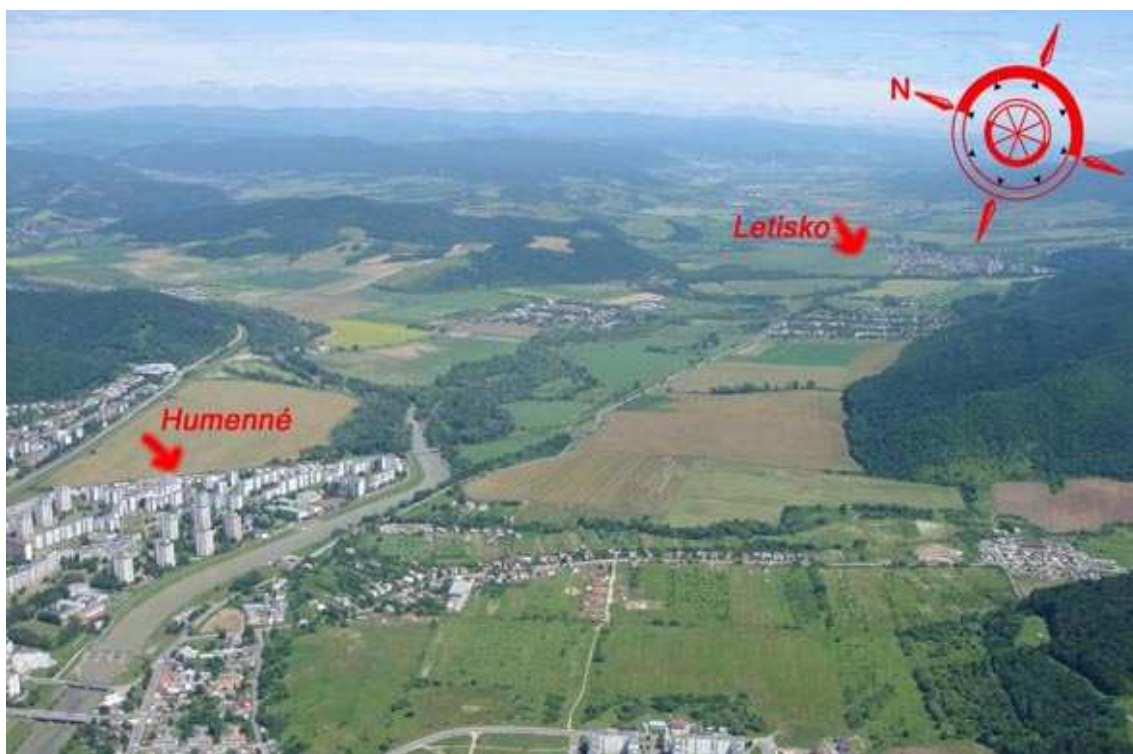
LZKC is a non-public domestic aerodrome with grass RWY, with dimensions of 850 m x 50 m.

The pilot making the approach landing incorrectly assessed the glideslope and during the descent manoeuvre did not react to the low altitude and large distance from the RWY threshold. Due to the premature start of flare-out approximately 200 m in front of the RWY threshold the aircraft was losing speed and then also height. The pilot did not react which ended by hard landing 30 m in front of the RWY threshold. The aircraft got damaged when it came into contact with concrete bridge over the reclamation canal in the RWY clearway.
