# MINISTRY OF TRANSPORT, CONSTRUCTION AND REGIONAL DEVELOPMENT OF THE SLOVAK REPUBLIC

## FINAL REPORT

on investigation of air accident  
of powered hang-glider MW155/TOMI CROSS5  
registration No. **OM – H041**

Date: 20.08.2011

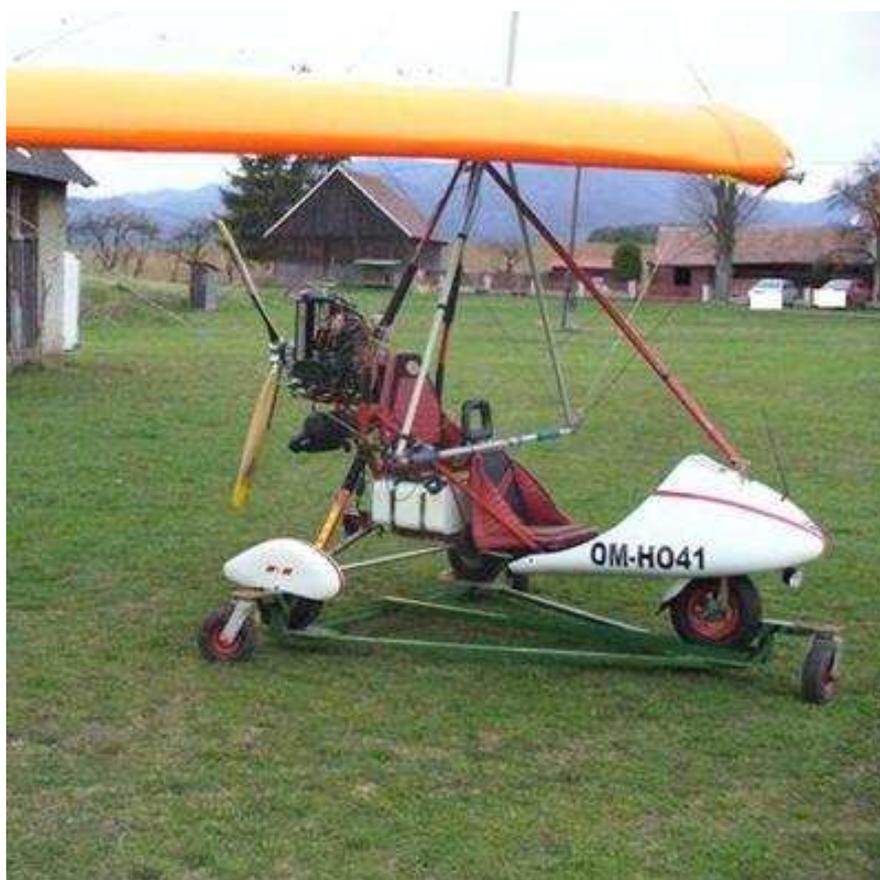
Type of operation: general aviation  
Type of aircraft: flying sport equipment – powered hang-glider  
MW155 / TOMI CROSS5 („PHG“ )  
Registration number: OM-H041
