FINAL REPORT

on investigation of air accident

of aircraft type **Z-226 M / VSO - 10**

Registration No. **OM – KMF / OM - 3503**

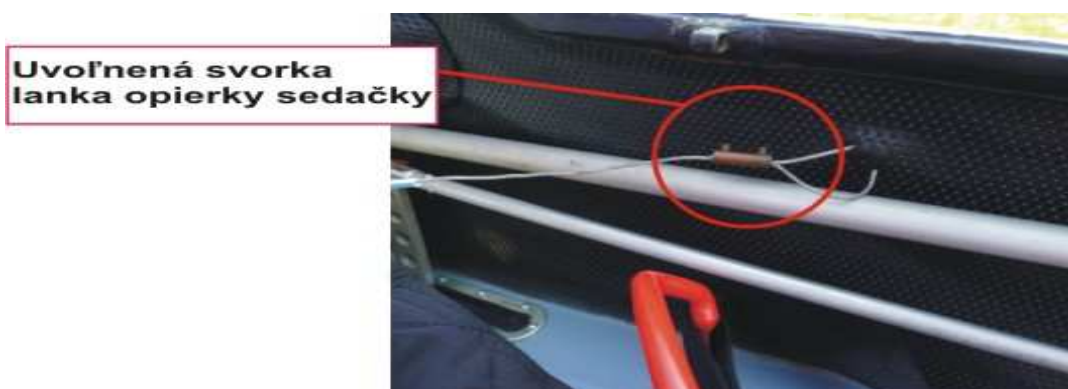
The damage to the glider was caused by the release of the seat back cable lock, followed by the shift of the seat. The pilot by mistake opened the glider's cockpit cover (loss of cockpit that was torn from the hinges).

The main cause of the accident was the release of the seat back cable lock.
