FINAL REPORT

on investigation of air accident
of aircraft **TATRA T-101**
Registration No. **OK-TAO**

Date: 23.09.2011

Place: Airport Žilina / LZZI

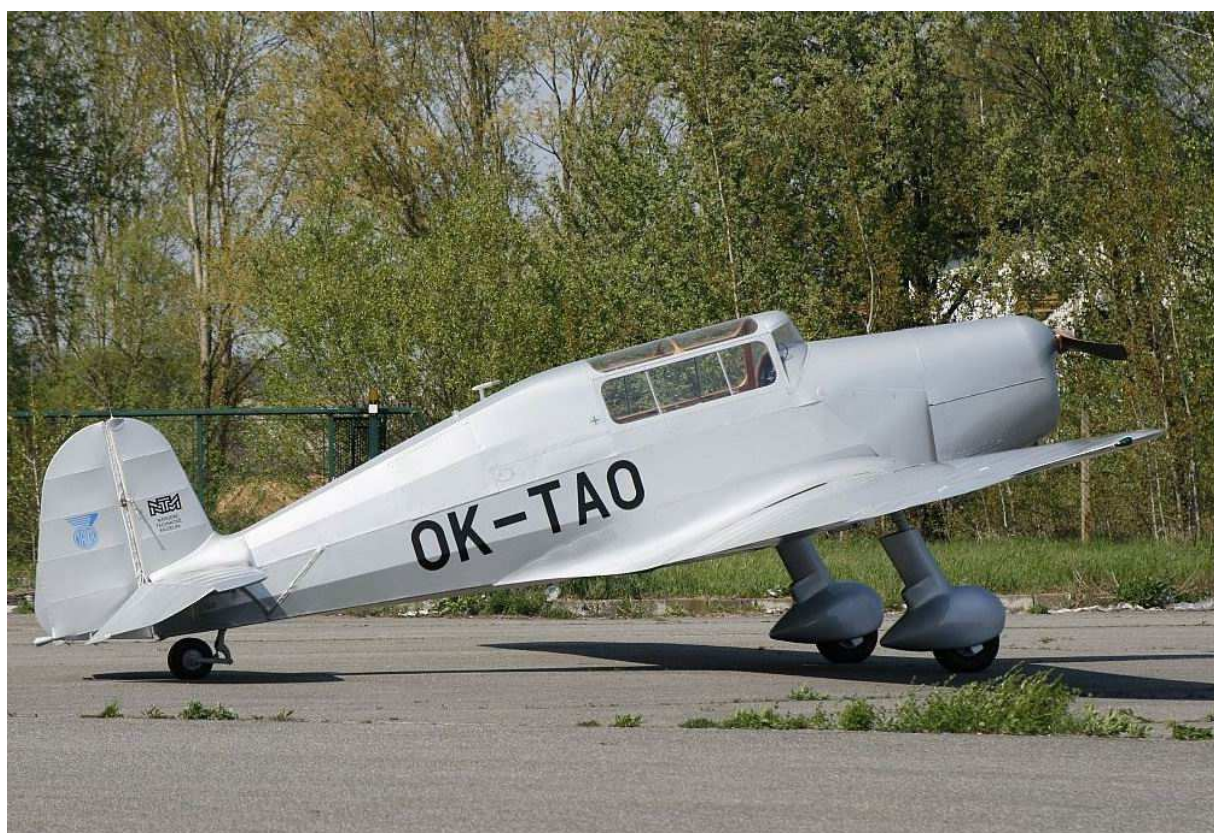
The left leg of landing gear got partially broken off the suspension, the first leg of landing gear got bent to the right side. No other damage to the aircraft was detected.

From conclusions of the expertise it ensues that breaking of attachment was caused by static failure and heavy contamination of steel used (woody fracture) and structural cut (failure on the weld / basic material interface, in the heat affected zone).
