Reg. No. : SKA2013003

FINAL REPORT

on investigation of accident
of glider type **SZD-41A Jantar STD**
registration No. **SP-3071**

Place: Úľanka – football ground

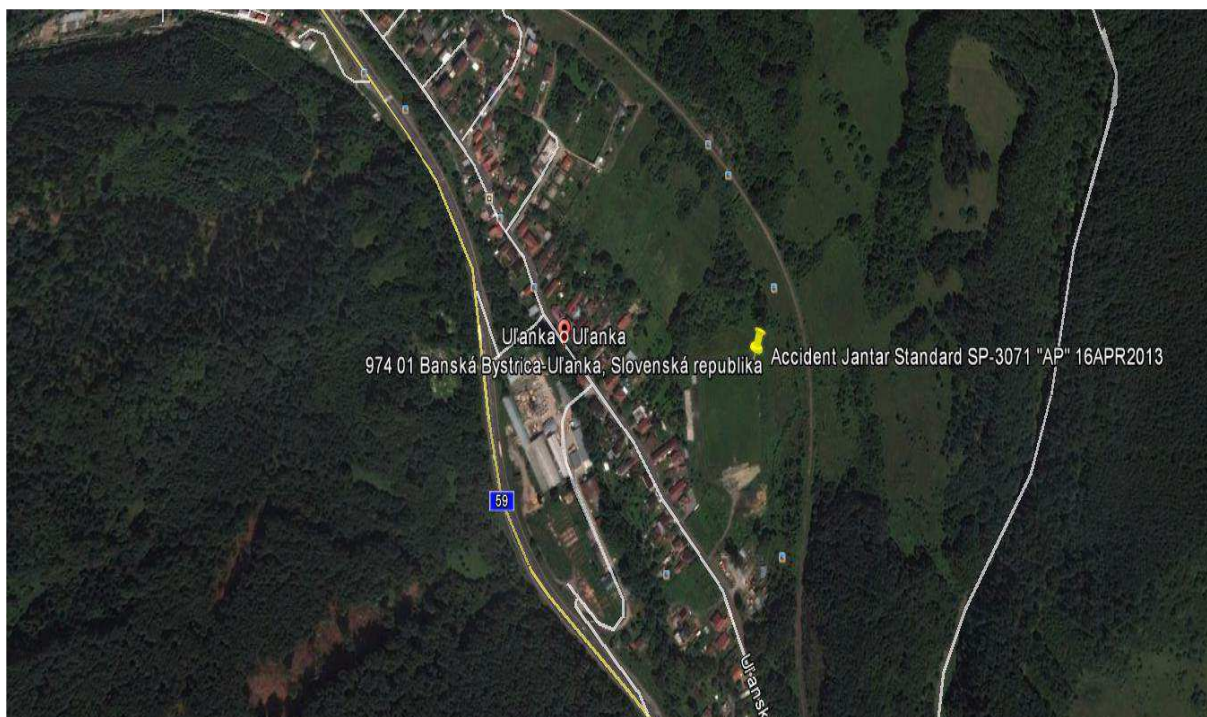
1.12 Wreckage and impact information

After landing the front part of the fuselage (fig.1), left windtip arc (fig. 2), left aileron (fig. 3) and tail control surfaces (fig. 4) of the glider were damaged, the rudder wheel (fig. 5) was bursted in and the right side of the fuselage under the right wing (fig. 6) was cracked.

The place of accident is described by geographic coordinates: N 48°47'07''; E 019°06'53''. The glider remained in one piece and damage after the accident.
