Reg. No.: SKA2013005

FINAL REPORT

on investigation of accident

of aircraft types **Schleicher ASW 27-18E** and **WT-9 Dynamic**
registration No. **D-KJIL** and **OM-DYB**

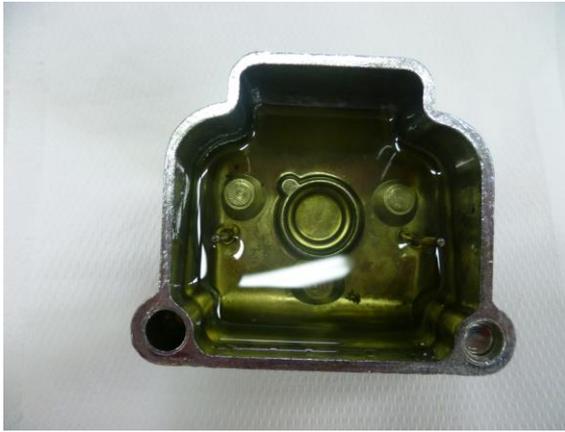
Fig. 11

The WT9 engine was inspected on 28 May 2013. The fuel from fuel tanks was sampled and visually checked for the presence of foreign bodies and water (fig. 9) with negative result. Afterwards both carburettors were removed from the engine (fig. 10) for the purpose of inspection of the float chamber. The right float chamber was without finding (fig. 11). In the left float chamber (fig. 12) was detected the presence of vegetable impurities (fig. 13 and fig. 14). After cleaning of the float chamber the carburettors were mounted back in the WT9 engine. After a thorough check of the fuel installation in the engine bay both carburettors were adjusted and the ground engine test was implemented. During the engine test the engine was running without problems in all modes and showing parameters according to the Operating manual of engine ROTAX 912.

During the check of carburettors the potential risk of penetration of impurity into the float chamber from the carburettor drip tray through the airbox overflow hose and the float chamber vent hose was detected because they were connected to the same overflow hose. The penetration of impurity could cause an irregular engine run or a drop of its power.

During the analysis of engine carburetors vegetable impurities were detected in the left float chamber, which probably caused the drop of engine power during the take-off.

- introduced in its internal fuel filter replacement procedures measures to prevent the penetration of impurities into the fuel system.
