Reg. No. : SKS2013001

## FINAL REPORT

on investigation of serious incident  
of aircrafts **WT-9 Dynamic** and **Z-37-2**  
Registration No. **OM-PDB** and **OM-YJG**

Date: 19.04.2013

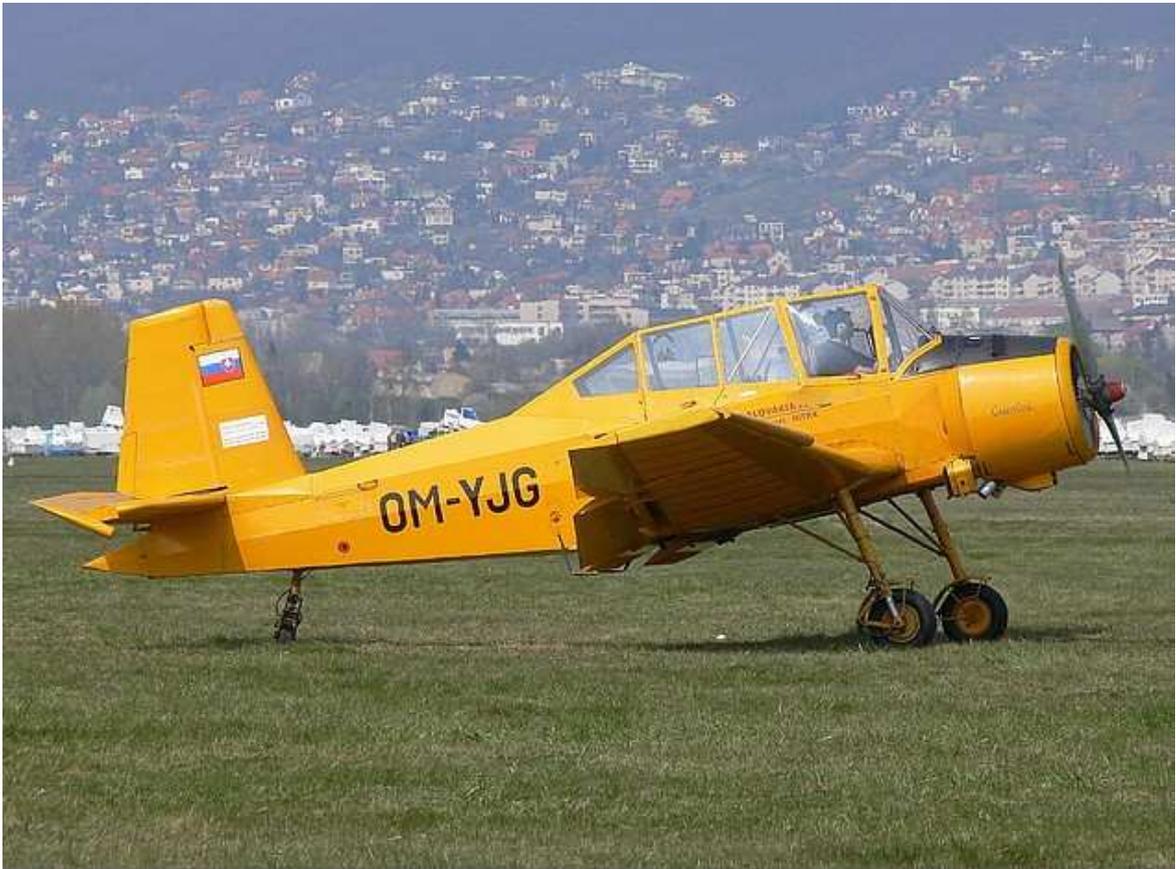
## Z-37-2

The released rope fell over the rear section of aircraft Z-37-2 Čmelák, partially twined around its rear fuselage and elevator and damaged its trimming tab.
