## FINAL REPORT

on investigation of serious incident  
of aircraft type **EuroFOX VISION**  
registration No. **OM-LIV**

Date: 02.08.2013

Place: Tesárske Mlyňany

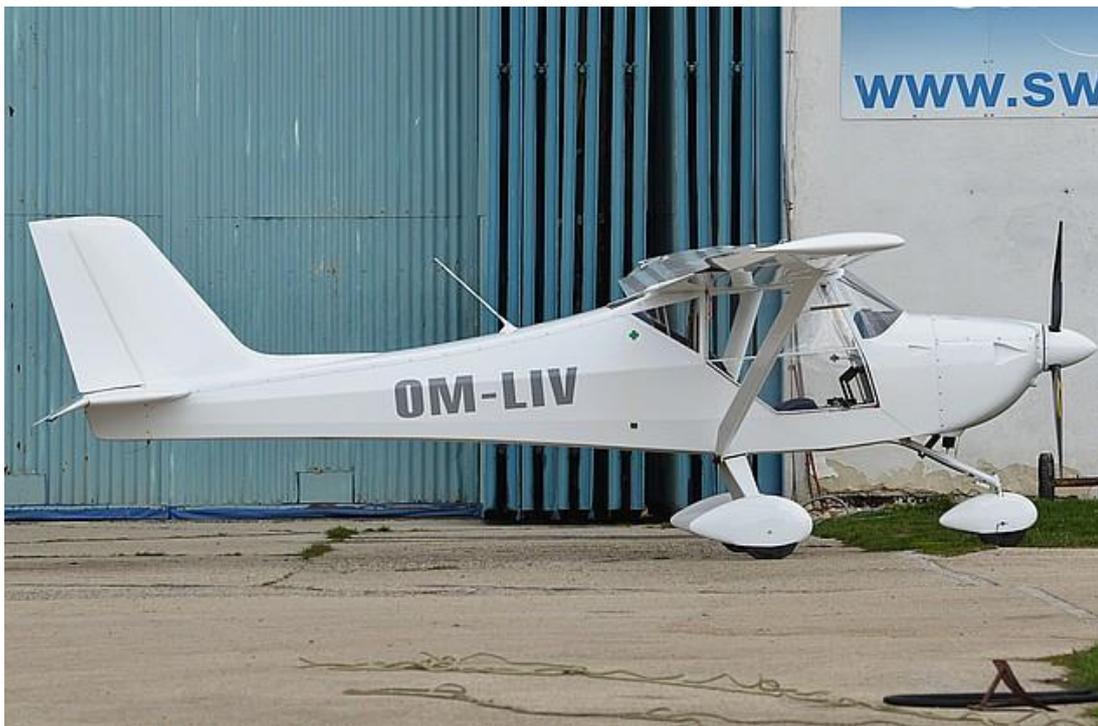
Type of aircraft: EuroFOX VISION  
Registration No.: OM-LIV

The aircraft was substantially damaged in the serious incident (damaged propeller blades, right front fuselage and right wing leading edge).
