## **FINAL REPORT**

on investigation of serious incident  
of aircraft type **EuroFOX 912 3k-Tow**  
Registration No. **OM-LAN**

Date: 18.08.2013

Place: Airport Nitra / LZNI

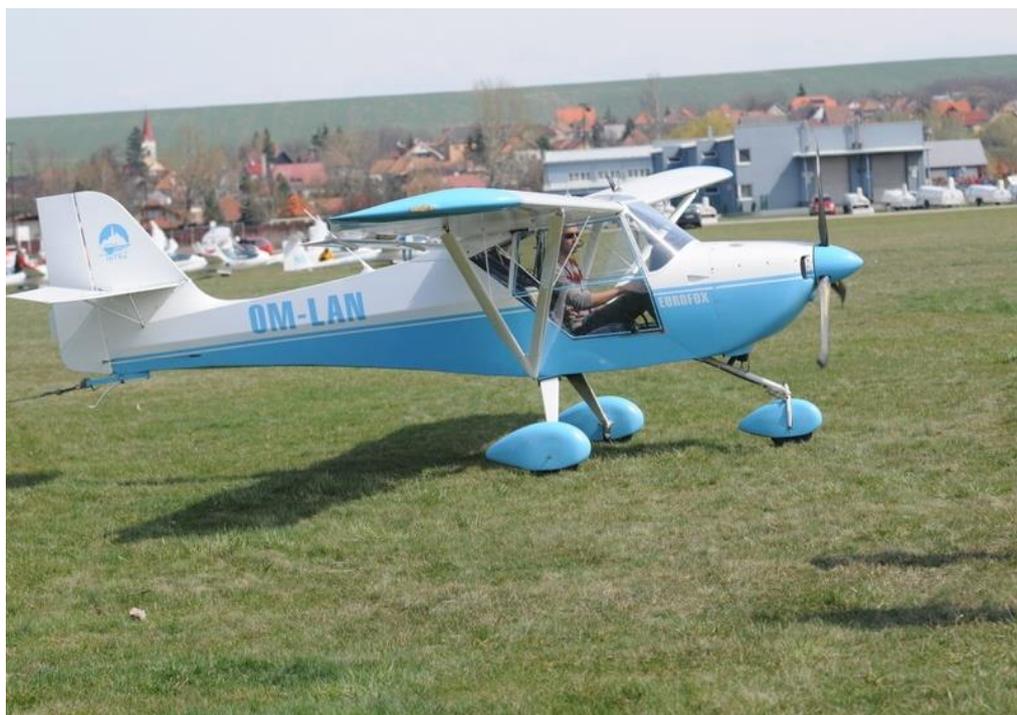
In view of the significant depth of the undulation the front landing gear leg got broken, the aircraft tilted over hard to its nose, the rotating propeller came into contact with the ground and the engine was stopped by force.

Scope of damage: front landing gear leg broken, engine stopped by force, all three propeller blades destroyed, front landing gear wheel spats, sump guard and propeller spinner damaged, strut frame of the front fuselage deformed in the area of attachment of the front landing gear leg and canvas cover of the underbody broken.
