## FINAL REPORT

on investigation of serious incident

of aircraft type **WT-9 Dynamic**

Registration No. **OM-AKM**

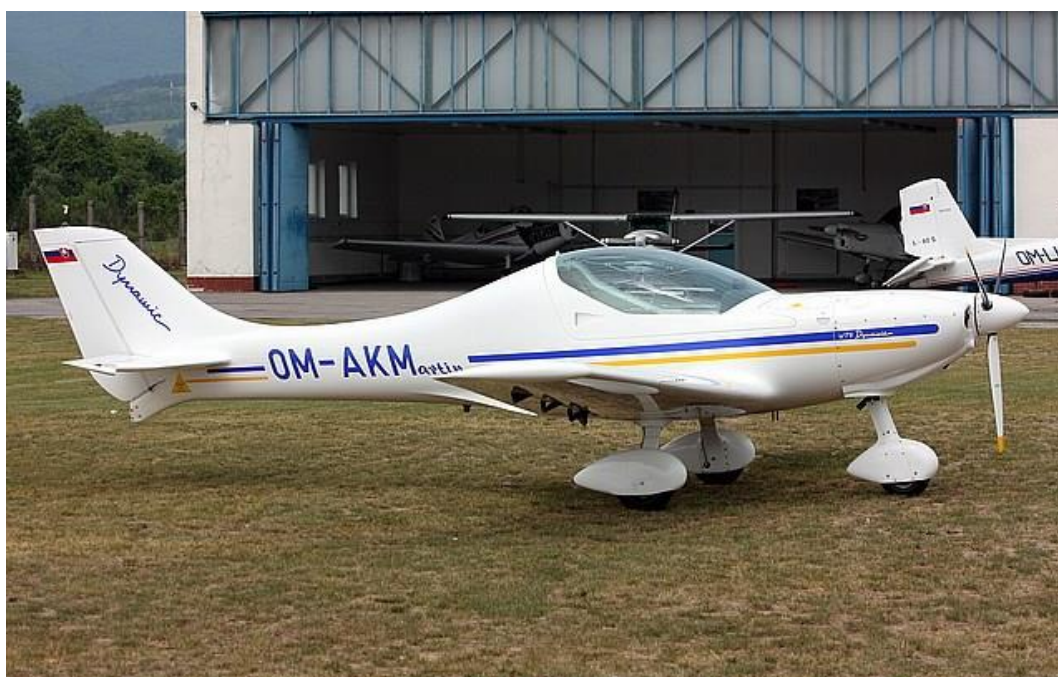
Fig. 1 Oil leak

No damage was detected on the airframe other than pollution of the aircraft surface from a large oil leak. The following inspection detected a destruction of the engine caused by puncturing the engine block.

The puncturing of the engine block and oil leak from the engine caused fire in the aircraft, which was extinguished by the pilot during the flight.
