FINAL REPORT

on investigation of accident
of glider type **Astir CS 77**
Registration No. **D-4802**

Reg. No.: **SKA2014003**

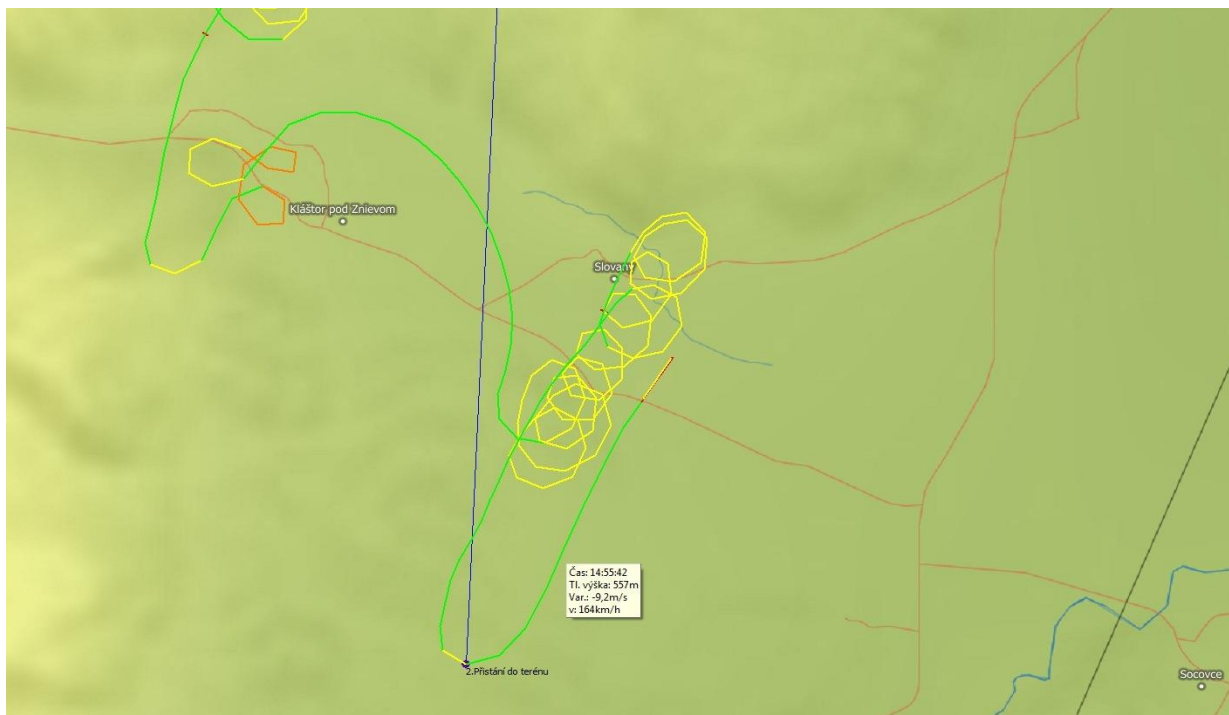
During the subsequent downwind landing approach the pilot increased the vertical descending speed excessively (9.8 m/s) with a gradual increase of speed up to 165 km/h, which caused him to fly over the chosen surface. In the end of the surface there was a road with a one-meter high embankment, oriented vertically to the direction of landing. At the last moment the pilot tried to fly over the embankment, but the tail of the glider came into contact with the ground. Subsequently the glider landing gear touched the embankment, which caused the glider to jump off and lose the speed. Approximately 8 m behind the road the front fuselage hit the ground under a steep angle and turned over to its back. It remained standing in this position.

- Front fuselage fully destroyed
- Fuselage broken
- Stabilizer and elevator broken off
- Air brakes broken out.
