FINAL REPORT

on investigation of accident
of glider type **Cirrus VTC**
Registration No. **OM-2908**

Reg. No: **SKA2015003**

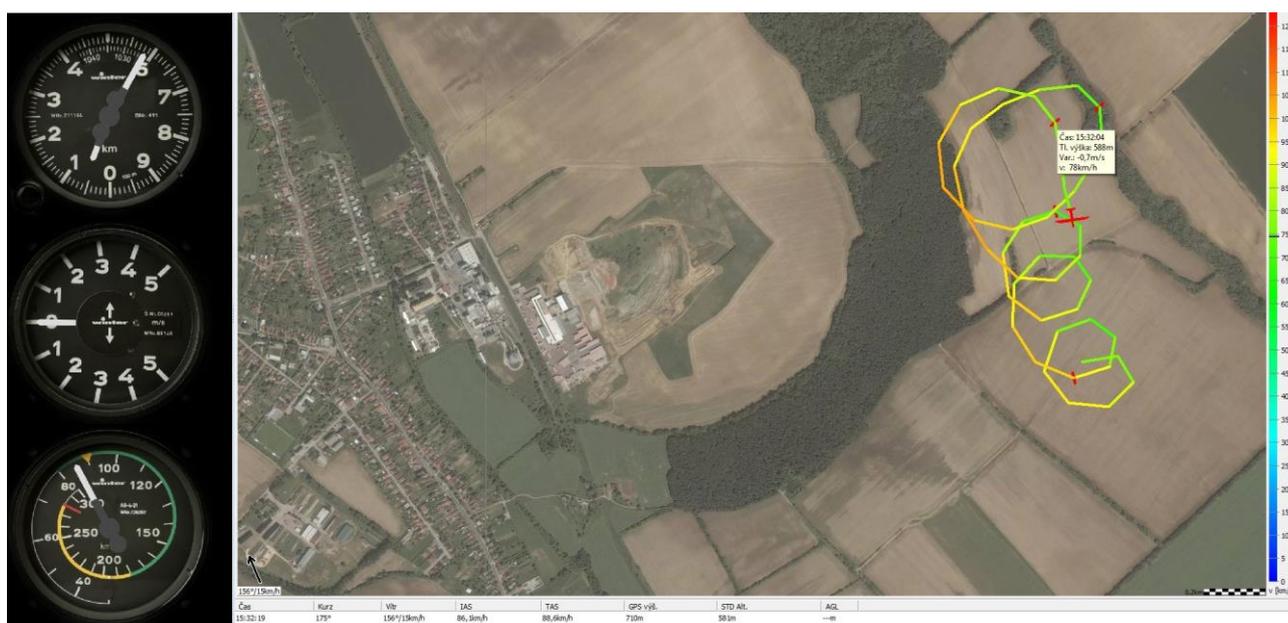
According to the pilot's statement, at the altitude of 700 m AMSL, when making a right-hand turn in the uplift current with average climbing speed of 1 m/s, the glider lined up for a straight-line flight and did not react to deflection of controls.

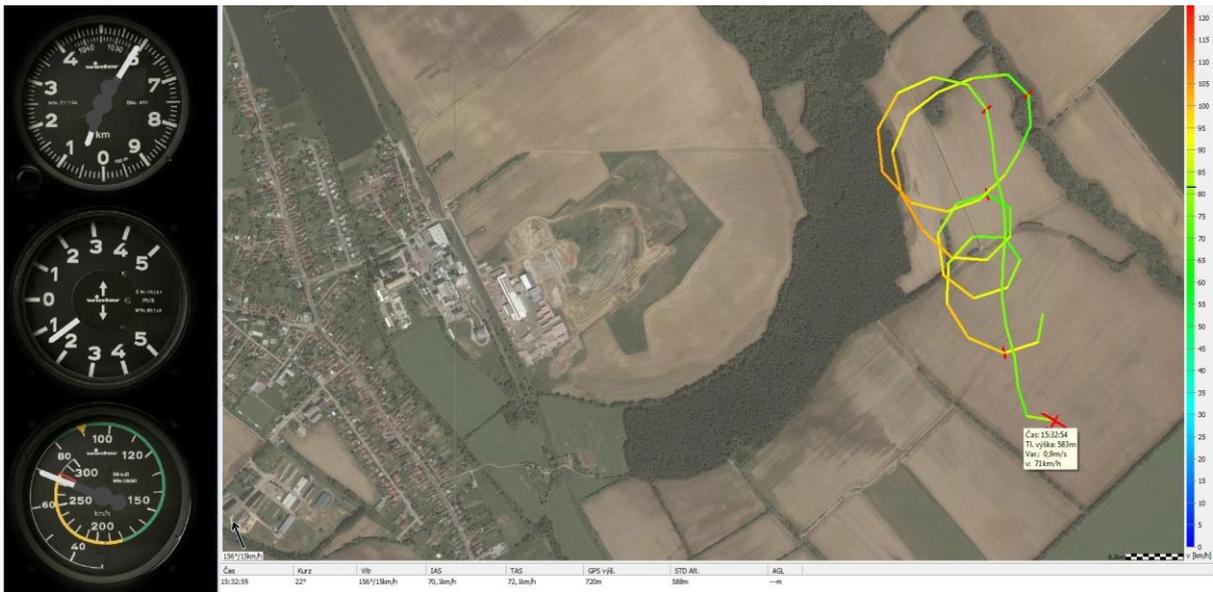
Once the glider had been put in a left bank, it went into a stall with left-turn spin, which the pilot was able to stop by vigorous pushing and then reported on the ATZ frequency of the aerodrome LZTR the impossibility of turning right.

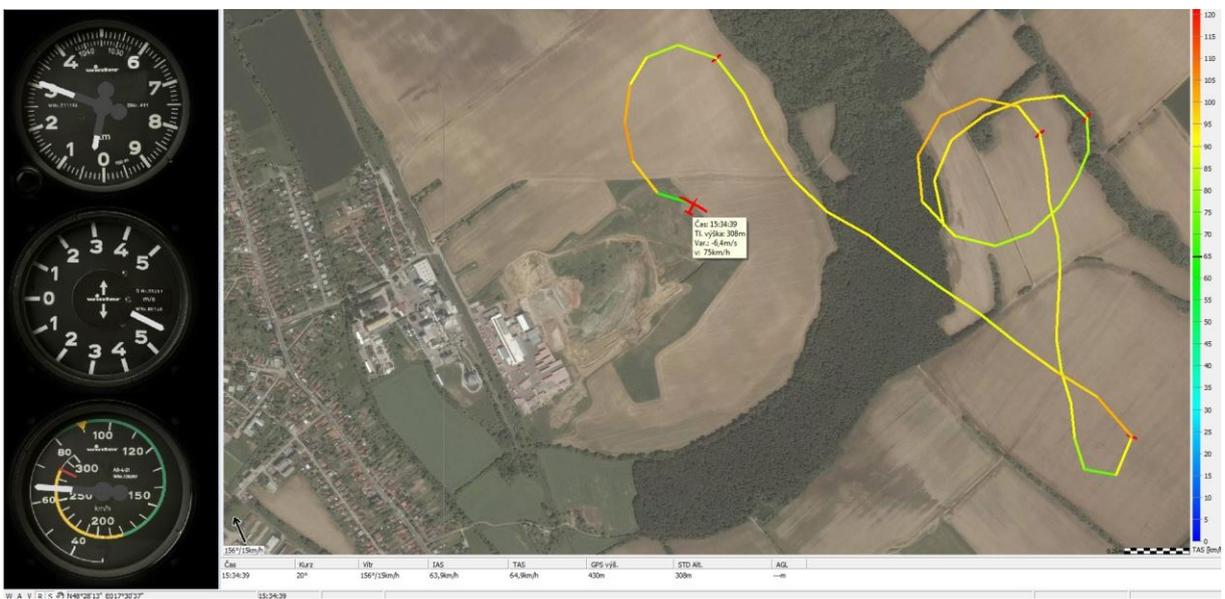
However, having been put in the left-hand turn, the glider again went into a left-hand spin.

After the stopping of spin rotation the glider was in a steep dive low above the ground. Therefore the pilot decided to solve the situation by field landing in the direction of the glider, but all he managed to do was open the air brakes. Afterwards, the glider came into a harder slipping contact with the ground, which caused its damage. Further damage to the glider occurred in the ground roll phase, because it continued to turn left. The pilot left the damaged glider with help of a passer-by.
