FINAL REPORT

on investigation of accident
of helicopter type **AGUSTA A 109K2**
Registration No **OM-ATB**

Reg. No: **SKA2015004**

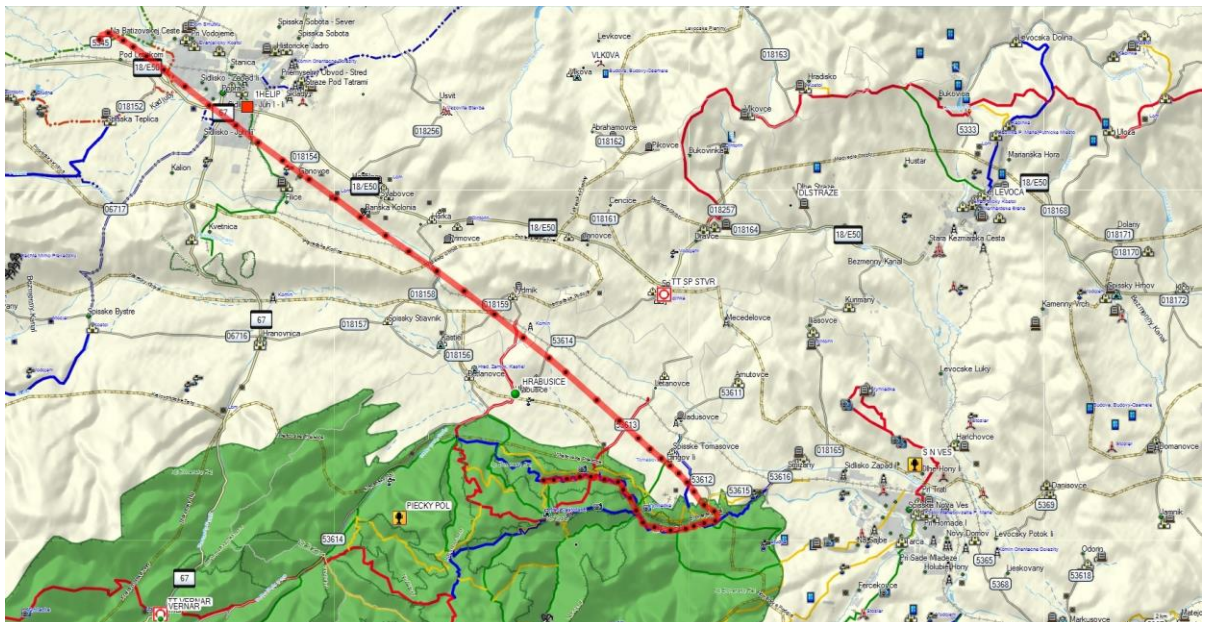
1.12 Wreckage and impact information

N 48°57'10.10" E 20°25'12.70"

The helicopter crashed into a narrow gorge, on the bank of a river, in hardly accessible area with thick forest stand. A portion of wrecks was dispersed in its proximity, in the river. Segments of rotor blades were found on a hardly accessible hillside of the gorge.
