# FINAL REPORT

on the safety investigation of the air accident

helicopter type **Bell 429**

Registration Mark **OM-ATR**

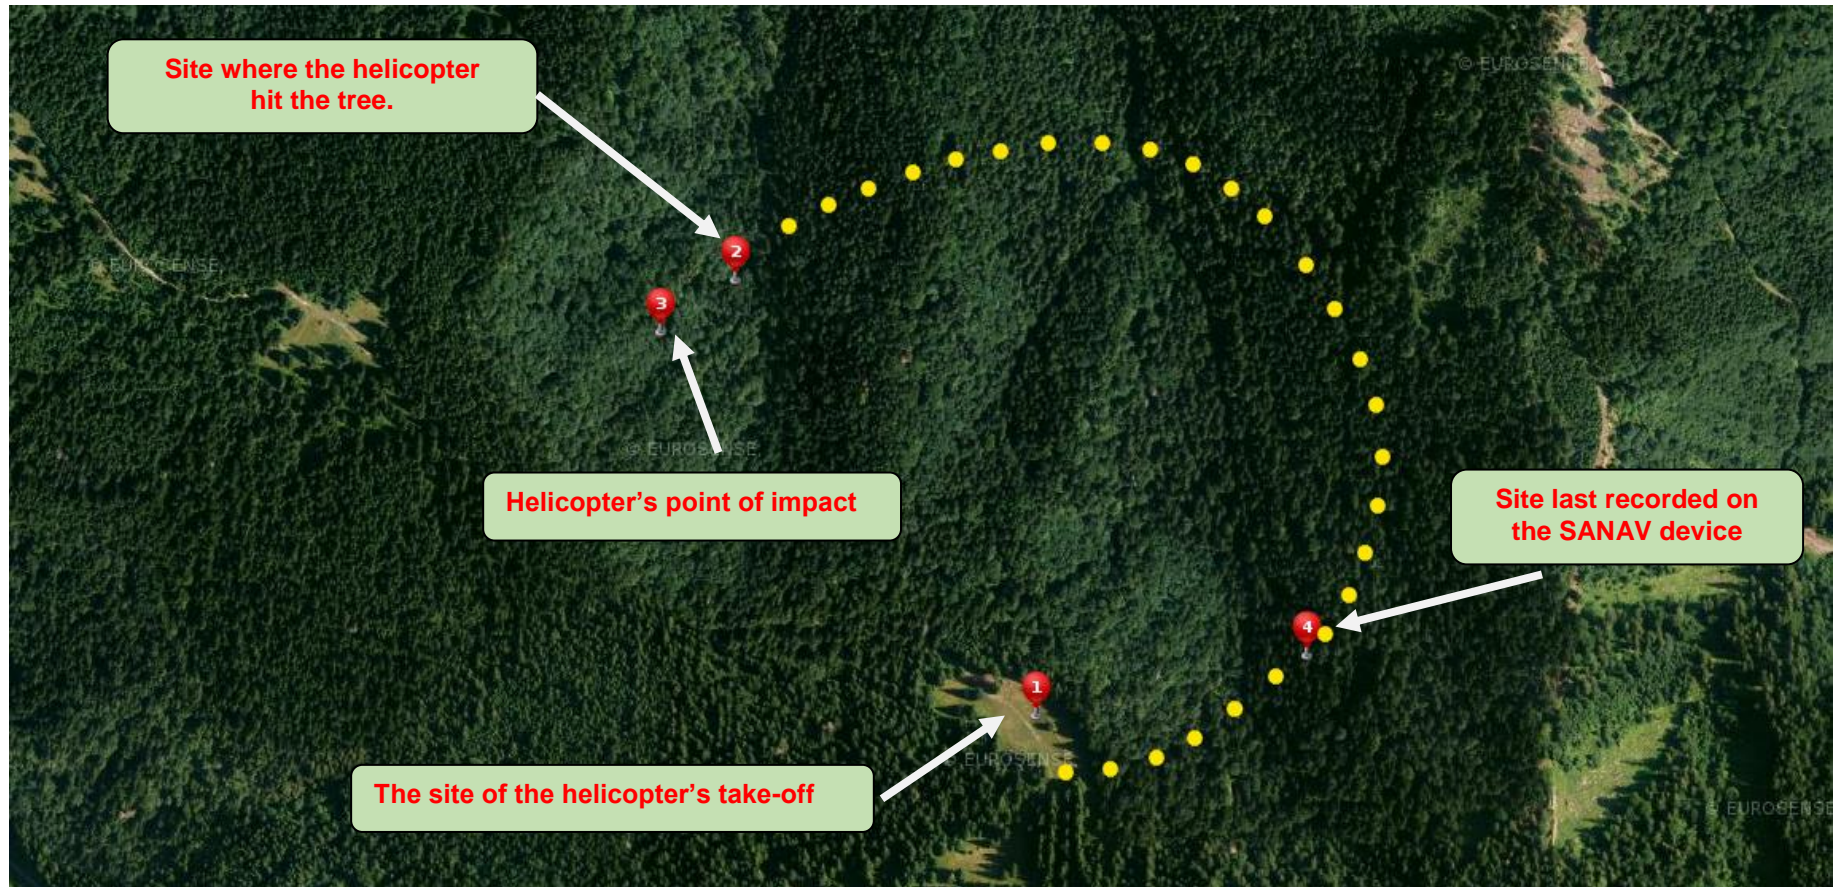
On the basis of witness testimonies, it can be assumed that the last phase of the flight continued on a dark moonless night hidden from the view of present witnesses/firefighters and rescuers/behind a high forest stand by a left-hand torque westward toward the town of Banská Bystrica.

The average steady torque in the horizon at 360° at the estimated 80 kt flight speed was set at 640 meters after the map's recalculation. On the basis of the average, the total circumference of the fictitious torque was set at 1,396 m.

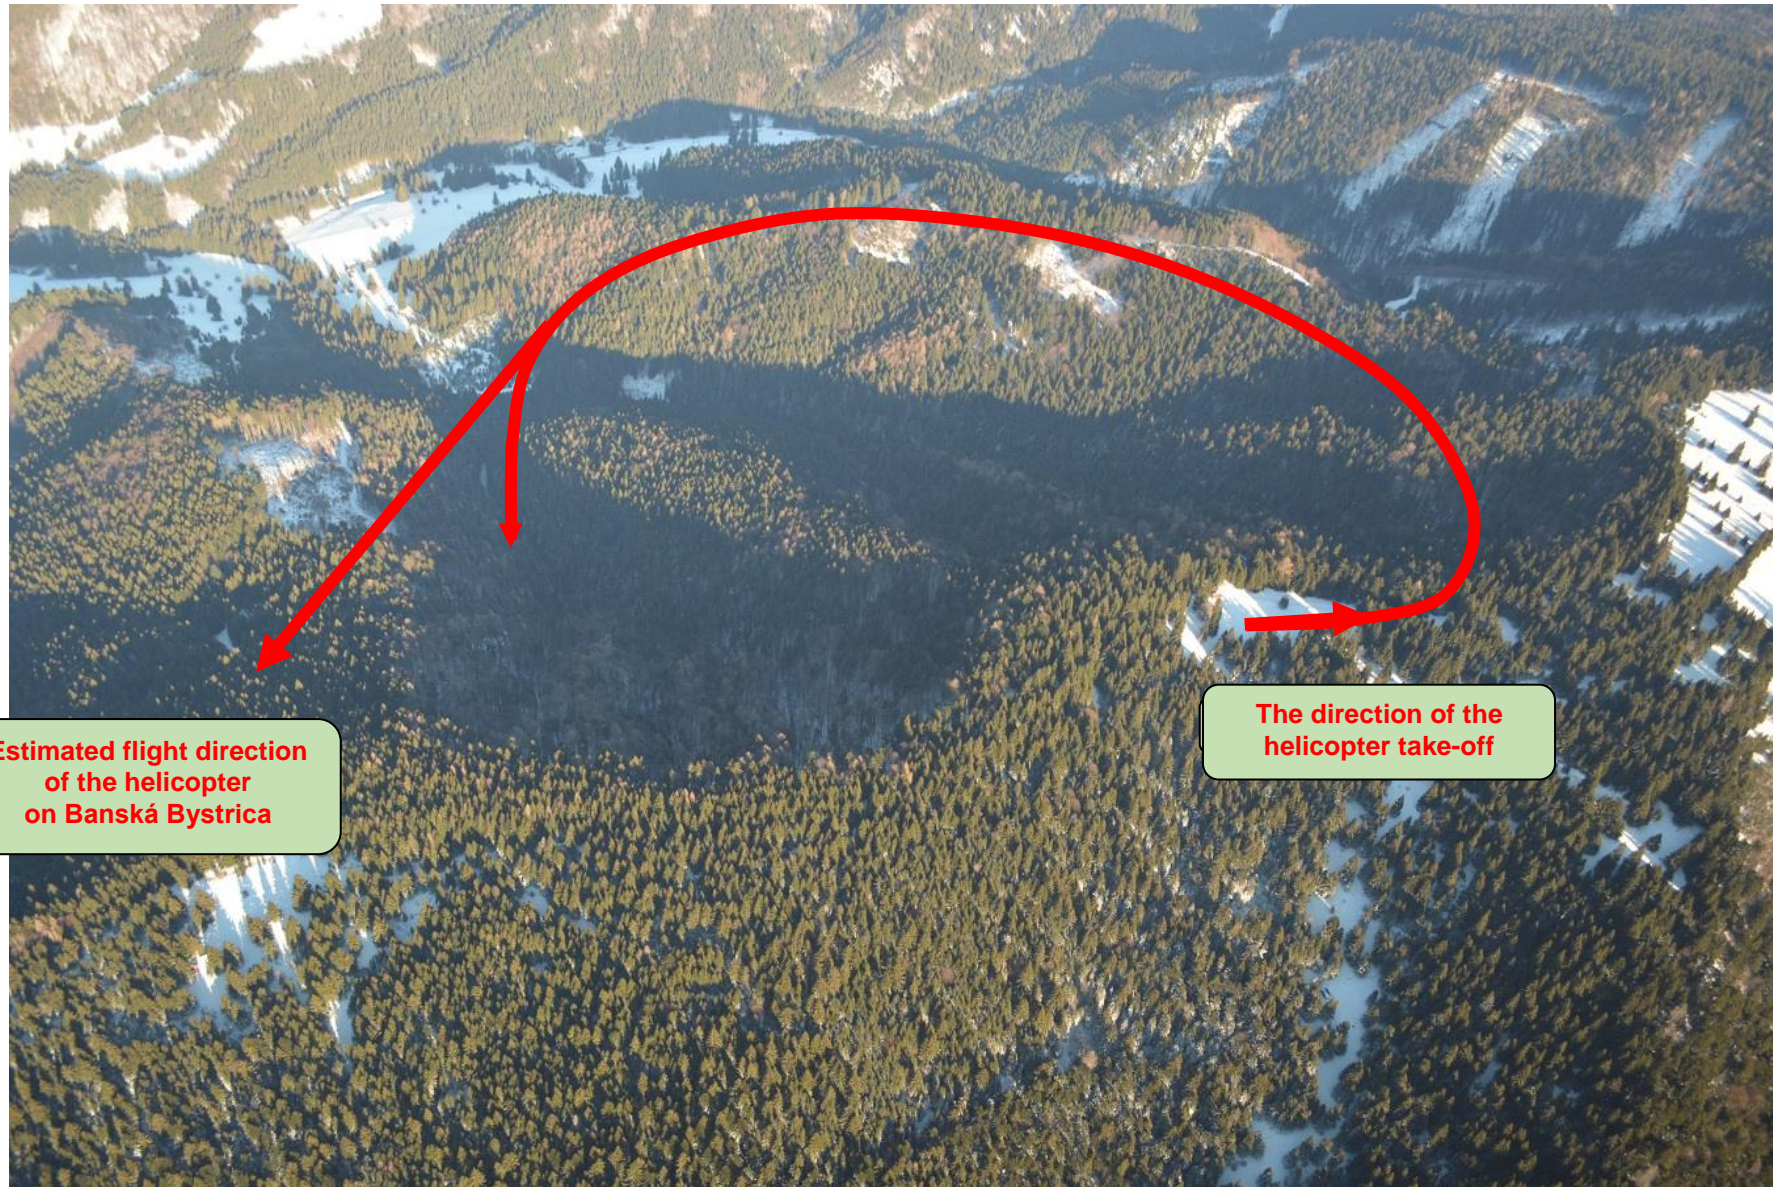
**Estimated flight direction  
of the helicopter  
on Banská Bystrica**

**The direction of the  
helicopter take-off**

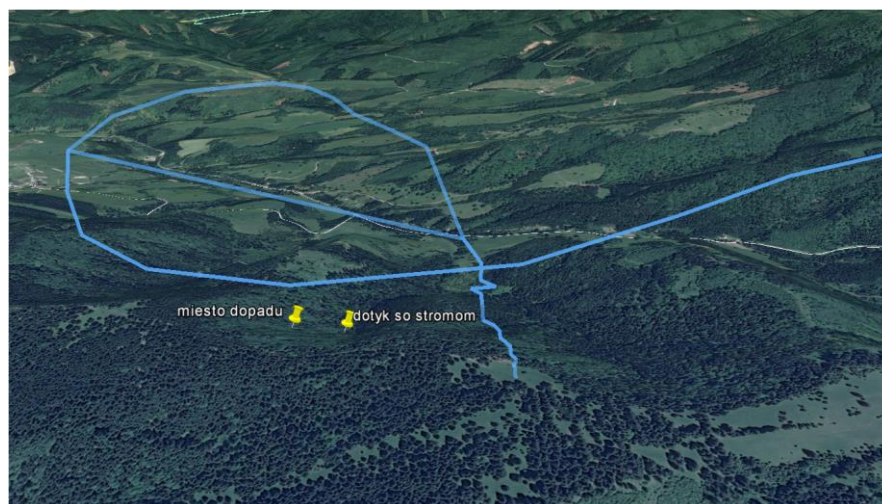
*Landing - the complete record*

*(a file from the operator was added to the missing 29 positions from the device log)*

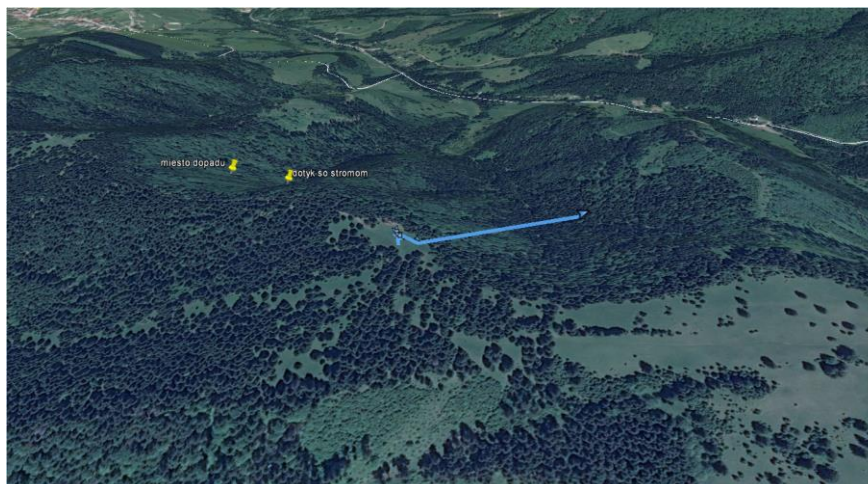
*Take-off (a set of 19 positions from the device log after startup)*

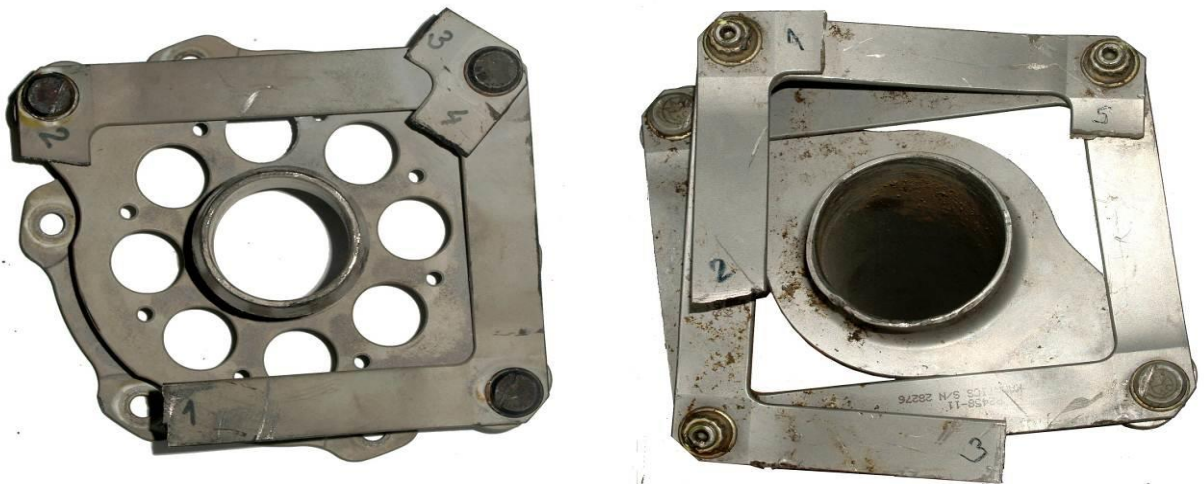
On the flexible coupling behind the shaft, 5 fractures were examined on flexible blade rectangles. From fractures 1 to 3, both fracture areas of fractures 4 and 5 were examined only after one fracture area.

All the fracture areas present on the submitted parts of the couplings were microscopically examined, and the basic characteristics of the fatigue mechanism of the material damage (the initiation site, the clear area of the processing and relaxation belts and the visible area of the final material degradation) were not found on them.

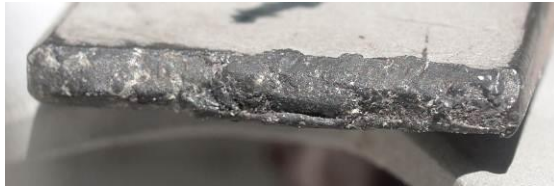
The first blade rectangle of the output flexible coupling of the right-hand drive shaft directly attached to the shaft flange was clearly deformed by the flexural load  $M_o$ . It is clear that at the time of this deformation the remaining part of the coupling had to be compact and functional to be able to transfer this bending load. Thus, it can be clearly stated that damage to this flexible coupling occurred only when the helicopter crashed.
