FINAL REPORT

of the safety investigation of the aviation accident

HALLEY / APOLLO CXMD flying sport vehicle

Ref. No.: **SKA2016008**

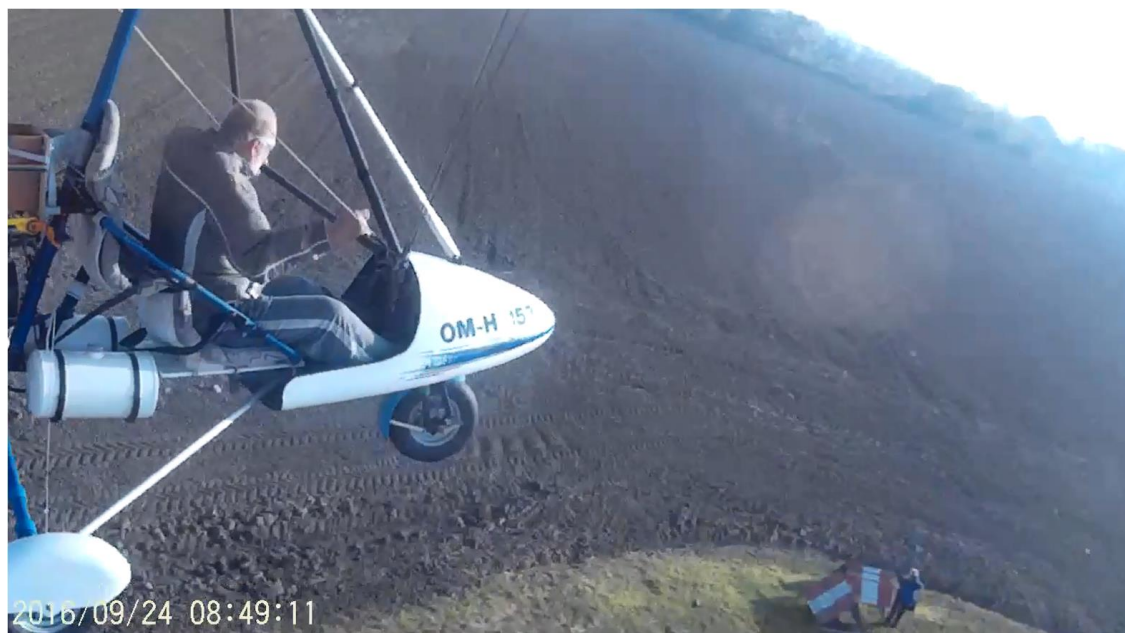
At 6:46:45, he took off from RWY14. After take-off, he continued to fly following the right circuit RWY14 with the intention of carrying out a low-level flyover above the person watching the whole flight. He carried out the flyover at 6:49:11, at ground-level height, with a heading of ca 110° in the right-hand-rotating inclination.
