AVIATION AND MARITIME INVESTIGATION AUTHORITY
Námestie slobody 6, P.O.BOX 100
810 05 Bratislava

FINAL REPORT

on the Expert Investigation of an Aviation Accident

Airplane type **WT9 Dynamic LSA/Club**

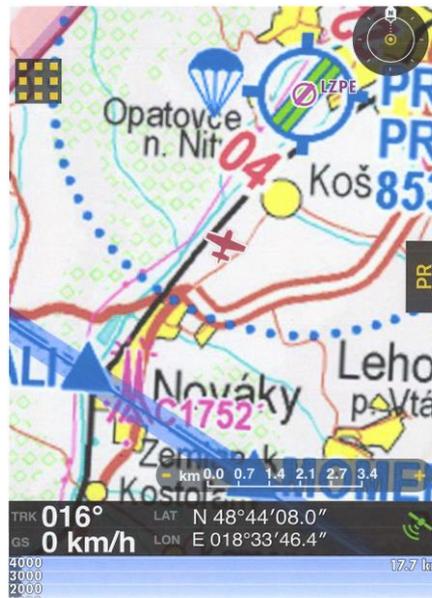
The place of the airplane crash

The airplane was located on the edge of an agricultural plot with a longitudinal axis of 315°, without the cockpit cover, which was undamaged in the hillside at a distance of 25 m from the airplane fuselage. The front part of the fuselage with the engine was deformed at the bottom by the impact on the ground. The engine covers were deformed and broken, the front chassis leg, the oil cooler along with the air rectifier to the cooler were broken as well as propeller blade No. 1, and propeller blade No. 2 was partially broken and the propeller cone was damaged. The main chassis's legs were pushed into the central wing and the laminate wheel covers were broken. The fuselage was broken twice in the crew compartment space along with the central wing, about 25 cm from the dashboard and at the place of the seat backs separating the luggage compartment from the cockpit. The left part of the central wing had a perforated leading edge and its bottom part was broken. The lower stabilizing surface was broken in the rear part of the fuselage. At the end of the fuselage, a device for glider lifts and a bracket for storing the spin-recovery parachuter was mounted. Both parts were damaged and broken. An unwrapped strap of a spin-recovery parachute that was not activated during the flight was connected to the towing device. After the towing device was broken on the ground, it fell out of the bracket spontaneously, being still in an unpacked state.

The stabilizer and the altitude rudder were significantly damaged, the right part of the rudders was broken in half. The left side of the rudder was broken in 1/2. The keel surface and the indicator were broken in half.

The left half of the wing was broken off from the central wing and had a broken left flap at the distance of 35 cm from the central wing. The left wing was broken at 1/3 of its length. The bottom wing covering was cut and the left winglet was broken. The leading edge was cut at a distance of 80 cm from the wing end. The outer "stall stripe" was unstuck from the leading edge and the leading edge was detached at the level of the left fuel tank shutter.

The right half of the wing had a detached leading edge at the outer "stall stripe". The speed sensor was broken at the bottom part of the wing. The right winglet was broken and the right wing was broken at 1/3 of its length. The right flap was damaged at its bottom part in a compartment of the second hitch.
