AVIATION AND MARITIME INVESTIGATION AUTHORITY
Námestie slobody 6, P.O.BOX 100
810 05 Bratislava 15

FINAL REPORT

on Investigation of a Serious Incident
of aircraft type **PS-28 Cruiser**
registration number **OM-STR**

Ref. No.: SKS2016002

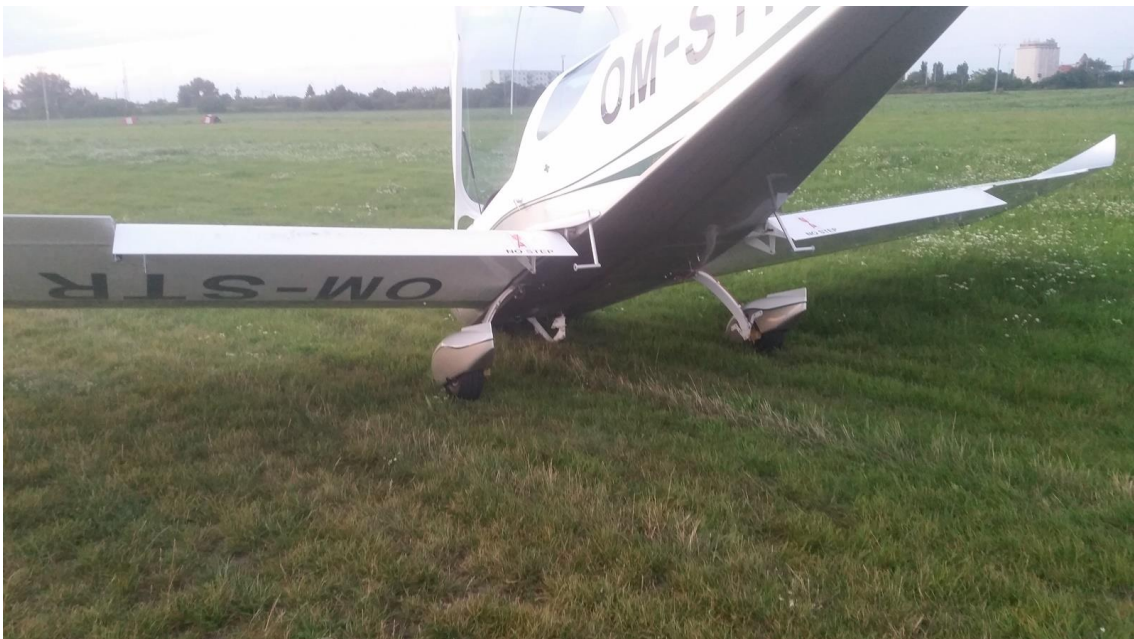
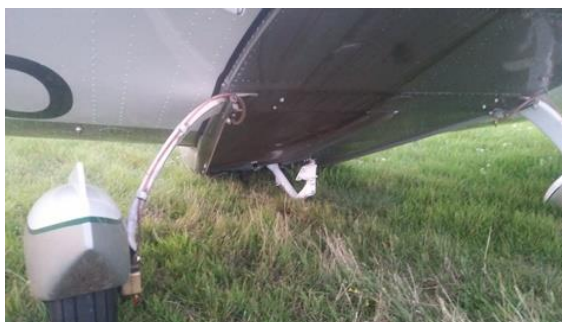
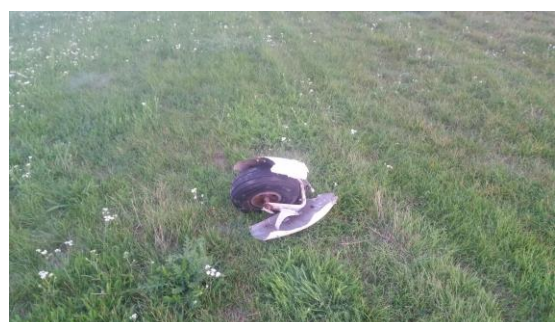
1.12 Wreckage and impact information

The front landing gear and propeller were damaged in the incident, the exhaust and the heating pipes were deformed, the engine mount was cracked, the cabin floor and the coating in the bottom of the fuselage were deformed.

At the time of damage, the relevant bolted joint was overloaded with horizontal backward force as demonstrated by the actual bending of the landing gear leg backwards.
