FINAL REPORT

on investigation of air accident
of aircraft **WT-9 Dynamic Club T**
registration No. **OM-PDA**

Date: 17.04.2012

Place: Prievidza Airport / LZPE

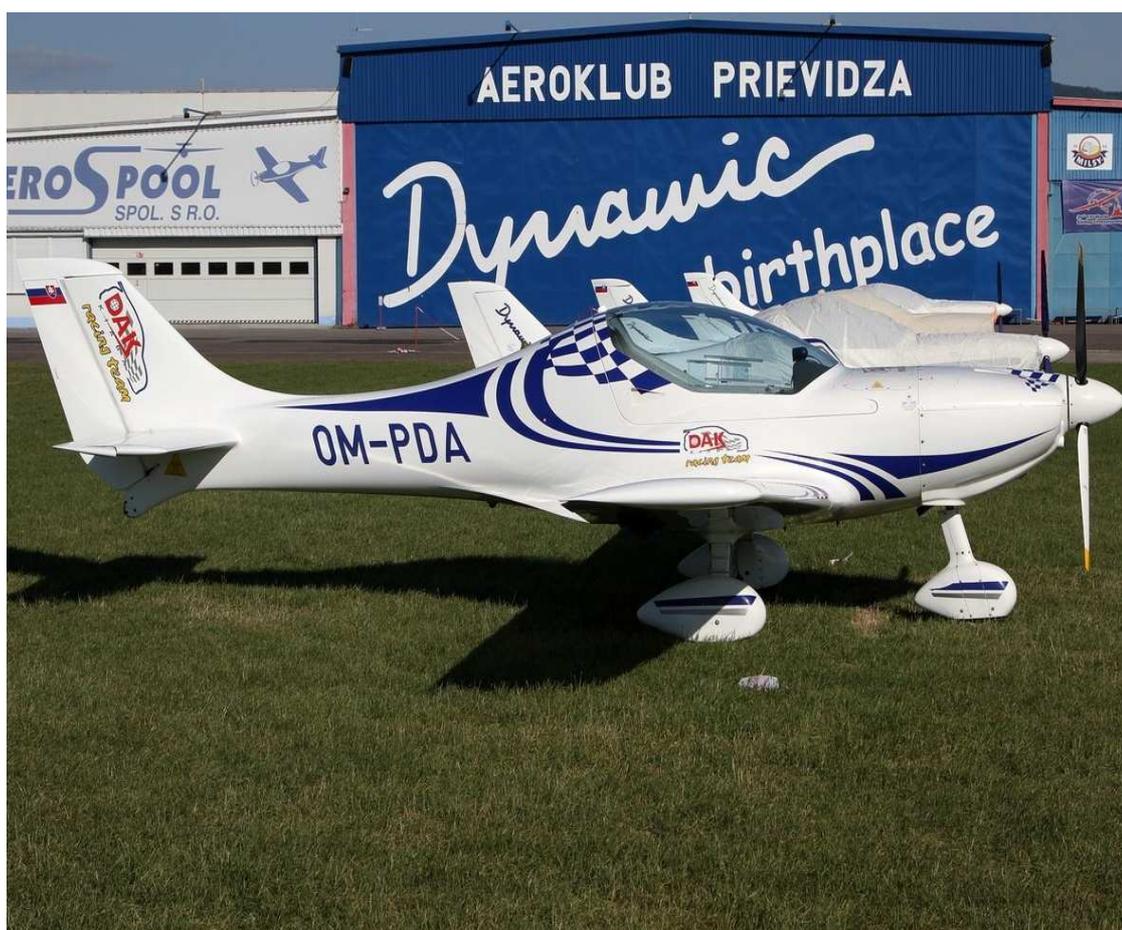
After the collision of the rotating propeller with the ground all the three propeller blades broke off in one third of the length of the propeller blade shank, the engine was stopped by force, and the fork of attachment of the front landing-gear leg wheel and the aerodynamic covers of the nose landing gear got broken.

- the pilot taxied with the aircraft at higher speed and did not notice the obstacle on the safety strip. The front landing gear wheel got stuck in a hole and the aircraft became damaged.
