FINAL REPORT

on investigation of air accident
of aircraft **Standard Cirrus**
registration No. **OK-8918**

Date: 20.05.2012

Place: 0.6 km east of the community Istebné

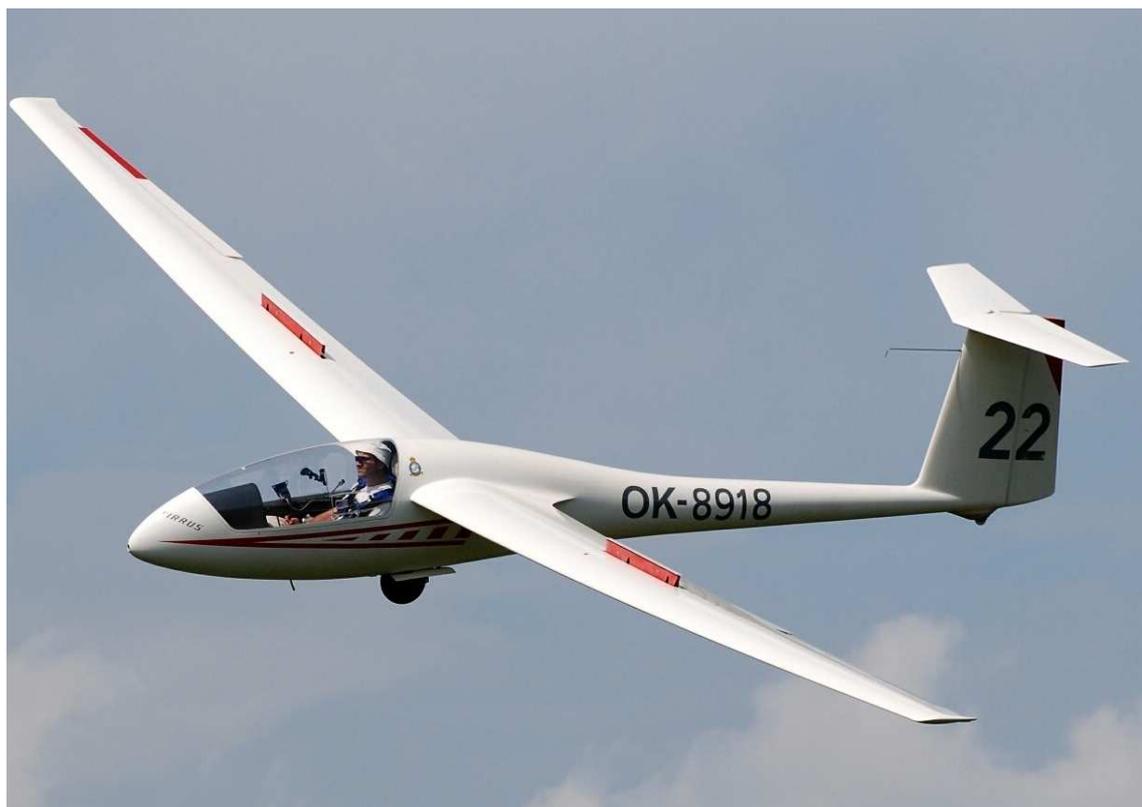
When the aircraft bounced off the uneven ground and touched the ground, its wing came into contact with the ground and the aircraft turned around. Due to this movement and hard contact with the ground, the cockpit got damaged and snapped open, and the tail wheel and horizontal rudder got damaged.
