FINAL REPORT

on investigation of accident
of helicopter type **Mi-8T**
Registration No. **OM-TMT**

Date: 03.08.2012

Place: Airport Poprad / LZTT

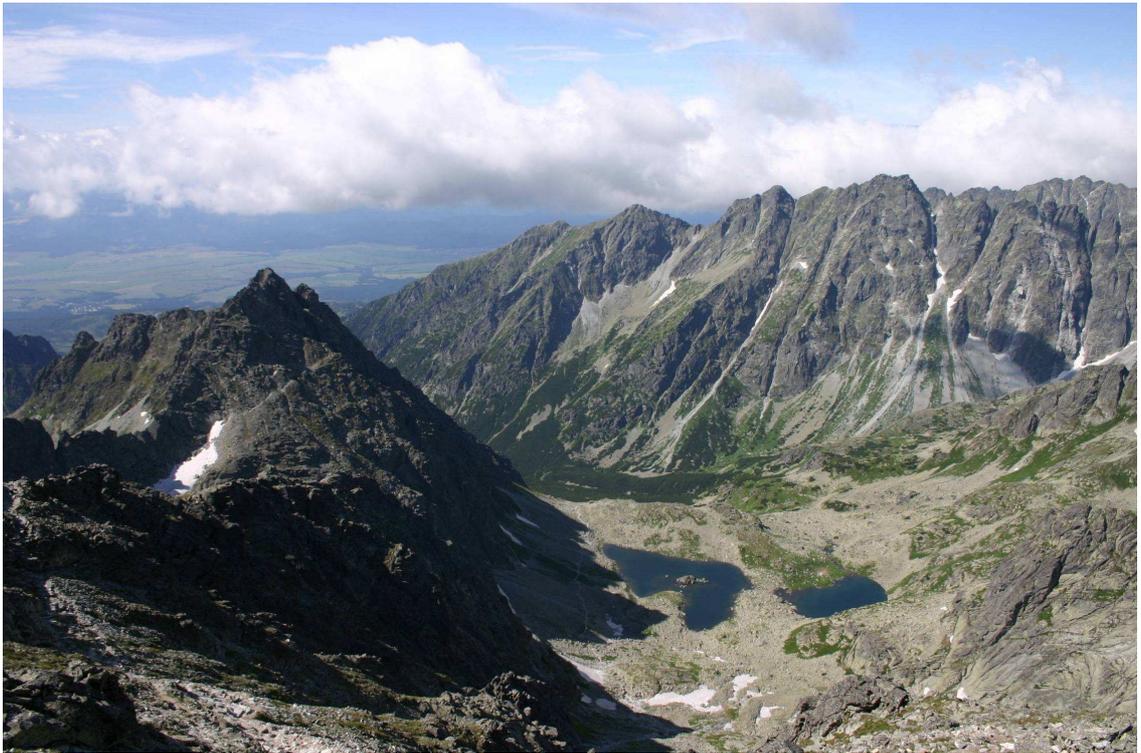
The flight proceeded with free underslung transport cable

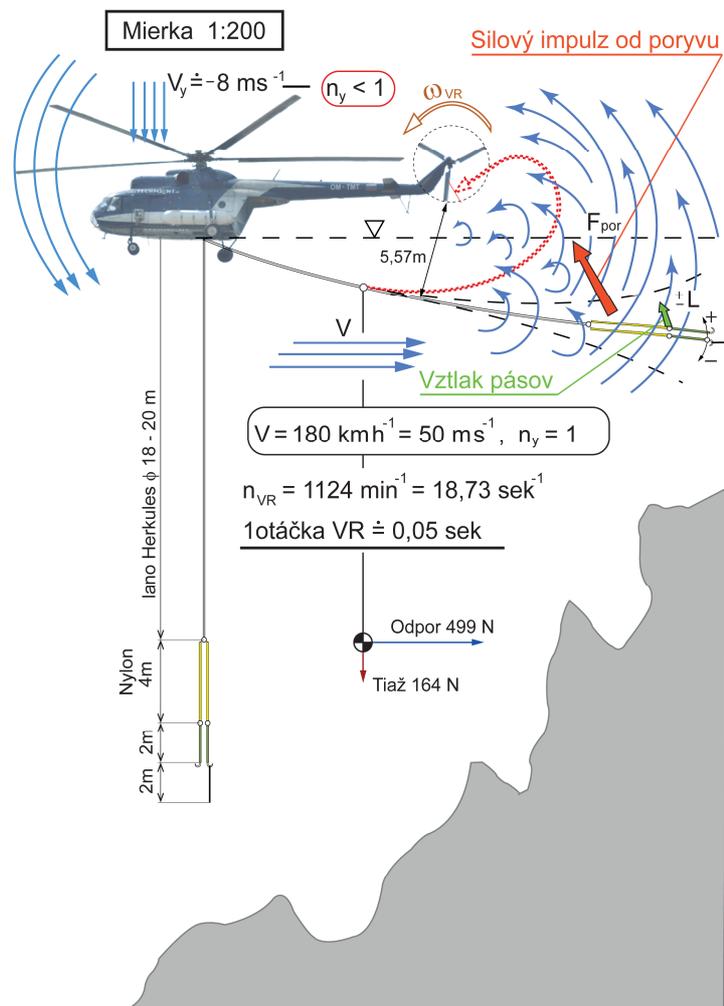
Estimated physical model of atmospheric processes which were the primary factor of the accident of the helicopter

Local meteorological situation in the upper part of the Mengusovská valley under the lakes Žabie plesá and its accidental dynamic development are typical for valley, where orographic and heat effects are in mutual contradiction at sudden change of circulation from a sunlit to a shaded area. The heated air gets into convection, which is thermal non-homogeneity in the form of rising air bubbles.

The trigger of convection at ground levels is the thermal gradient larger than 4.2° per km, occurring at fast overheating, in this case of the bedrock (beginning of August was characterized by temperatures around 30°C), which initiates the rising air bubble, bringing it up to the level of free convection (LFC). At the critical time, according to the enclosed thermodynamic chart, the value of LFC, where air bubble temperature is higher than the ambient temperature, was achieved at pressure level of 759 hPa, i. e. at an altitude of 2100 m. Upon contact of the hot downward anabatic circulation along the sunlit east side of the Mengusovská valley and the descending cooled catabatic circulation along the shaded west side of the valley, the air mass starts to rotate. In the end of the valley, in case of change of direction, the mechanism of cold air downburst is manifested by acceleration of downward circulation with ambient air induction to the emptied vacated area.

This rotating air mass (with estimated diameter of 500 m and width of 600 m) with approximate weight of 150 tonnes would reach, at temperature difference of 10°C between the sunlit and shaded side of the valley, acceleration of up to 0.2 m.s⁻¹, which gives estimated speed of vortex motion around 8m.s⁻¹ (according to an idealized calculation model, which only takes into account the temperature difference, although other effects are manifested in the practice). The interaction of the gradient of acceleration of partial internal circulations of contemplated air mass with disturbances of vertical pressure gradient, wind shear, ruggedness of landscape and turbulences generated by work of MR can significantly increase the intensity of turbulent air rotation and its momentum with large energy content.

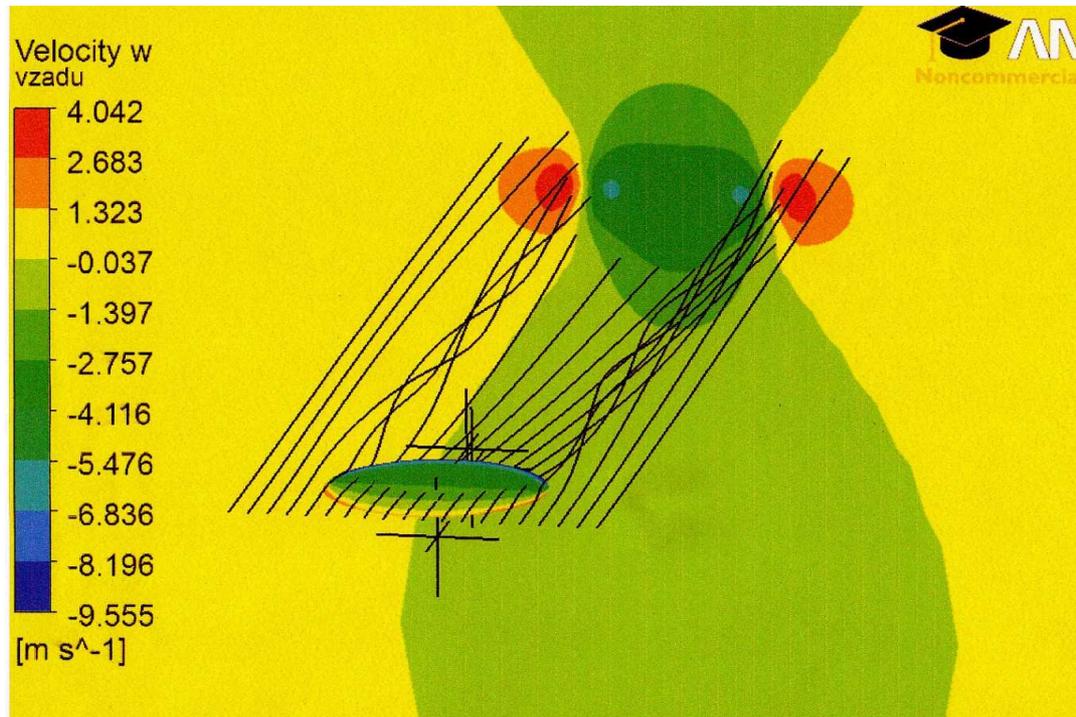
Collision of transport cable with anti-torque rotor of helicopter

The entry of the helicopter in the descending part of rotating air mass, falling with a speed of 8 m.s⁻¹ in the area of the lakes Žabie plesá, was manifested by sudden movement of helicopter with probable decrease of the load factor to a zero-near value ($n_y \approx 0.2$). Subsequently, the flight speed spontaneously increased from 180 km.h⁻¹ to 200 - 210 km.h⁻¹. The pilot with the highest probability subconsciously reacted by pulling on the cyclic pitch lever to correct the increased flight speed. The common denominator of these factors and its consequence was mutual approach of the transport cable and the plane of rotation of the anti-torque rotor. This occurred for the following reasons:

- a) An increase of the flight speed of helicopter after entry in the descending wind gust causes a rise in aerodynamic resistance of underslung load. A larger pull of resistance on the cable carrying the load will be manifested by rise of its position, i.e. approach to the anti-torque rotor.

- c) In the effort to reduce the spontaneous increase in speed caused by the wind gust the pilot probably subconsciously pulled on the cyclic pitch lever (in this case the proper reaction would be to lift the collective pitch control lever) and thus brought the helicopter to the positive pitch angle. The tail boom with anti-torque rotor sank and thus even more approached the raised level of the oscillating end cable section.

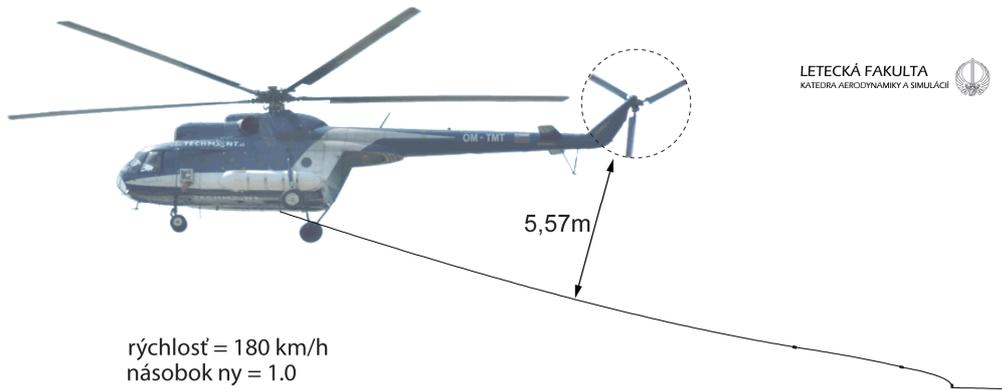
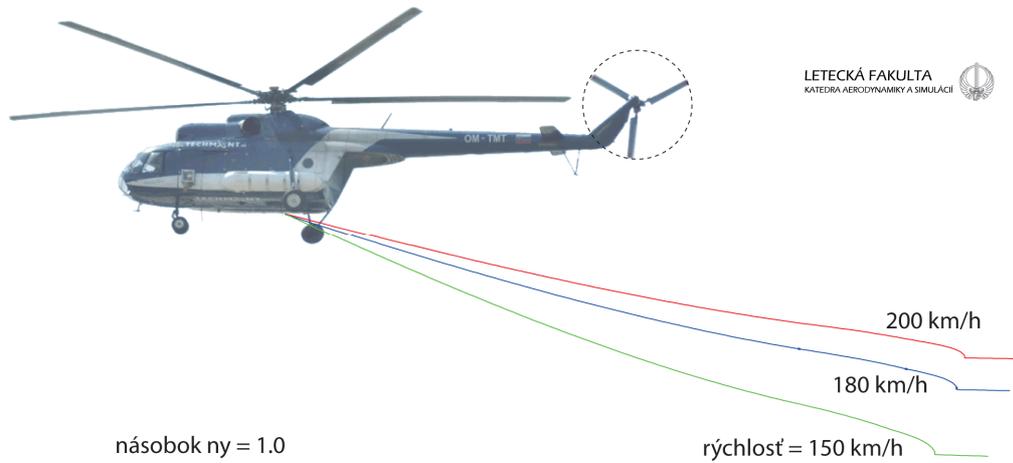
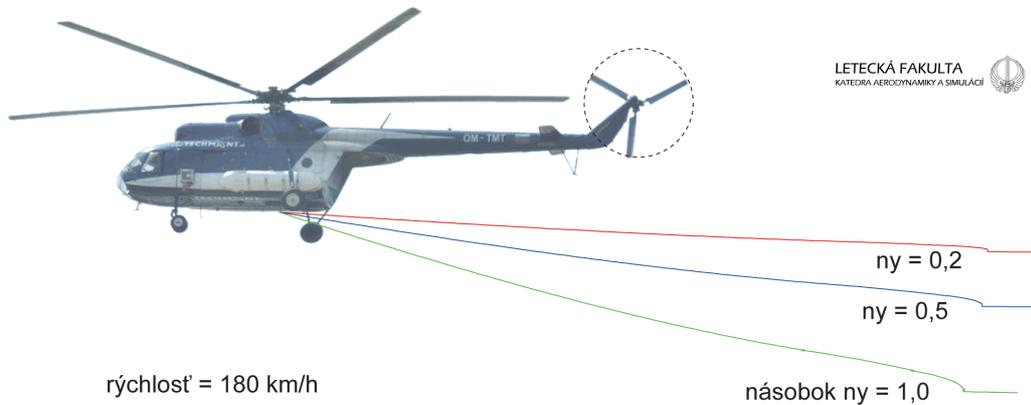
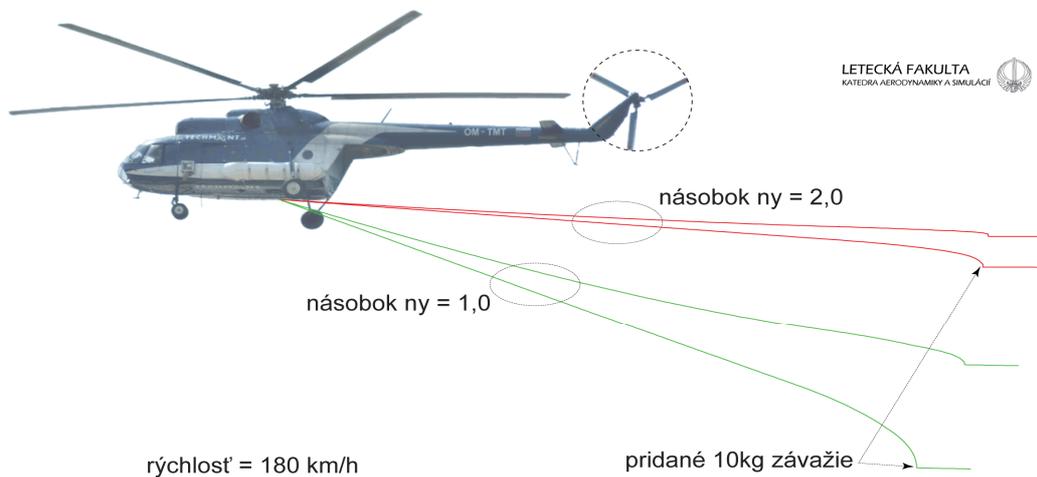
The positions of cable to the helicopter for different flights are shown by the computer simulation.

It must be noted that the described process of dynamic transformations is, timewise and by its location, a split-second random event, often without possibility for the crew to affect its result. Even long years of experiences are not a guarantee of safe flight in mountain conditions. Each flight in mountains is different in a way and the risk of instability of fair masses often does not indicate its presence (e.g. by formation of clouds). In this case the entry of the helicopter in the whirlwind, characterized by complex internal structure of turbulence with large kinetic energy, together with response of the helicopter and reaction of the pilot, were the cause of penetration of the transport cable into the working area of the anti-torque rotor.

Besides the above factors, the initiating impulse for penetration of the cable into the anti-torque rotor was probably the bank and drift of the helicopter. The asymmetric circulation of rotating air mass caused a vigorous sideways motion of the helicopter, which was the impulse for a lateral swing of the cable, in particular its very flexible nylon section, together with canvas strips situated in the core of the descending section of the turbulent vortex. The application of inertial forces of cable masses and aerodynamic forces to flexible nylon strips swept by the whirlwind caused that the end section of the cable rolled up in a loop and at that moment a relatively weak dynamic impulse was enough for it to swing up where it was probably sucked in by underpressure on the suction side of the anti-torque rotor and caught by rotor blades.

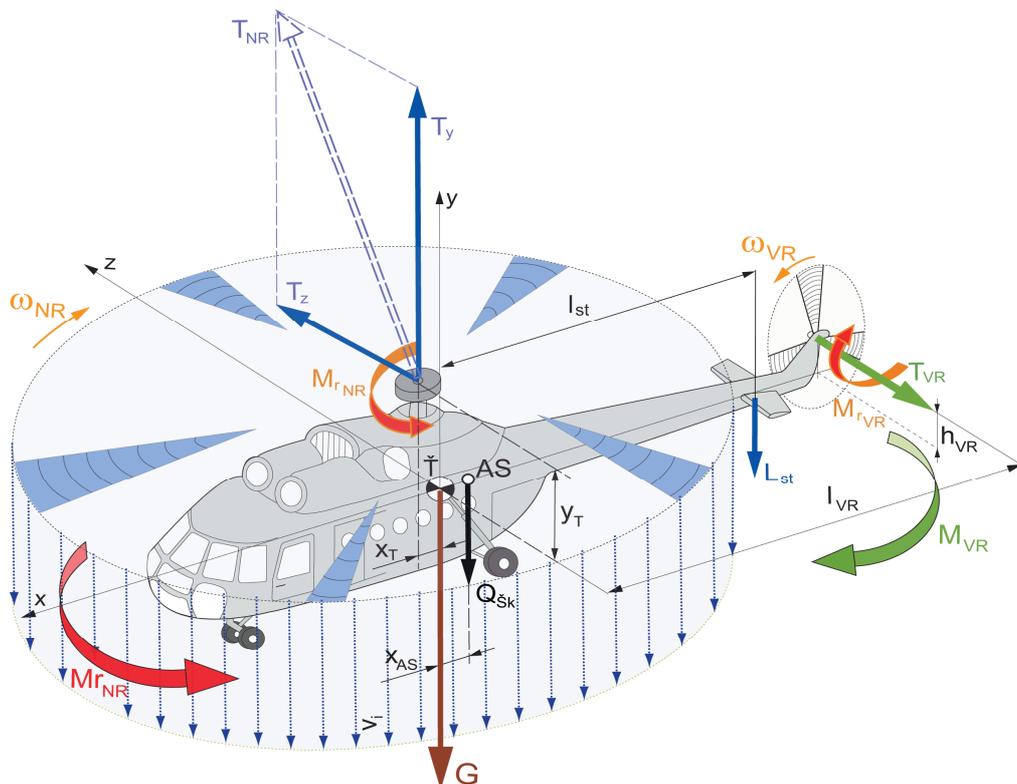
He made the approach from the flight direction and opted for a traditional helicopter landing with deceleration of the flight speed up to the hover position in a height of 3 – 5 m and touch-down by vertical lowering on the grass surface near the concrete runway of the airport. The following picture shows forces and moments affecting the helicopter in the critical final flight phase, which normally ends with helicopter hovering at zero flight speed, under balanced stabilised conditions:

Basic conditions of stabilised helicopter hover:

1. $T_y = W$: condition of constant hovering height
2. $T_z = T_{VR}$: condition of zero lateral shift of helicopter
3. $T_x = 0$: condition of zero shift in the longitudinal direction (axis x)
4. $M_{VR} = M_{rPR}$ condition of constant hovering direction

The main cause of the accident, by which the landing of helicopter ended, is the non-fulfilment of the fourth condition of balance of moments around the vertical axis of helicopter, i.e. $M_{VR} = M_{rPR}$.
