FINAL REPORT

on investigation of accident
of ultra-light aircraft type **TL 2000 STING**
Registration No. **OK- MUA 93**

Date: 19.08.2012

Location: Airport Prievidza / LZPE

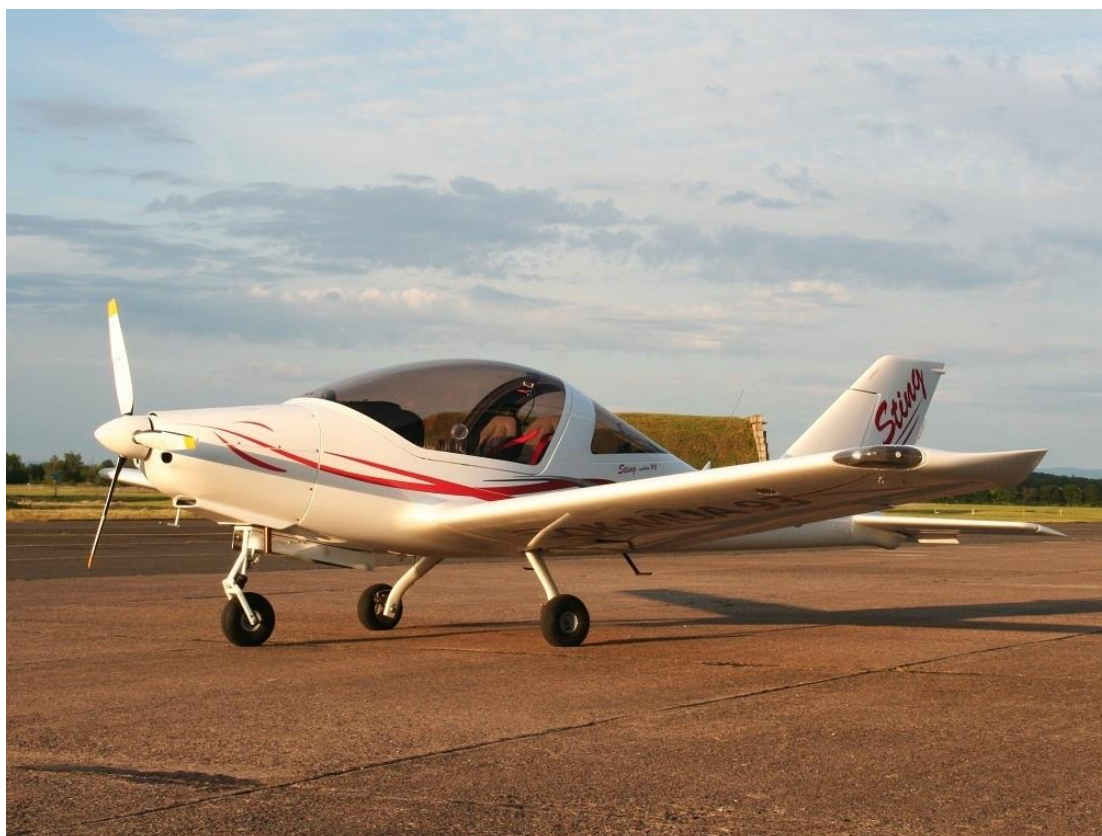
When landing at the airport LZPE, after contact with the grass runway 04 (hereinafter "RWY 04") the aircraft type TL 2000 STING Carbon RG, registration No. OK-MUA93, bounced off and ran out of RWY 04 to the ploughed field, due to which it suffered serious damage. The pilot and the passenger were not injured.

Damaged landing gear, right wing and propeller, engine stopped by force, broken cockpit hood.
