MINISTRY OF TRANSPORT CONSTRUCTION AND REGIONAL DEVELOPMENT OF THE SLOVAK REPUBLIC

FINAL REPORT

on investigation of air accident
of powered paraglider type **ORBIT 3 28 / MINIPLANE TOP80**
without registration number

Date: 17.09.2012

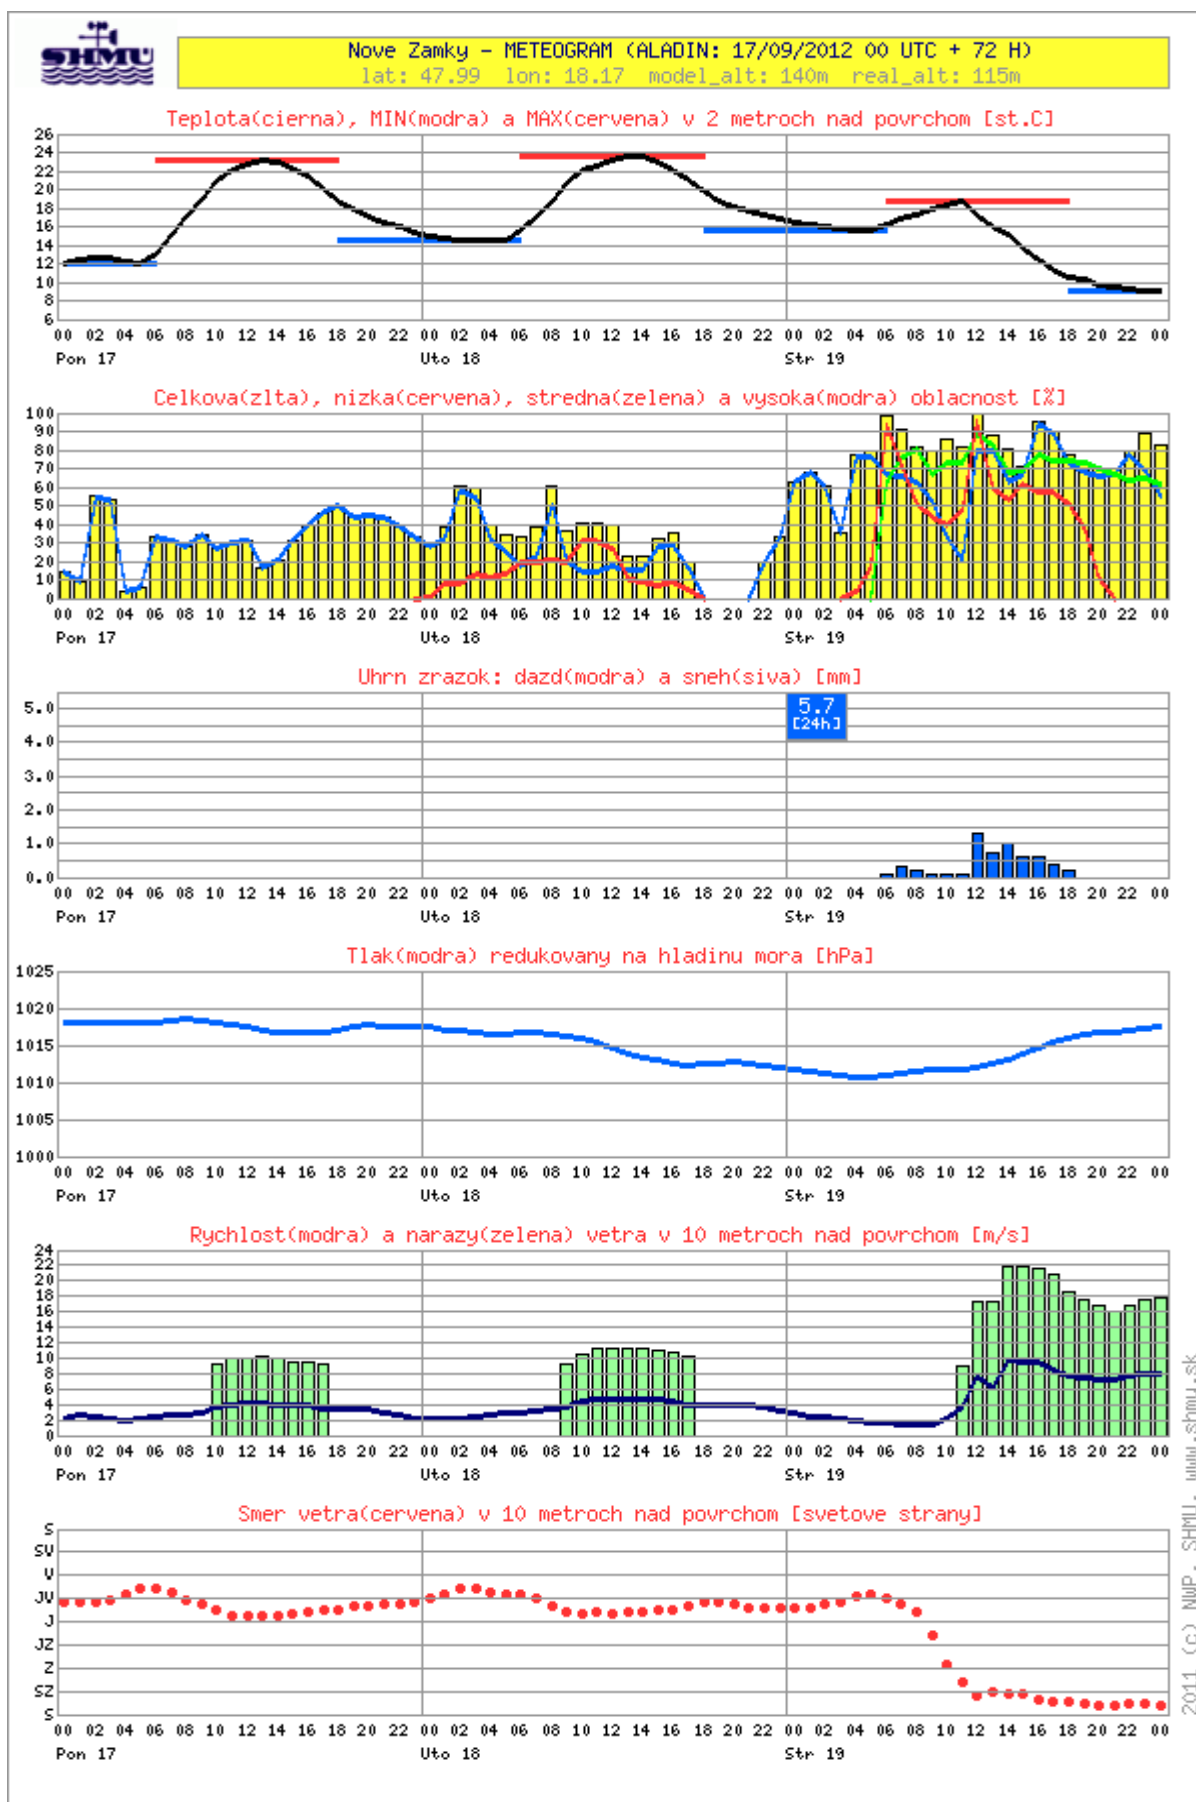
1.7.1. Weather forecast for 17.09 - 19.09.2012 for the location of Nové Zámky

could search for several possibilities of landing in an open area. The current meteorological conditions were more or less identical with weather forecast.

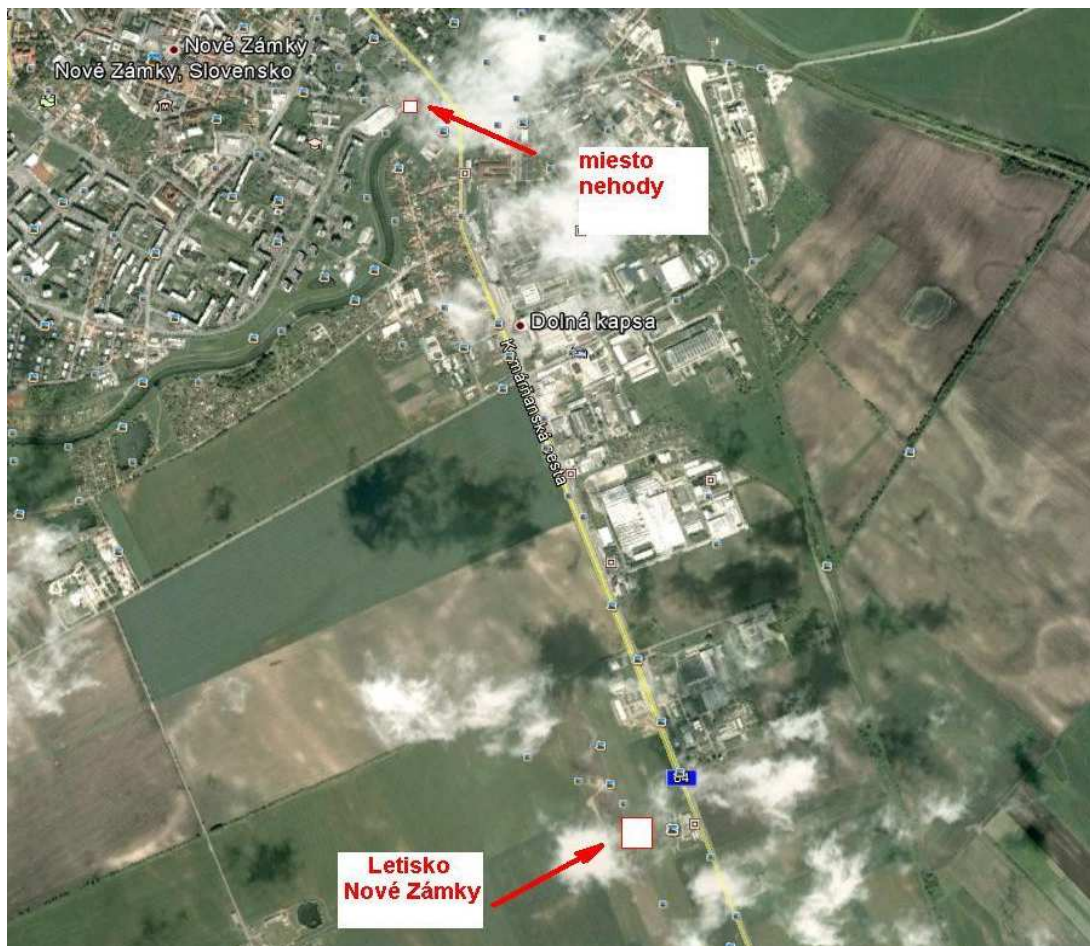
LZNZ is a public domestic aerodrome – take-off site of FSV, situated in an altitude of 115 m (376 ft), described by coordinates N 47° 57' 43.33 ; E 018° 11' 03.98, with runway 16/34, grass surface with dimensions of 1001 m x 69 m.
