FINAL REPORT

on investigation of air accident
of aircraft type **PULSAR**
registration No. **OM-AYF**

Date: 03.10.2012

Place: Airport Nitra / LZNI

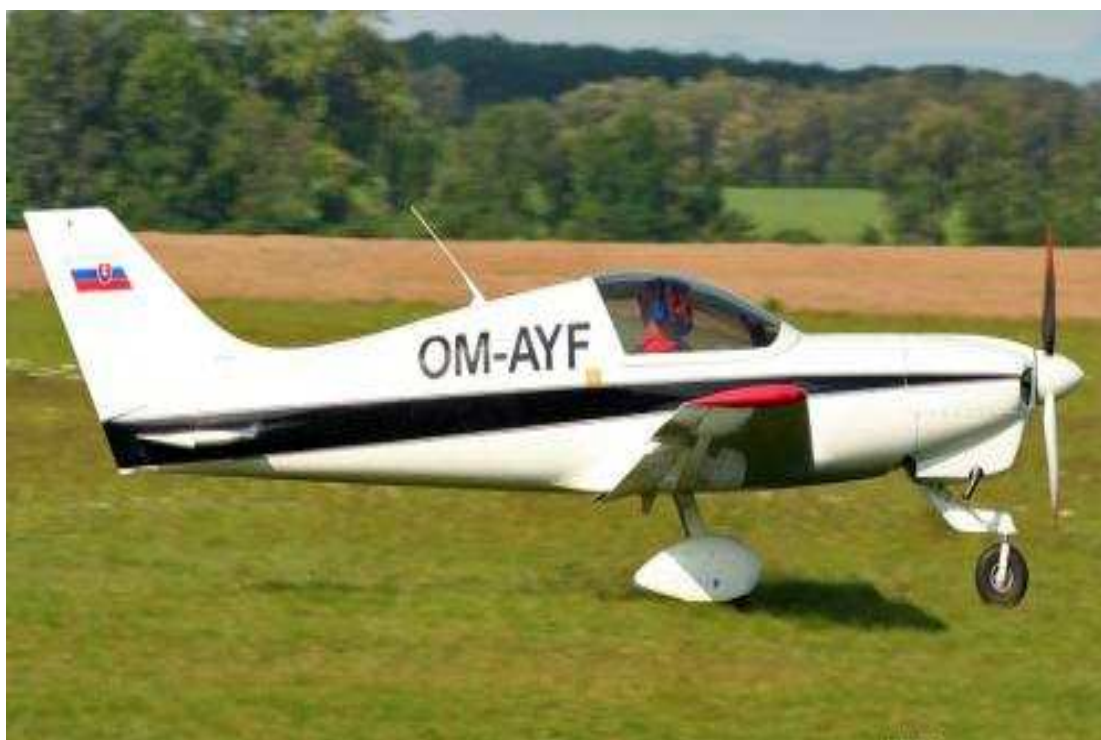
Broken front landing-gear leg, destroyed propeller.

After the last fourth bounce the front landing-gear leg broke off and the aircraft stopped on RWY. When the nose of aircraft inclined to RWY the working propeller got damaged.
