## Lateral runway excursion during landing roll, nose landing gear collapse

<b>Aircraft</b>	Airbus A300-B4 registered EI-EAC
<b>Date and time</b>	16 November 2012 at 4 h 25 UTC <sup>(1)</sup>
<b>Operator</b>	Air Contractors
<b>Place</b>	Bratislava Airport (Slovakia)
<b>Type of flight</b>	International public cargo transport
<b>Persons on board</b>	Captain (PF) ; Copilot (PNF) ; Flight Engineer
<b>Consequences and damage</b>	Aeroplane severely damaged

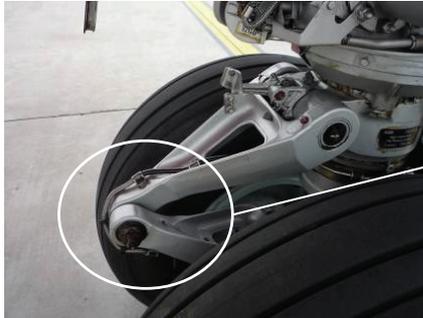
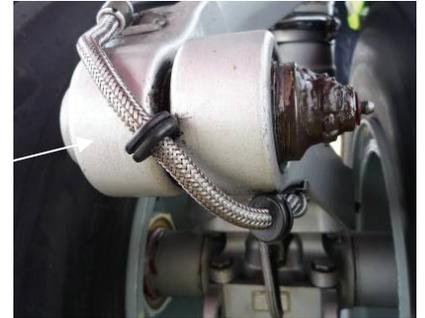
Control of the nose gear steering system is ensured by the assembly of the two shock strut arms. The upper arm, moved hydraulically by pilot inputs on the steering control wheel drives, via this hinge, the movement of the linked lower arm bogie torque link.

Diagram and photos (side and face views) of the NLG torque link assembly on the A300-B4

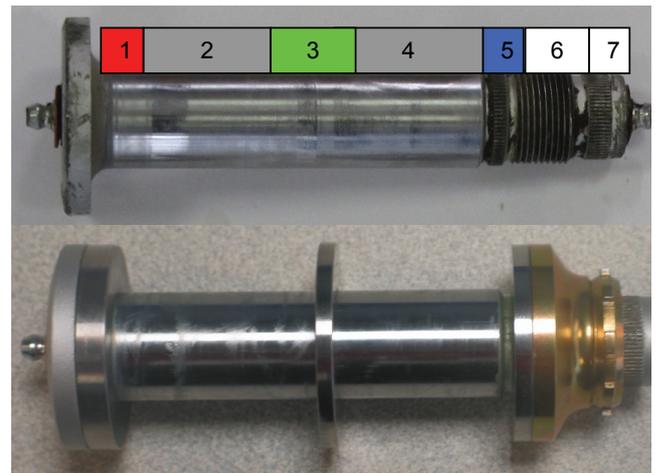
Liaison between the two arms of the torque link is ensured by an apex pin whose end has, successively, grooves, a thread and then more grooves. On this pin the following parts are installed:

1. a bevelled washer (P/N C59853-1),
2. the upper arm bearing,
3. a washer, (P/N C64066-1),
4. the lower arm bearing,
5. a grooved washer (P/N SL40374)
6. a crenelated nut,
7. a washer lock (P/N SL61WTM22P)

Apex pin without the torsion link arms

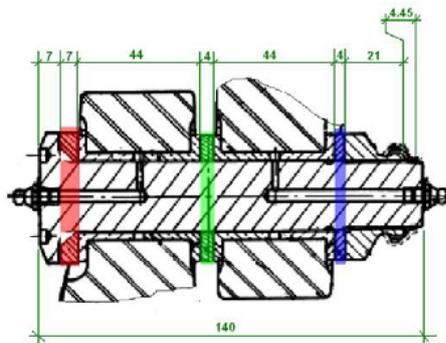
Dimensions

Dimensional analysis of the nominal installation showed that the total length of the assembled element was 140 mm. Once the last washer lock is positioned, the shaft projects by 4.5 mm. 0.5 mm of grooves are visible on the shaft.

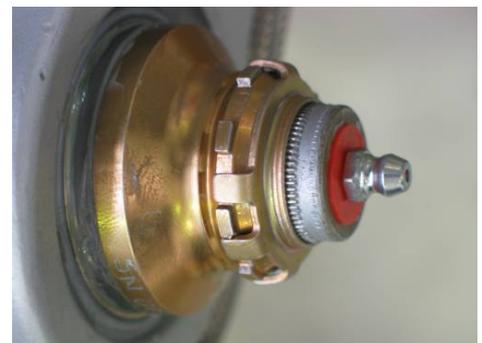
Photo of the end of the shaft with 0.5 mm of grooves visible after the washer lock.
