AVIATION AND MARITIME INVESTIGATION AUTHORITY
Námestie slobody 6, P.O.BOX 100
810 05 Bratislava

FINAL REPORT

on the safety investigation of an air accident
of a glider type **Ventus bT**
registration mark **D-KEYX**

Reg. No: SKA2018003

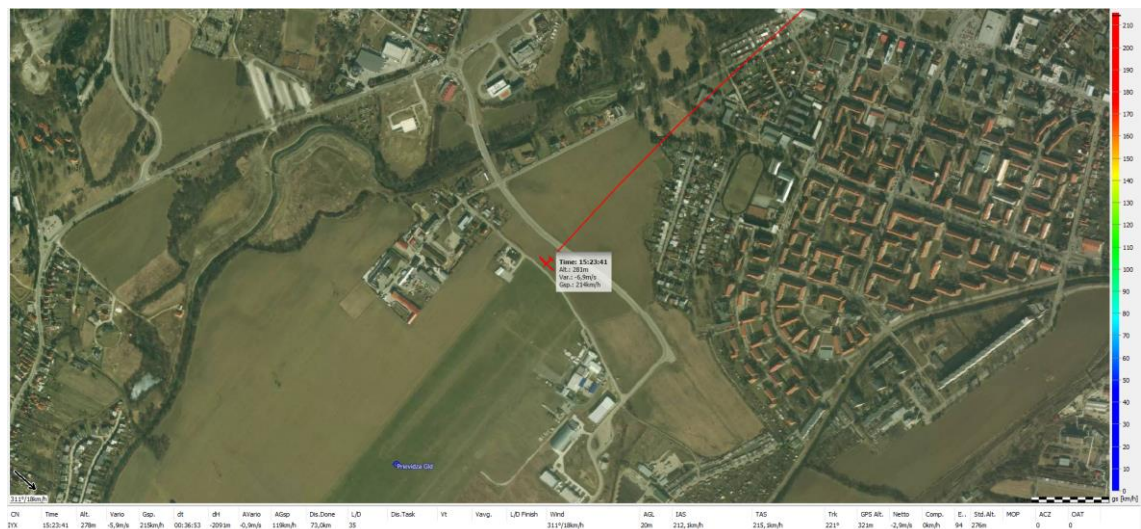
Approximately 50 m before the threshold of VPD22, at an altitude of 20 m, the pilot's landing speed was 214 km/h.

Then the glider made a hard touchdown on VPD22 at high speed without its speed brakes extended.
