FINAL REPORT

on the safety investigation of an air accident
of a helicopter type **Robinson R44 Raven I**
registration mark **OM-TTM**

Reg. No: **SKA2018005**

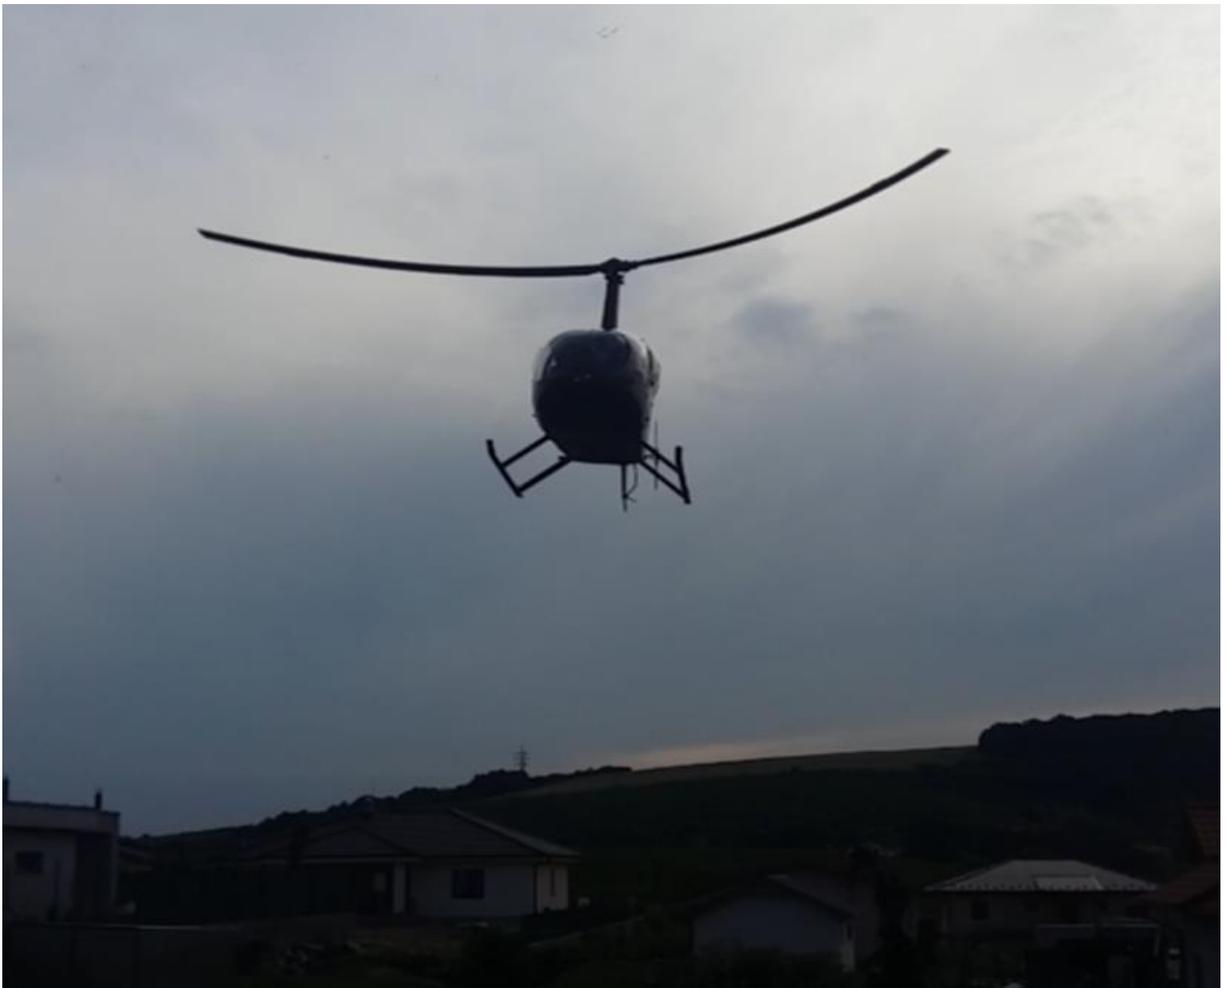
At 16:40 the pilot took off with the R44 in the municipality, heading 085°, and hovered 1 metre above the ground. After hovering above the ground and rotating to the right, the pilot moved with the R44, at an altitude above the rooftops of family houses and with a slow forward speed, heading 215°, in front of the house of his friends whom he had visited. In front of the house he turned left, heading 085°, and while the R44 was hovering, he said goodbye to his friends.

Then the pilot turned the R44 to the left in site. When turning, the pilot pushed the cyclic control stick and, while increasing the engine power, he departed with a descending flight, increasing the forward speed enormously with the heading 330°.

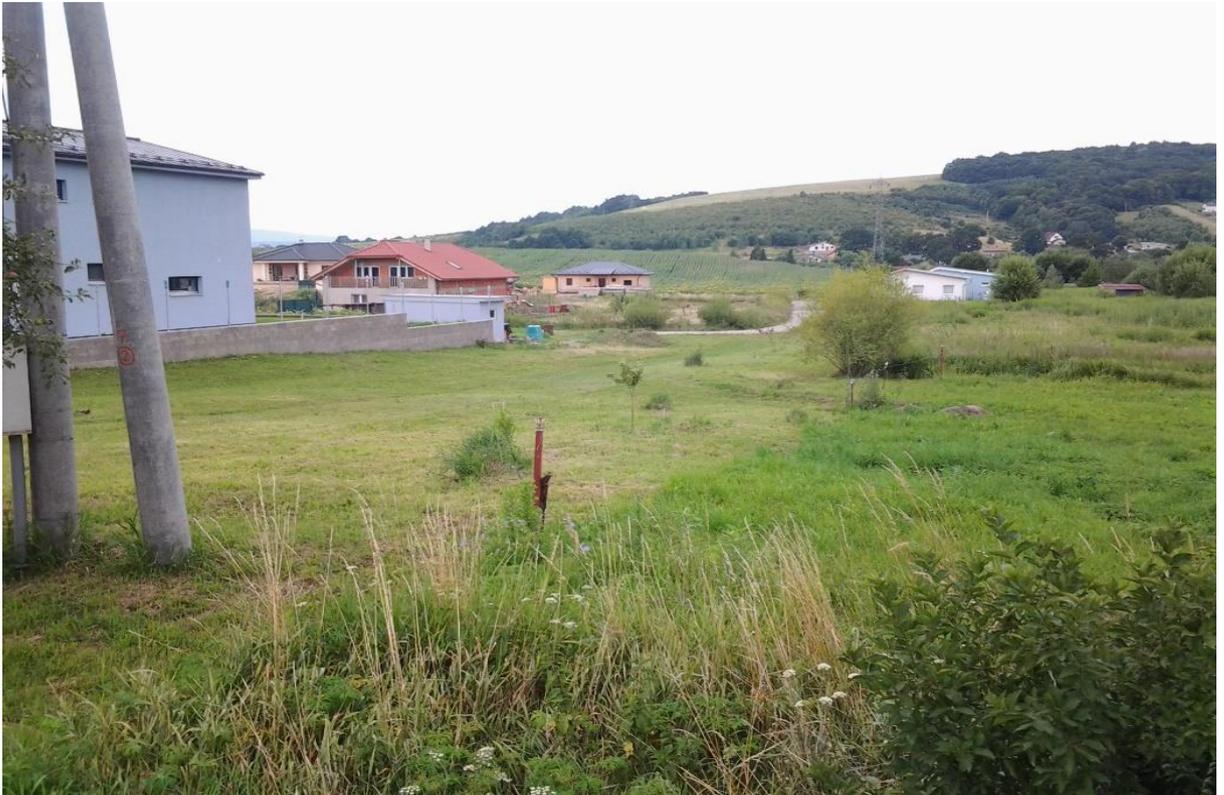
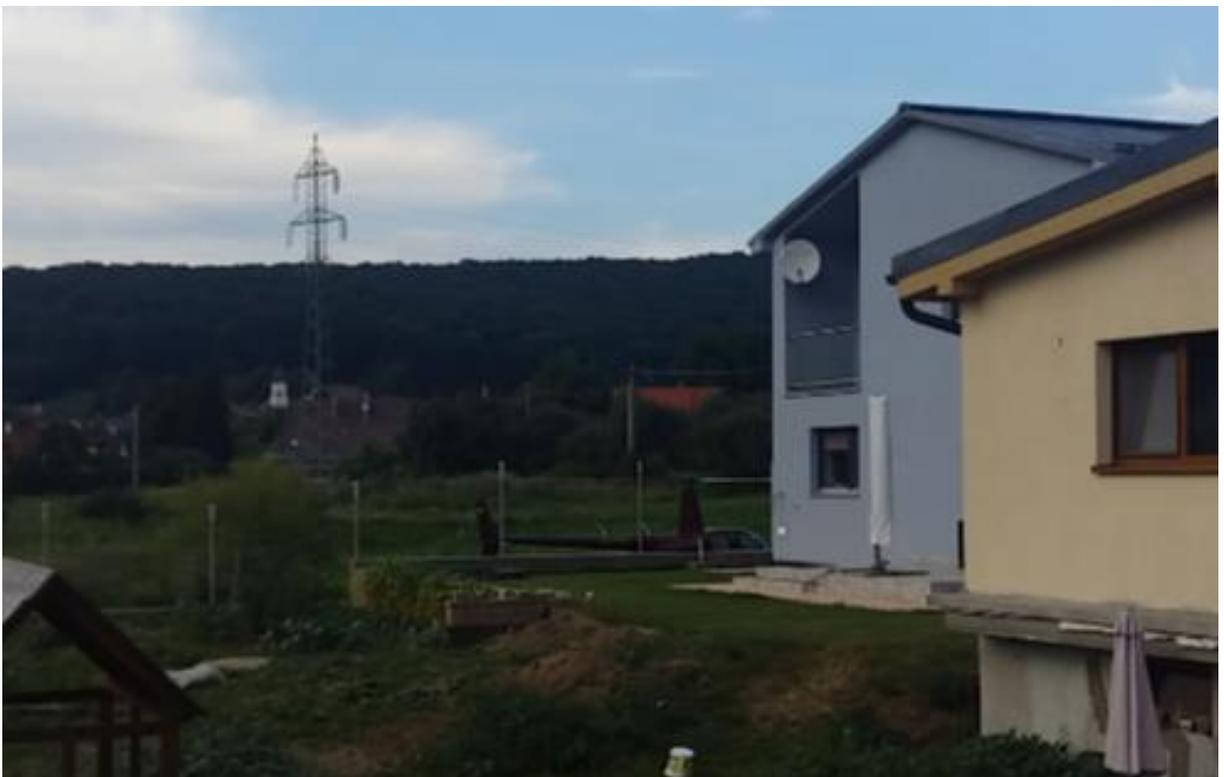
The landing and take-off site may be described as a 25x10 m area with a moderate incline, oriented in the direction 085°/265°, located near a family house with numerous obstacles in the surroundings. After landing, the R44 sat with its front part against the slope.

There was no equipment to indicate the wind direction or speed in the area.
