FINAL REPORT

on investigation of incident
of aircraft type **An-2 TD**
registration No. **OM- RST**

Date: 07.10.2012

Location: Airport Prešov / LZPW

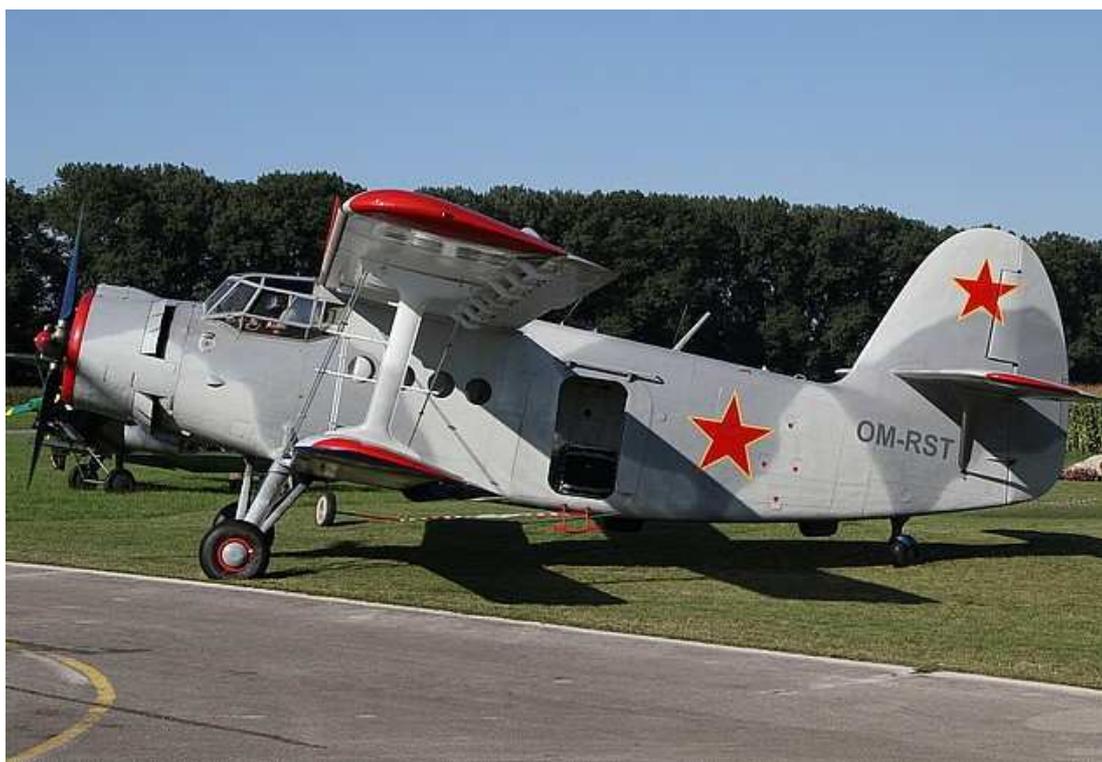
The aircraft wing and propeller were damaged in the incident.

The left wing and propeller of the aircraft were damaged in the air incident.
