**MINISTRY OF TRANSPORT, CONSTRUCTION
AND REGIONAL DEVELOPMENT
OF THE SLOVAK REPUBLIC**

FINAL REPORT

on investigation of an air accident
of powered hang glider **PROFI 14 TL / JOKER TRIKE**
Registration No. **OM - H737**

Date: 12.9.2010

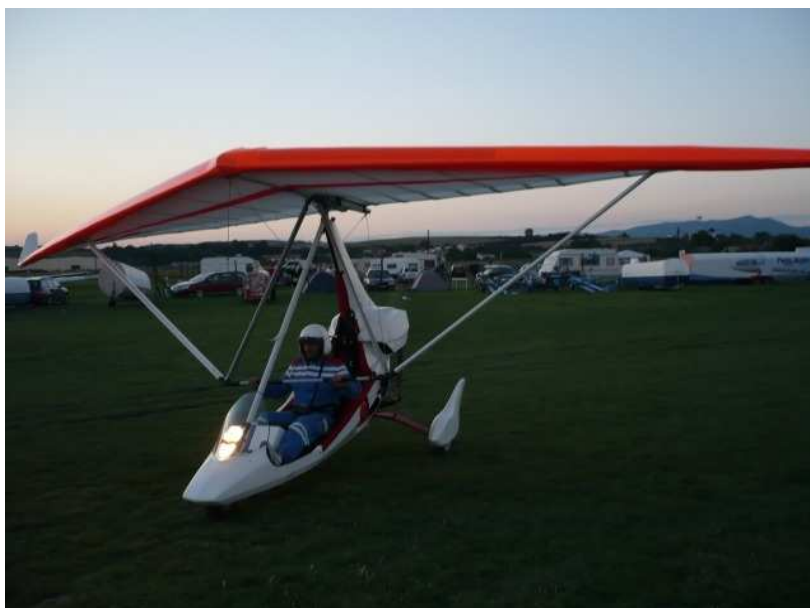
The PHG wing was seriously damaged and its repair seemed to be ineffective. The propeller blades were damaged (split in the length). The PHG landing gear was damaged in the front section.

Fig. 1: Damaged PHG (picture taken after PHG positioning on landing gear wheels)
