Reg. No: SKA2010004

FINAL REPORT

on air accident investigation
of aircraft type **WT-9 Dynamic**
registration: **OM-DYD**

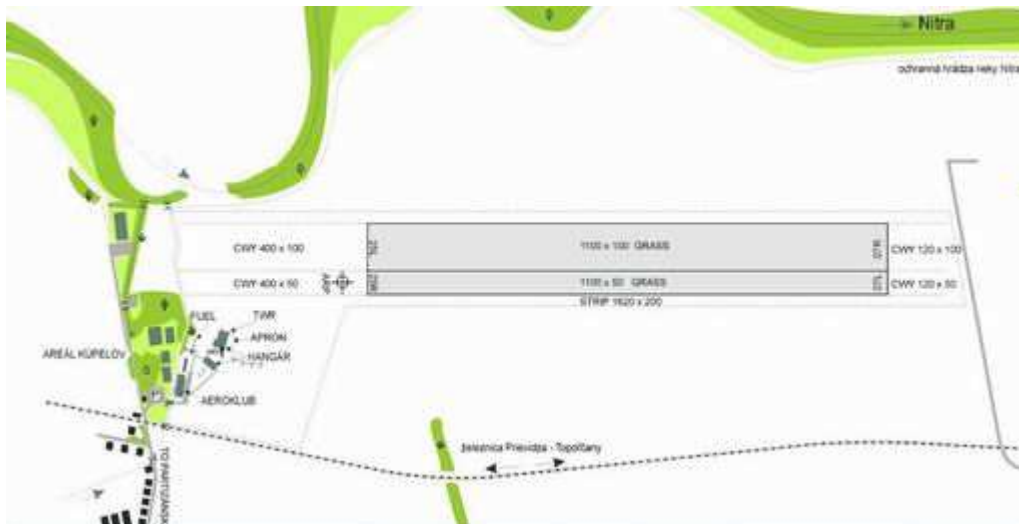
After the air accident the aircraft stopped at the level of threshold marking of the runway 25 with the front landing-gear leg bent backwards and broken propeller blades.

The threaded part of the bearing was broken off. Presence of progressive strips typical for fatigue mechanism of material damage was not detected on the fracture surface.

In the initial area of fracture spreading certain marks of bruised fracture surface caused by power closing of the fracture slot were visible. The fracture can be described as a progressive material damage, where the fracture was spreading step by step across the damaged area under the influence of very short dynamic power impulses (dynamic stress).

In the proximity of the fracture surface, three threads down (the distance corresponds to the height of the nut used in the joint), the presence of a parallel crack with the same orientation was detected.

The expertise showed a progressive breaking-off of the threaded part of the friction bearing of the attachment of the front landing-gear leg suspension. The loading of this component is characterized by forces generated in movement (taxiing, take-off and landing) of an aircraft. The size and frequency of these forces depends on the speed of the aircraft, on the runway bumps and on the landing mode. When an aircraft is used for example for training flights, an increased load of the aircraft structure and hence of the individual elements of the landing gear caused by forces generated in case of hard and repeated landings can be anticipated.

Based on the analysis it can be determined that the cause of the damage was a repeated excessive loading which affected the tear resistance of material used in the examined component.

The cause of the air accident was the breaking-off of the threatened part from the eye of friction bearing SMG 12-40 under the influence of excessive loading of the front landing-gear leg.

The aircraft manufacturer took a preventive measure relating to a one-off check of the component in question with use of colour defectoscopy for all aircrafts that are maintained in its service centre.
