Reg. No: SKA2010009

FINAL REPORT

on air accident investigation
of aircraft **Discus 2a** and **Discus 2T**
registration: **OK – 7000** and **SE - UOA**

Date: 04.07.2010

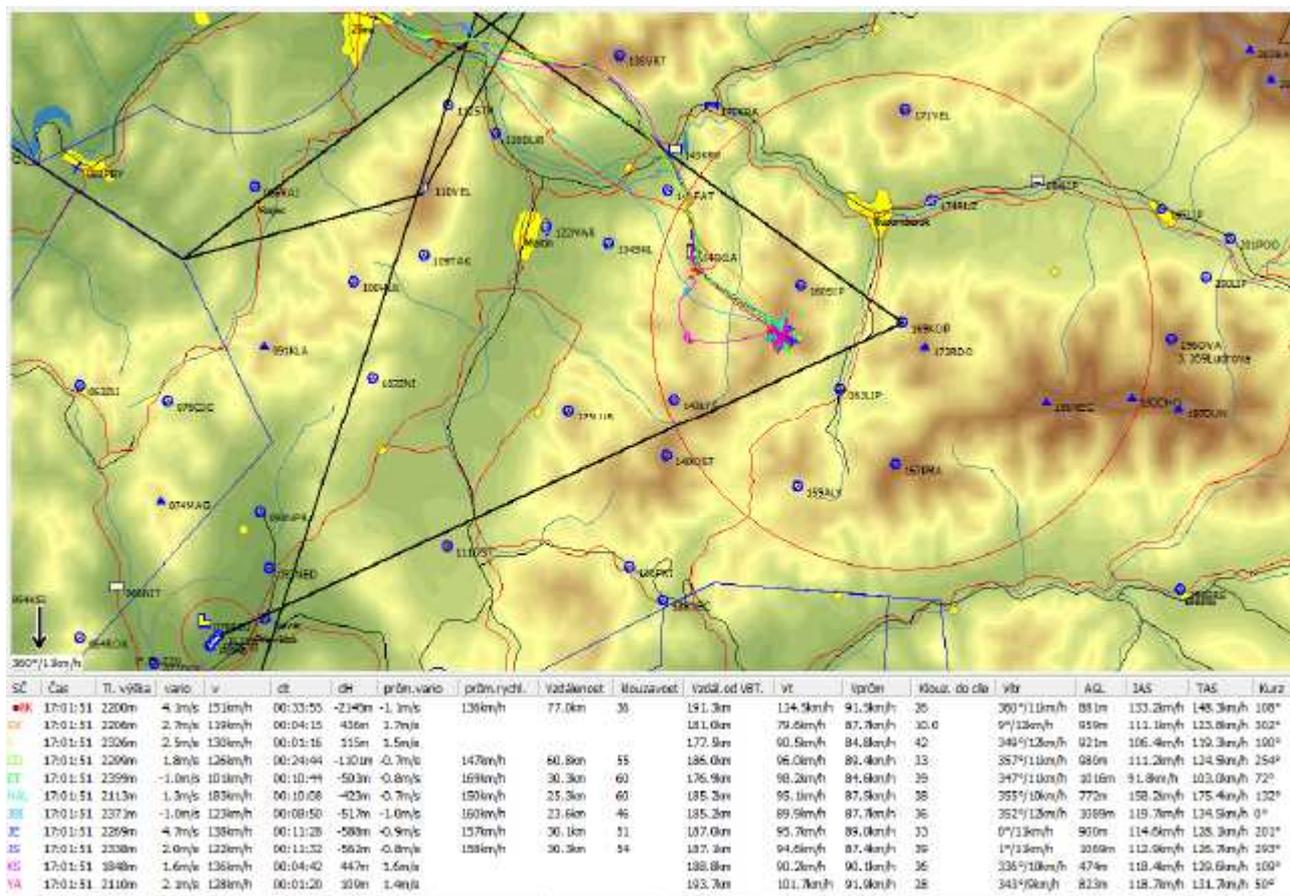
1.12 Wreckage and impact information

10 km SW from the city of Ružomberok. The place of accident is delimited by the geographical coordinates: N 48°59'24''; E 019°12'31''.
