**Reg. No: SKA2010018**

**FINAL REPORT**

of aircraft **FOX 912 3K**

registration No: **OM-DARO**

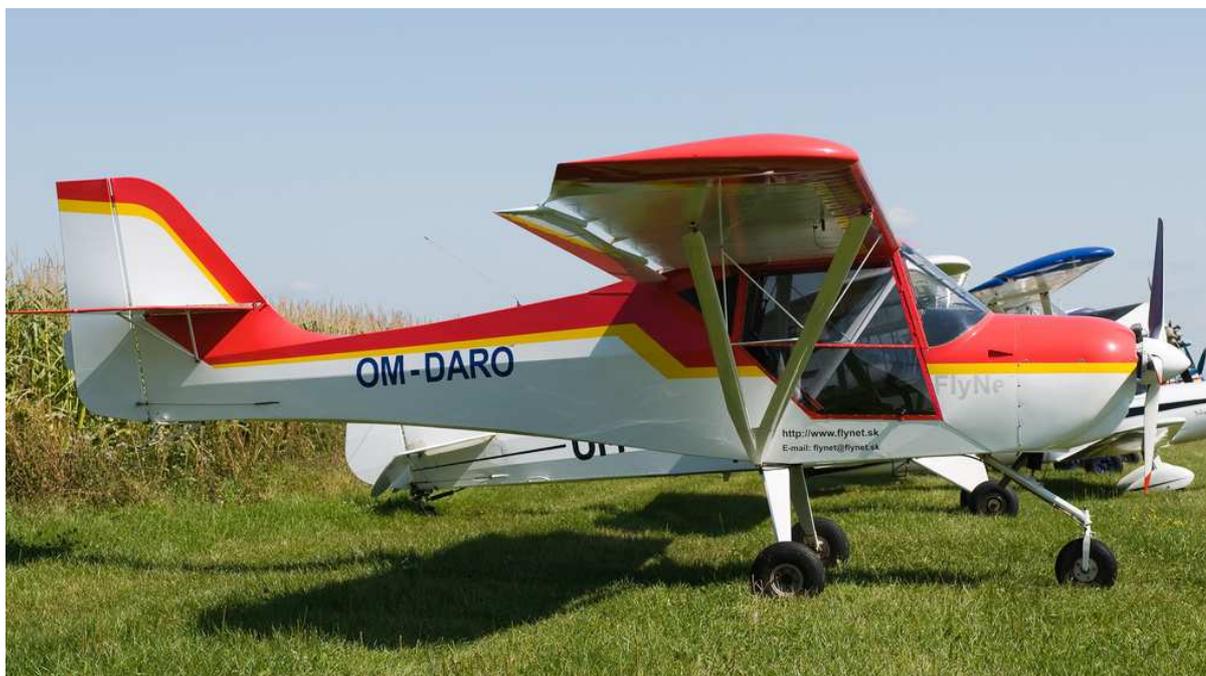
Operator / Owner:	Mgr. Roland Bilovský
Type of operation:	general aviation
Type of aircraft:	AEROPRO FOX 912 3K
Registration No:	OM-DARO
