**Reg. No: SKA2010019**

**FINAL REPORT**

on investigation of an air accident  
of aircraft type **CESSNA 172 S**  
registration No. **OM-AKT**

Date: 12.08.2010

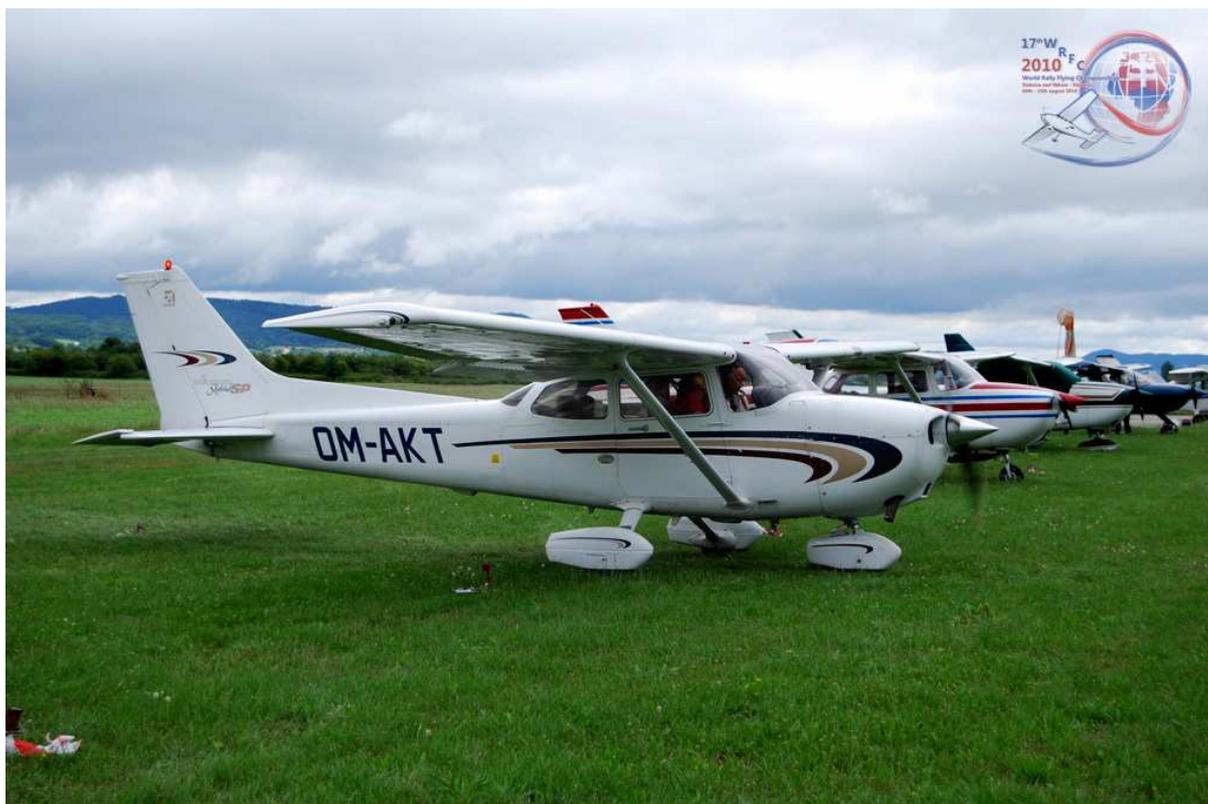
- Corrugated skin between the front door frame (wing strut) of the right pilot and attachment of the right MLG
- Deflected tube of right-hand landing gear and deformed covering in the area of the right-hand landing gear riser
- Broken (plastic) aerodynamic cover of vertical rudder
- Deflected end (approx. 2 cm) of the right horizontal rudder
- Depressed covering of body
- Broken bracing of the right-hand elevator.
