# FINAL REPORT

on the safety investigation of an air accident  
of aircraft type **Pilatus PC-6/B2-H4**  
registration mark **OM-FAA**

Reg. No: **SKA2019004**

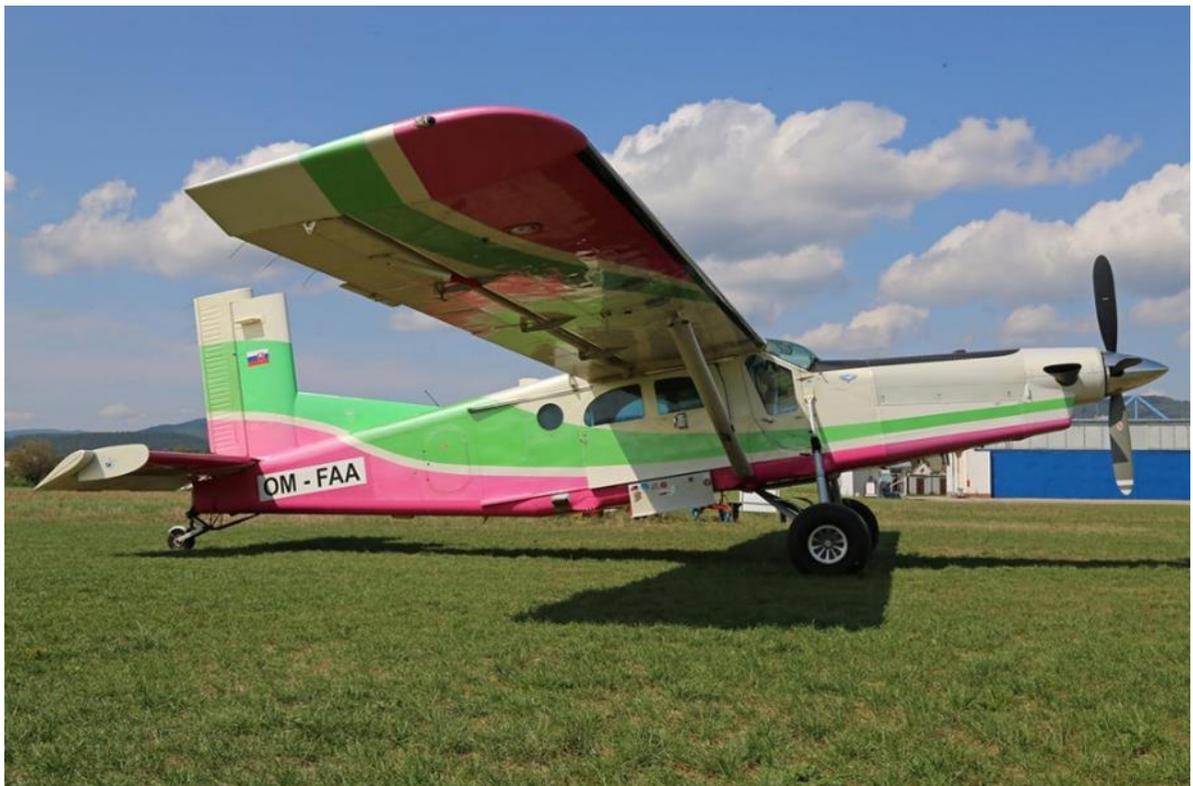
Aircraft type: Pilatus PC-6/B2-H4  
Registration mark: OM-FAA

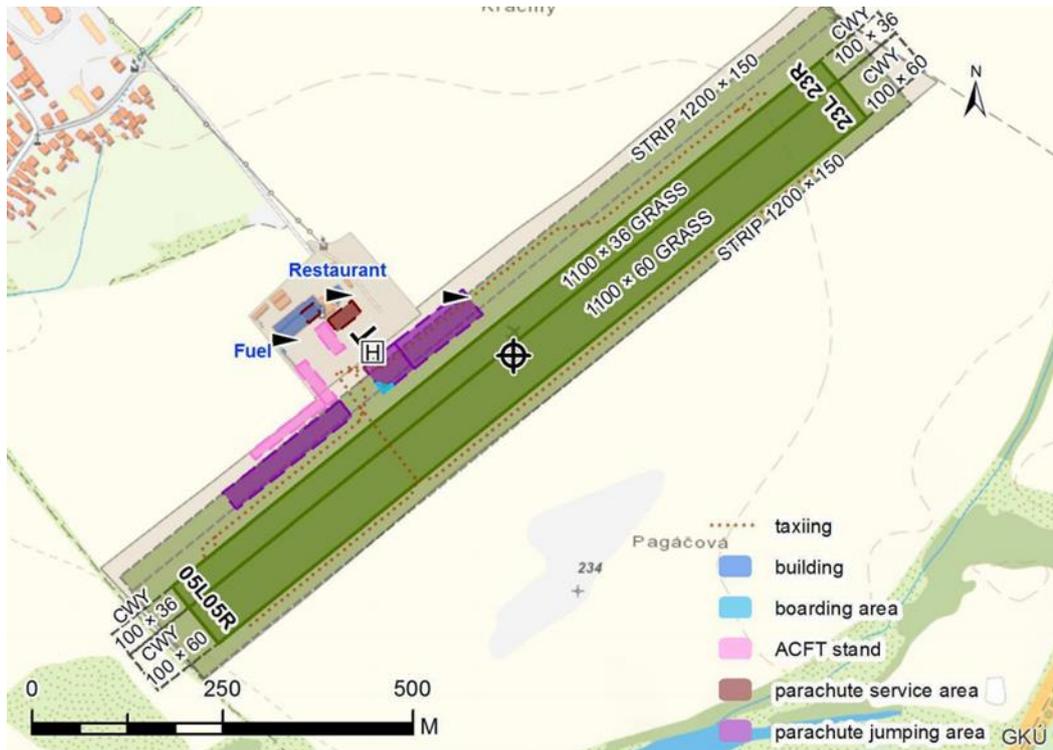
Airport chart published in the VFR Manual from 28 March 2019.

Parachuting activities at LZDB were performed based on the Dubnica Airport Operations Manual valid from 1 March 2008. Amendment 6 was made on 10 July 2018, regulating the procedures of performing parachuting activities where zones designated for parachuting staff were specified (parachute service area, boarding area, parachutist jumping area).
