AVIATION AND MARITIME INVESTIGATION AUTHORITY
Námestie slobody 6, P.O.BOX 100
810 05 Bratislava

FINAL REPORT

on safety investigation of an aviation accident
of an aircraft type **PIPISTREL VIRUS SW 121**
with registration mark **OM-PFC**

Reg. No: **SKA2019005**

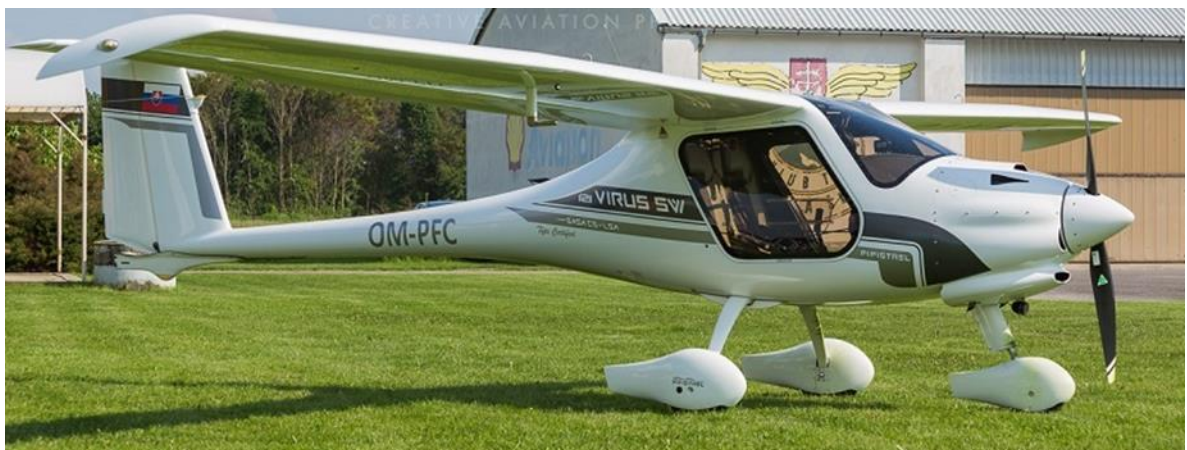
The aircraft sustained major damage during landing. The pilot did not suffer any injuries.

The cause of the aviation accident was an inappropriate response of the pilot to the aircraft bounce (wrong correction of the mistake when the aircraft bounced), resulting in a hard hit of the front landing gear with VPP MC.
